### **Inspection Report (Excavator)**

B&B Stock Number	A9837265
Year	2011
Make	John Deere
Model	135D
Serial Number	1FF135DXHBD302793
Hour Meter Reading	6396.9
Previous Application (e.g., earth moving, mining, demolition, etc)	Earth moving

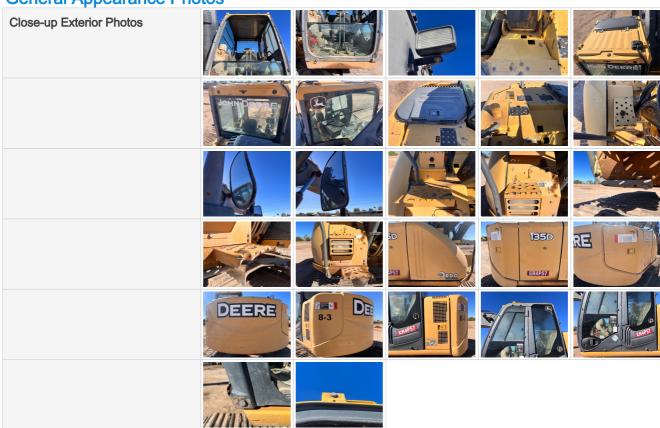
## **General Appearance Photos**

Inspection Rating Criteria	Rating Scale	Explanation	
	1 - Service Required	Requires immediate repairs to function as expected.	
	2 - Above Average Wear & Tear	Exhibits greater wear than expected given age and usage. While operable, further diagnosis may be needed.	
	3 - Normal Wear & Tear	Exhibits wear that is consistent with age and usage. Operation is normal, and as expected.	
	4 - Very Light or Minimal Wear	Exhibits very minimal wear. Operation is better than expected given age and usage.	
	5 - Like New, Recently Replaced	Excellent condition, free of visible wear or damage. Operation is within factory specifications.	
Body Panels	2 - Above Average Wear &	Tear	
Body Panel Condition	Visible chipped paint or de	nts

Doors / Canopy Latches	2 - Above Average Wear & Tear
Doors / Canopy Latches Condition	Intermittent sticking observed on one or more latches/doors
Comments	Door latch sticks
Steps / Ladders	2 - Above Average Wear & Tear
Steps / Ladders Condition	Bent or broken steps or rungs
Handrails	1 - Service Required
Handrails Condition	Bent or broken railings, Other (see comments)
Comments	Entry handrail missing/right side rail bent missing hardware
Glass	3 - Normal Wear & Tear
Mirrors	2 - Above Average Wear & Tear
Mirror Condition	One or more mirrors are broken or missing
Comments	Driver side mirror missing
Exterior Lights	2 - Above Average Wear & Tear
Exterior Lights Condition	One or more exterior lights are non-operational
Comments	Missing head lights
Overall Exterior	2 - Above Average Wear & Tear
Comments	Above average wear and tear. Missing components

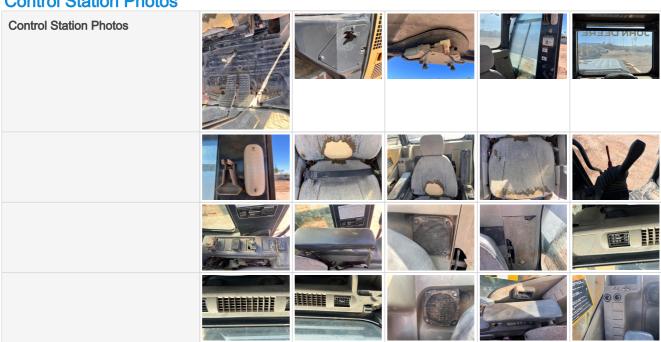
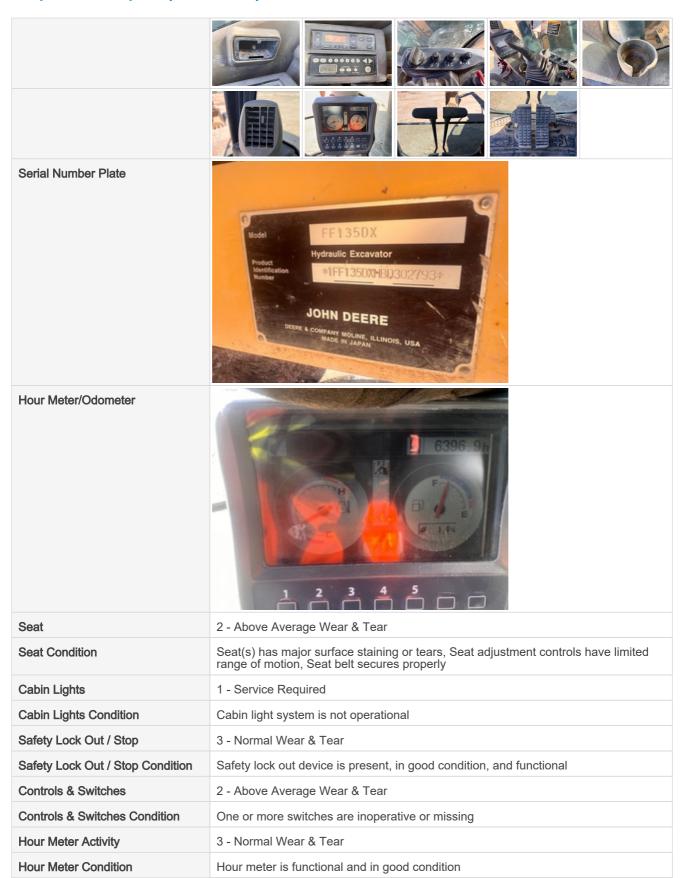
### **Control Station Photos**

Other Gauge Activity	3 - Normal Wear & Tear
Other Gauge Condition	All cockpit gauges are functional and in good condition
Heater & A/C	1 - Service Required
Heater & A/C Condition	Fan vents are not blowing air
Travel Alarm	1 - Service Required
Travel Alarm Condition	System is configured but not operating correctly
Horn	1 - Service Required
Horn Condition	Horn installed but functioning improperly
Backup Camera	0
Control Station Overall Rating	2 - Above Average Wear & Tear
Control Station Overall Condition	Minor cosmetic wear to cabin surfaces, floors, panels, and ceiling

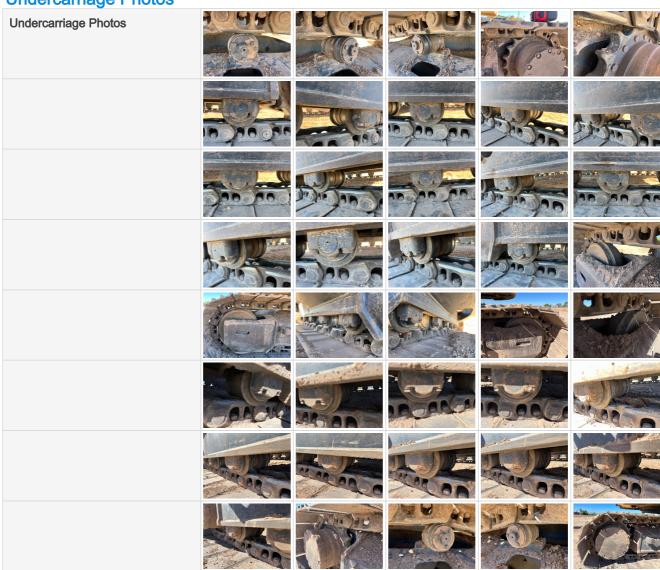
**Undercarriage Photos**

Sprocket Teeth	2 - Above Average Wear & Tear
Comments	Worn
Track Bushings	2 - Above Average Wear & Tear
Track Frames	3 - Normal Wear & Tear
Pivot Shafts	0

Equalizer Bar & Joints	0
Front Idler	3 - Normal Wear & Tear
Track Tensioner	3 - Normal Wear & Tear
Track links	3 - Normal Wear & Tear
Bottom Rollers	2 - Above Average Wear & Tear
Comments	Worn
Carrier Rollers	2 - Above Average Wear & Tear
Comments	Worn
Overall Undercarriage	3 - Normal Wear & Tear
Overall Percent Estimate	30%
Overall Undercarriage Comments	Above average wear and tear
