Inspection Report (Excavator)

B&B Stock Number	A1240083
Year	2017
Make	Hyundai
Model	HX220 L
Serial Number	HHKHK601HH0000489
Hour Meter Reading	6678.5
Previous Application (e.g., earth moving, mining, demolition, etc)	Earth moving

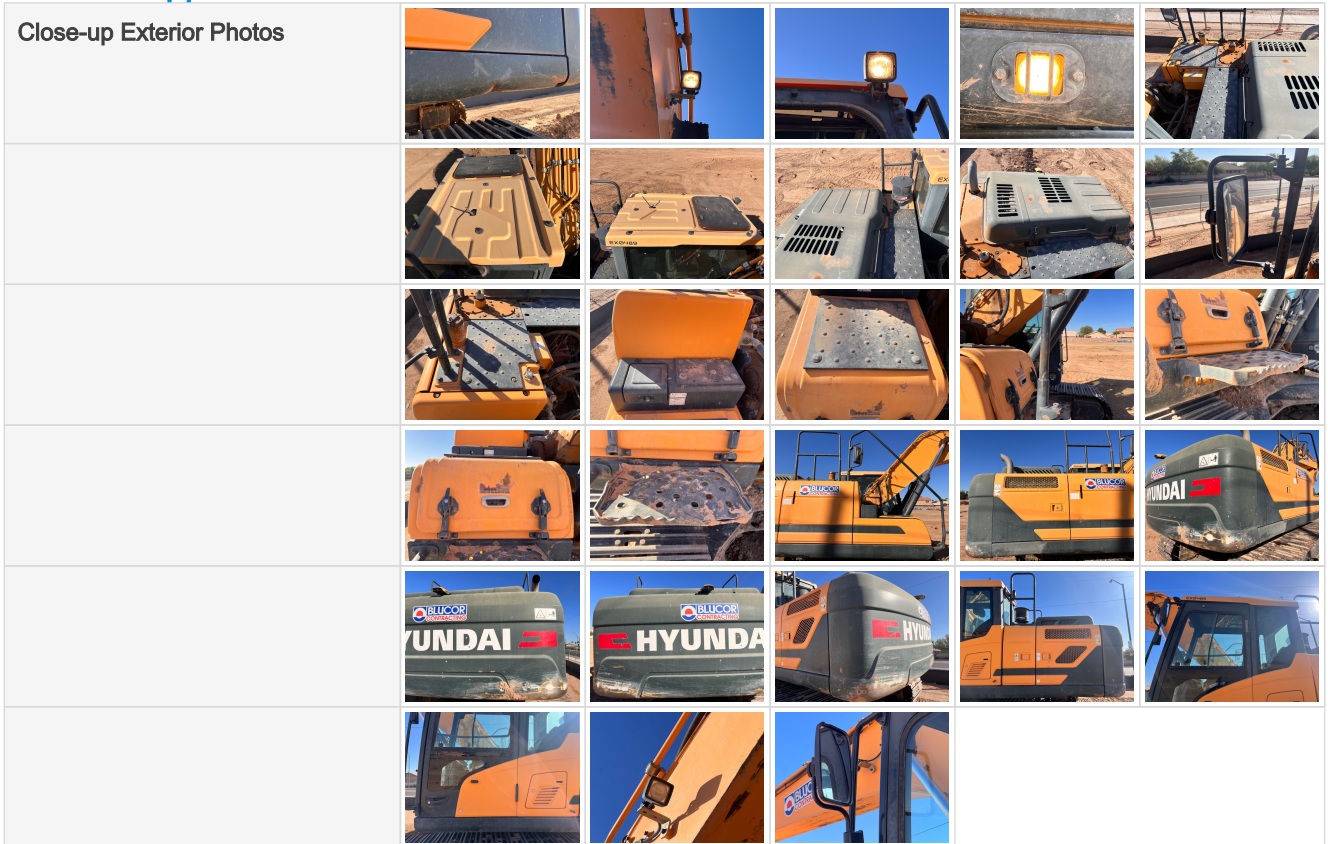
General Appearance Photos

Doors / Canopy Latches Condition	Intermittent sticking observed on one or more latches/doors
Steps / Ladders	2 - Above Average Wear & Tear
Steps / Ladders Condition	Bent or broken steps or rungs
Comments	Right side step bent
Handrails	3 - Normal Wear & Tear
Handrails Condition	Handrails are fully intact and appear structurally sound
Glass	3 - Normal Wear & Tear
Glass Condition	Glass intact, no visible damage
Mirrors	2 - Above Average Wear & Tear
Mirror Condition	One or more mirrors are broken or missing
Comments	Missing right side mirror
Exterior Lights	2 - Above Average Wear & Tear
Exterior Lights Condition	One or more exterior lights are non-operational
Comments	Right side boom light inoperative
Overall Exterior	3 - Normal Wear & Tear
Comments	Normal wear and tear. No major issues to report

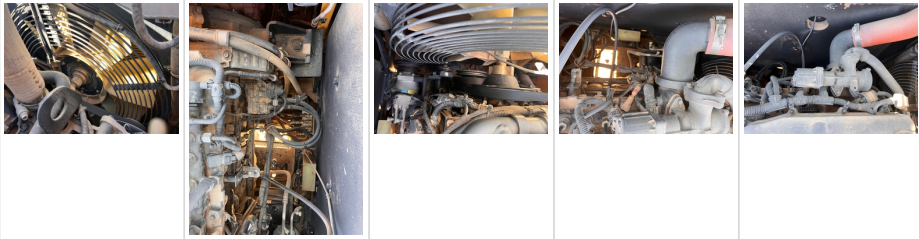
Engine Compartment Photos

Overall Engine Rating	3 - Normal Wear & Tear
Overall Engine Appearance	Very dirty
Overall Engine Comments	Broken coolant reservoir tank / fuel leak low coolant alarm

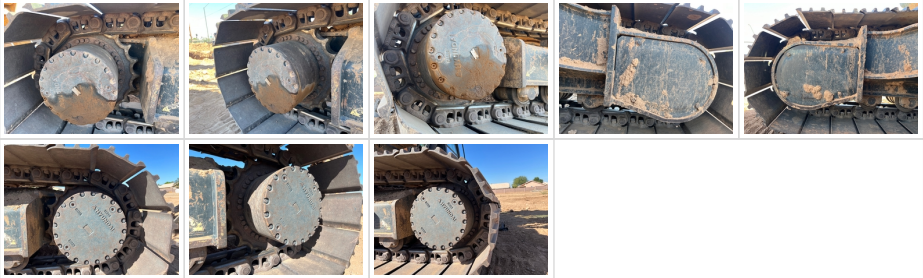
Drivetrain Photos

Hydrostatic Drive Configuration	Other (see comments)
Comments	Drive motors
Drive	N/A
Transmission Components	0
Drive Motors	2 - Above Average Wear & Tear
Comments	Seepage at rear right drive motor
Parking Brake	0
Overall Drivetrain Rating	3 - Normal Wear & Tear
Overall Drivetrain Comments	Seepage at rear right drive motor. Normal wear and tear. No major issues to report

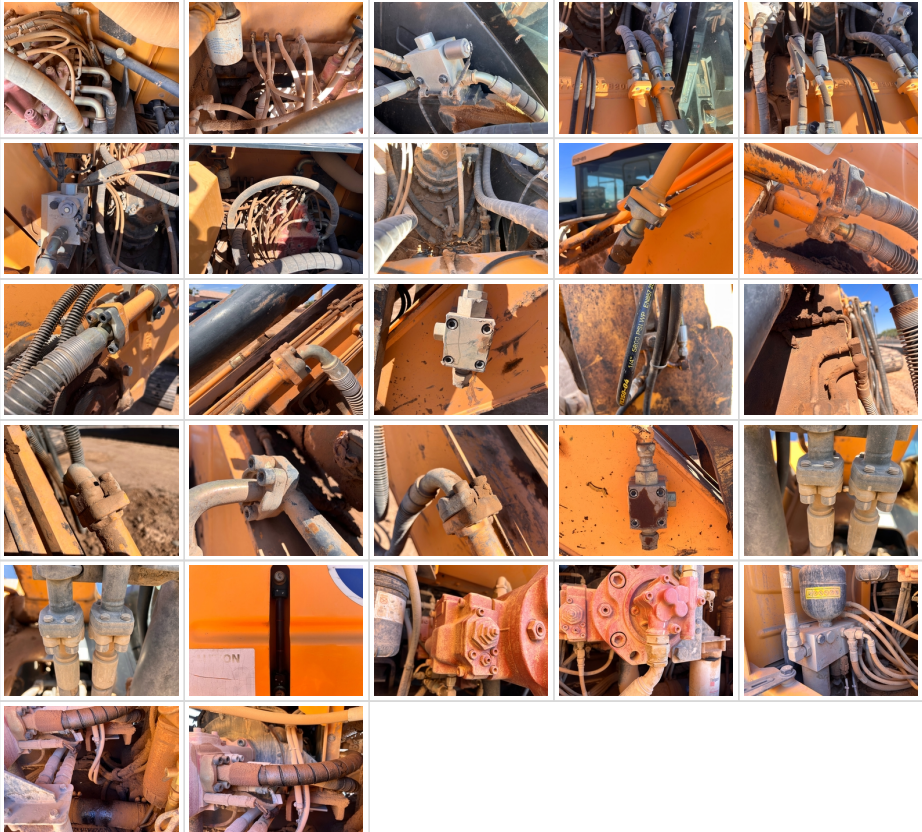
Hydraulic System Photos

Wet or Damp Hydraulic Lines / Fittings	Yes				
Hydraulic Lines/Fittings	3 - Normal Wear & Tear				
Hydraulic Lines / Fittings Condition	Hydraulic lines & fittings are clean and in good condition

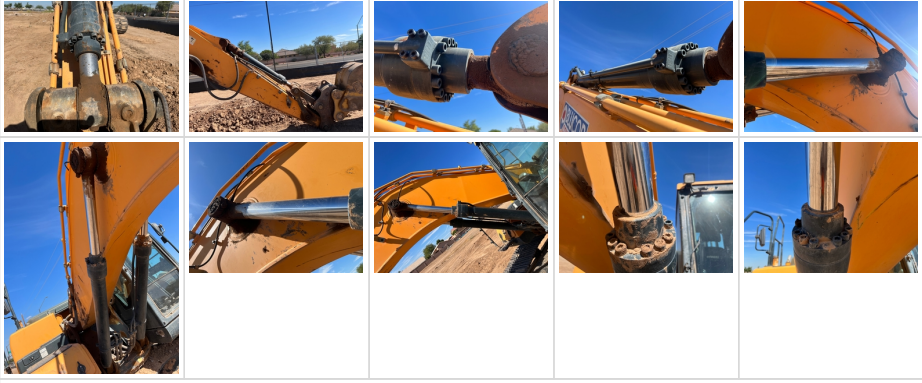
Hydraulic Cylinder Photos

Mounting Pins	3 - Normal Wear & Tear				
Cylinder Oil Leaks	No				
Hydraulic System Overall	2 - Above Average Wear & Tear				
Comments	Dried seepage/ wet hydraulic lines

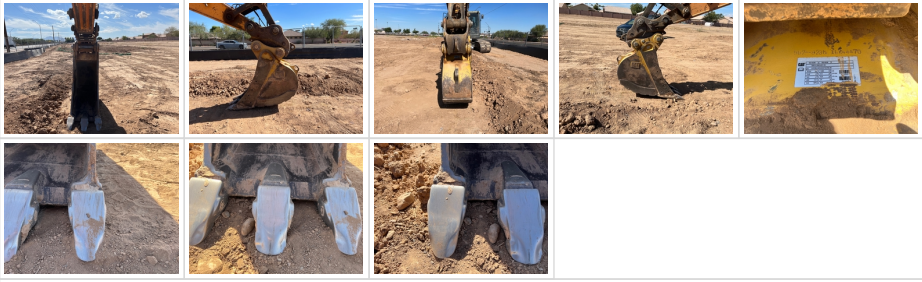
Attachment Photos

Bucket	3 - Normal Wear & Tear				
Bucket Teeth	2 - Above Average Wear & Tear				
Blade	0				
Blade Edge	0
