Inspection Report (Boom Lift)

B&B Stock Number	A8315419
Year	2002
Make	Genie
Model	S-60
Serial Number	MO6005
Hour Meter Reading	7414
Previous Application (e.g., earth moving, mining, demolition, etc)	used in rental equipment

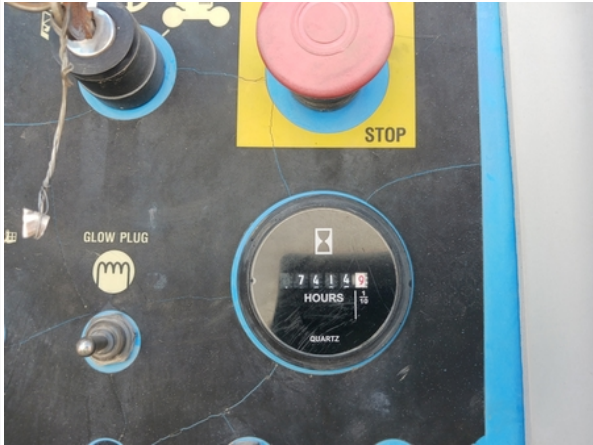
Hour Meter/Odometer

Seat	0
Cabin Lights	0
Safety Lock Out / Stop	3 - Normal Wear & Tear
Safety Lock Out / Stop Condition	Safety lock out device is present, in good condition, and functional
Controls & Switches	3 - Normal Wear & Tear
Controls & Switches Condition	All switches are installed and functional
Hour Meter Activity	3 - Normal Wear & Tear
Hour Meter Condition	Hour meter is functional and in good condition

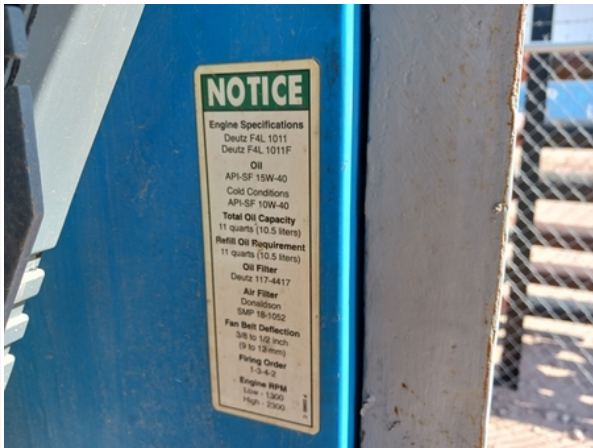
Engine Data Plate

Engine Type (Make, Model, Cylinders, Hp)	Deutz, F4L 1011			
Emissions Tier	Undetermined			
Engine Serial Number	unable to verify			
Engine Fuel Type	Diesel			
Blow-by (Visual Observation Check)	No			
Unusual Noises (Upon Start-up, Idle, Shutdown)	No			
Engine Smoke (Upon Start-up, Idle, Shutdown)	No			
Engine Exhaust Color	Clear			
Battery	3 - Normal Wear & Tear

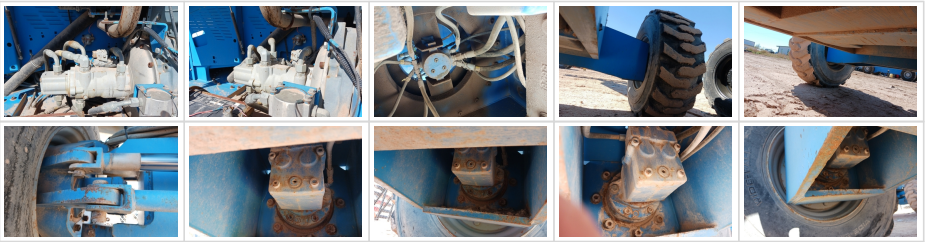
Drivetrain Photos

Hydrostatic Transmission?	Yes					
2 Speed?	No					
Hydrostatic Drive Configuration	Other (see comments)					
Comments	unable to determine

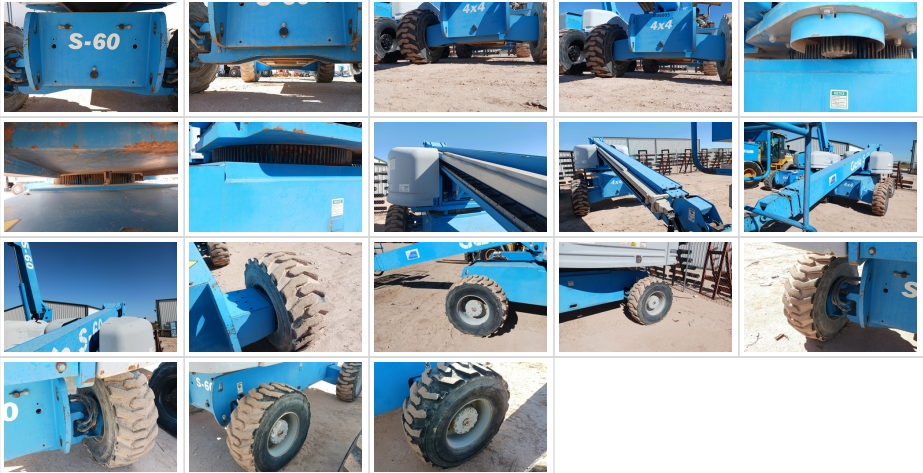
Chassis Photos

Frame	3 - Normal Wear & Tear				
Stance	3 - Normal Wear & Tear				
Swing Table	3 - Normal Wear & Tear				
Boom	3 - Normal Wear & Tear				
Boom Wear Guides	3 - Normal Wear & Tear				
Jib	0				
Front Axle Appearance	3 - Normal Wear & Tear				
Rear Axle Appearance	3 - Normal Wear & Tear
