Inspection Report (Telehandler)

B&B Stock Number	A6582369
Year	2013
Make	Caterpillar
Model	TH514C
Serial Number	unable to verify
Hour Meter Reading	3687
Previous Application (e.g., earth moving, mining, demolition, etc)	rental equipment

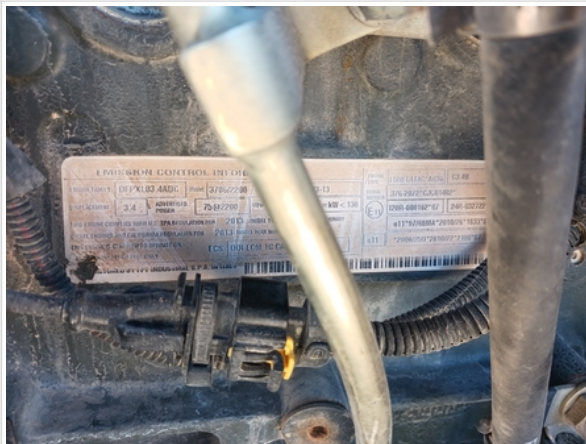
Engine Data Plate

Engine Type (Make, Model, Cylinders, Hp)	Cat, C3.4B, 3706/2200, 101Hp				
Emissions Tier	Tier 4i				
Engine Serial Number	376-2072-CJG01402				
Engine Fuel Type	Diesel				
Blow-by (Visual Observation Check)	No				
Unusual Noises (Upon Start-up, Idle, Shutdown)	Yes				
Unusual Noise Notes	Other (see comments)				
Comments	at start up a high pitch whine is heard				
Engine Smoke (Upon Start-up, Idle, Shutdown)	No				
Engine Exhaust Color	Clear				
Battery	3 - Normal Wear & Tear				
Battery Condition	Clean & dry appearance, tight connections				
Radiator	3 - Normal Wear & Tear				
Radiator Condition	Radiator fins & components appear to be in good working order, no signs of damage or leaks				
Belts	3 - Normal Wear & Tear				
Belt Condition	Belts appear in good condition & alignment with proper tension				
Hoses	3 - Normal Wear & Tear

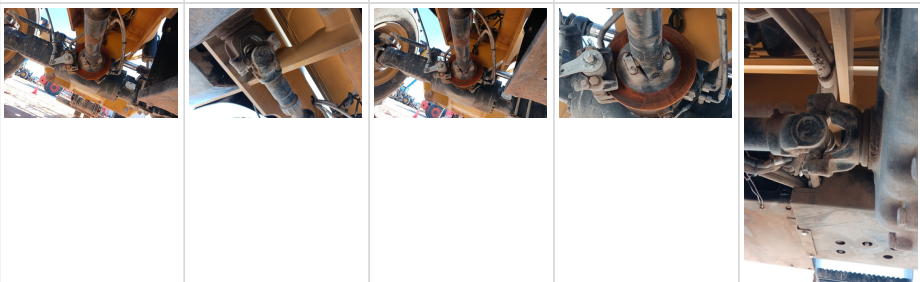
Drivetrain Photos

Hydrostatic Transmission?	No				
2 Speed?	No				
Hydrostatic Drive Configuration	Other (see comments)

Comments	The machine comes with a powershift transmission
Transmission Info (Make/Model/Speeds)	unable to determine
Drive	Other (see comments)
Other Drive Type	unable to verify
Transmission Components	3 - Normal Wear & Tear
Transmission Condition	Good forward and reverse function, No unusual noises or vibrations
Drive Motors	3 - Normal Wear & Tear
Parking Brake	3 - Normal Wear & Tear
Parking Brake Function	Good brake function
Overall Drivetrain Rating	3 - Normal Wear & Tear
Overall Drivetrain Comments	The drive train is in good operating condition with a normal level of wear and tear
Front Axle	3 - Normal Wear & Tear
Rear Axle	3 - Normal Wear & Tear
