Inspection Report (Boom Lift)

B&B Stock Number	M06003
Year	2002
Make	Genie
Model	S-60
Serial Number	M06003
Hour Meter Reading	7056
Previous Application (e.g., earth moving, mining, demolition, etc)	This machine was used as rental equipment

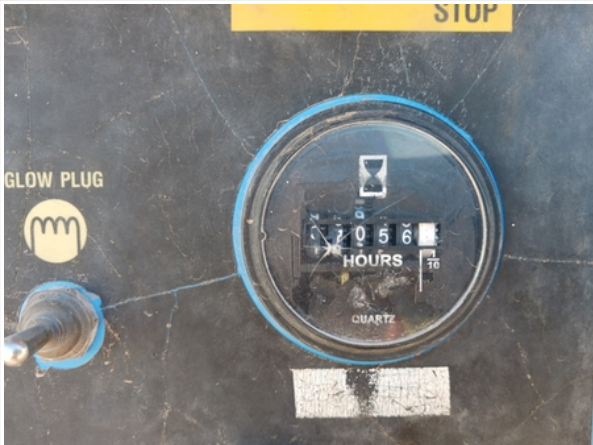
Hour Meter/Odometer

Seat	0
Cabin Lights	0
Safety Lock Out / Stop	3 - Normal Wear & Tear
Safety Lock Out / Stop Condition	Safety lock out device is present, in good condition, and functional
Controls & Switches	3 - Normal Wear & Tear
Controls & Switches Condition	All switches are installed and functional
Hour Meter Activity	1 - Service Required
Hour Meter Condition	Hour meter is unreadable or not functioning
Last Known Hour Meter Reading	7056
Other Gauge Activity	3 - Normal Wear & Tear
Other Gauge Condition	All cockpit gauges are functional and in good condition
Heater & A/C	0
Travel Alarm	3 - Normal Wear & Tear
Travel Alarm Condition	Travel alarm is installed and functioning as expected
Horn	3 - Normal Wear & Tear
Horn Condition	Horn installed but functioning improperly, Other (see comments)

What Needs Work	The right side rear tire is low, and the hour meter doesn't work properly	
Any Additional Info from the Seller?	This machine was used for rental equipment	
Date/Time	11-08-2023	
Inspector Name	Steven Mesa

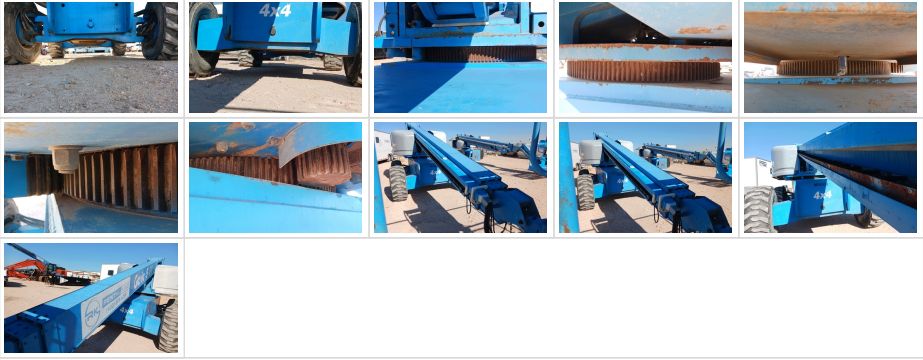
Chassis Photos

Frame	3 - Normal Wear & Tear				
Stance	3 - Normal Wear & Tear				
Swing Table	3 - Normal Wear & Tear				
Boom	3 - Normal Wear & Tear				
Boom Wear Guides	3 - Normal Wear & Tear				
Jib	0				
Front Axle Appearance	3 - Normal Wear & Tear				
Rear Axle Appearance	3 - Normal Wear & Tear

Overall Chassis	3 - Normal Wear & Tear	
Overall Chassis Comments	The chassis is in good working order.
