## Inspection Report (Skid Steer)

B&B Stock Number	A2175007
Year	2012
Make	Caterpillar
Model	259B3
Serial Number	CAT0259BJYYZ03372
Hour Meter Reading	3312.9
Previous Application (e.g., earth moving, mining, demolition, etc)	Earth moving

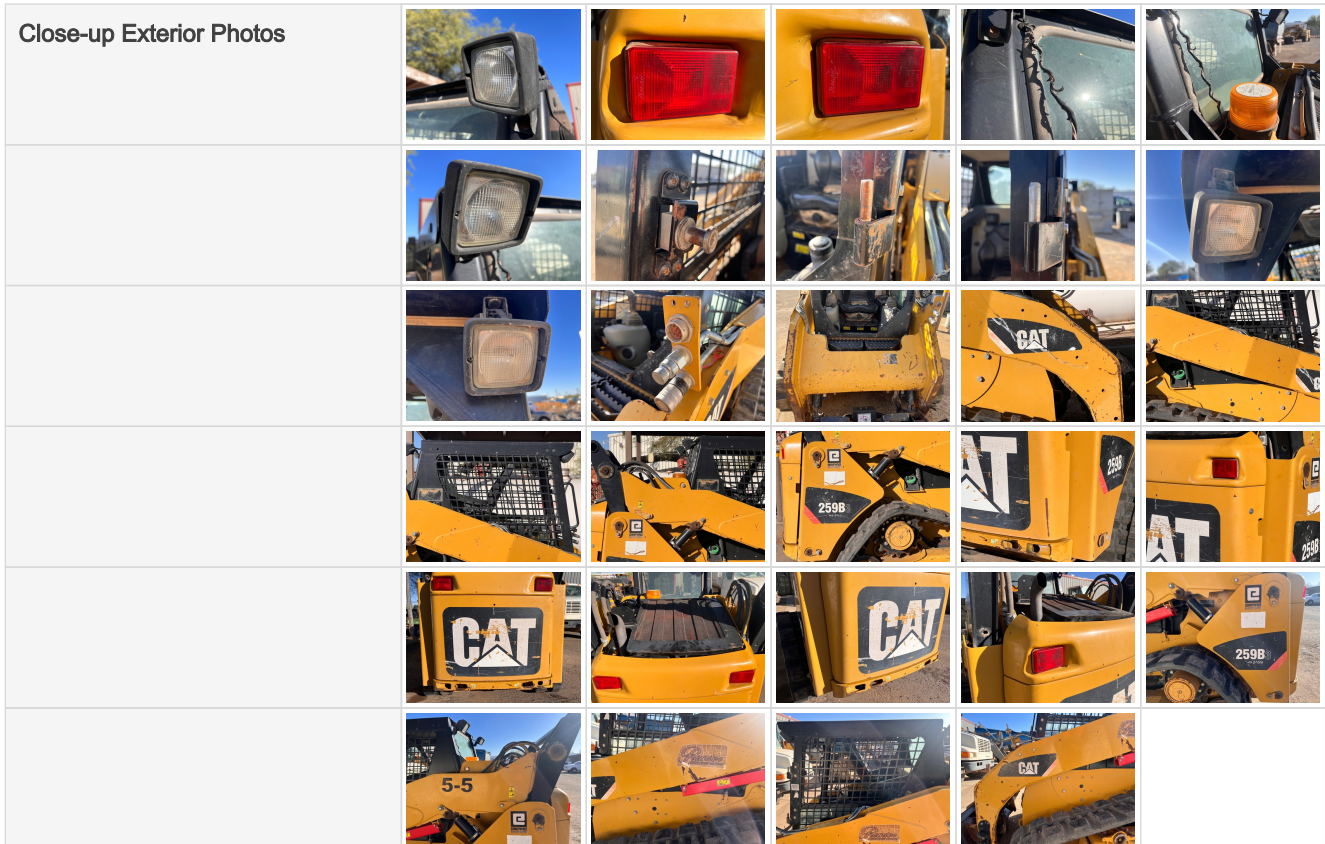
#### General Appearance Photos

Inspection Rating Criteria	Rating Scale	Explanation
	1 - Service Required	Requires immediate repairs to function as expected.
	2 - Above Average Wear & Tear	Exhibits greater wear than expected given age and usage. While operable, further diagnosis may be needed.
	3 - Normal Wear & Tear	Exhibits wear that is consistent with age and usage. Operation is normal, and as expected.
	4 - Very Light or Minimal Wear	Exhibits very minimal wear. Operation is better than expected given age and usage.
	5 - Like New, Recently Replaced	Excellent condition, free of visible wear or damage. Operation is within factory specifications.
Body Panels	2 - Above Average Wear & Tear	
Body Panel Condition	Visible chipped paint or dents, Areas of surface rust observed	
Doors / Canopy Latches	1 - Service Required	
Doors / Canopy Latches Condition	Other (see comments)	
Comments	Missing cab door	
Steps / Ladders	3 - Normal Wear & Tear

Handrails	3 - Normal Wear & Tear	
Handrails Condition	Handrails are fully intact and appear structurally sound	
Glass	1 - Service Required

Glass Condition	Other (see comments)
Comments	Missing both side glass windows
Mirrors	3 - Normal Wear & Tear
Mirror Condition	Mirrors present and intact, no visible damage
Exterior Lights	3 - Normal Wear & Tear
Exterior Lights Condition	No visible damage, lighting system is operational
Overall Exterior	2 - Above Average Wear & Tear
Comments	Above average wear and tear to exterior paint with areas of surface rust

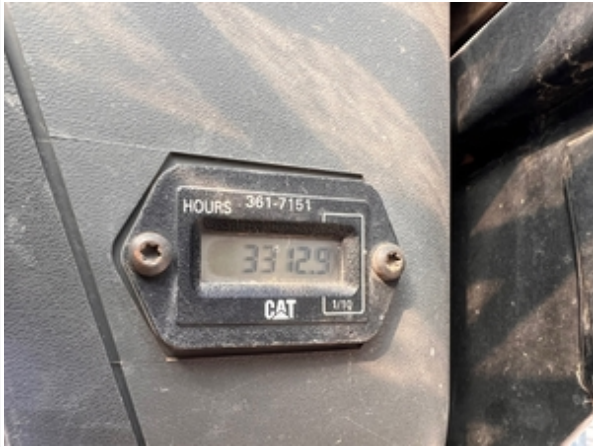
<b>Hour Meter/Odometer</b>

<b>Seat</b>	3 - Normal Wear & Tear
<b>Seat Condition</b>	Seat(s) in good condition, no stains or tears in upholstery, Seat belt secures properly
<b>Cabin Lights</b>	1 - Service Required
<b>Cabin Lights Condition</b>	Cabin light system is not operational
<b>Comments</b>	Can dome light inoperable
<b>Safety Lock Out / Stop</b>	3 - Normal Wear & Tear
<b>Safety Lock Out / Stop Condition</b>	Safety lock out device is present, in good condition, and functional
<b>Controls &amp; Switches</b>	2 - Above Average Wear & Tear
<b>Controls &amp; Switches Condition</b>	Switches have good functionality, minor cosmetic damage observed
<b>Comments</b>	Minor cosmetic damage
<b>Hour Meter Activity</b>	3 - Normal Wear & Tear
<b>Hour Meter Condition</b>	Hour meter is functional and in good condition
<b>Other Gauge Activity</b>	3 - Normal Wear & Tear

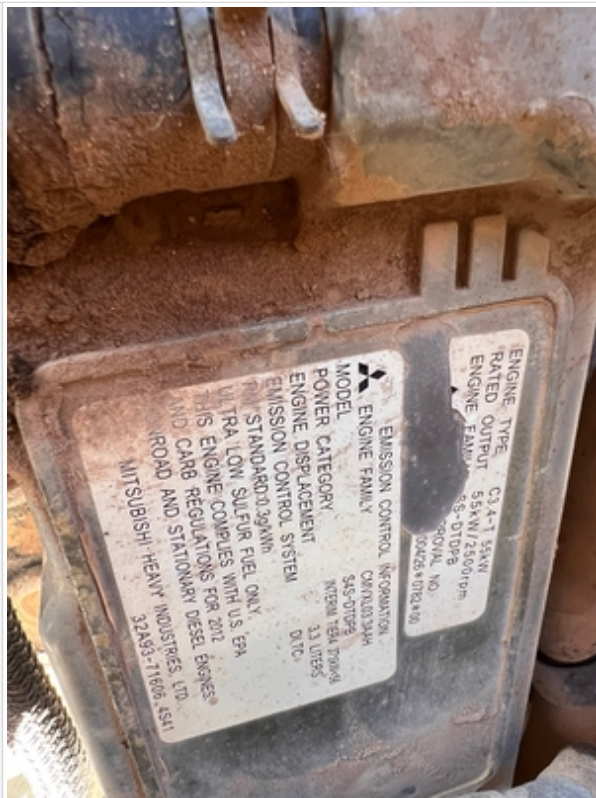
<p>Engine Data Plate</p>

<b>Engine Type (Make, Model, Cylinders, Hp)</b>	MITSUBISHI , S4S-DTDPB
<b>Emissions Tier</b>	Tier 4i
<b>Engine Serial Number</b>	G23AE-119
<b>Engine Fuel Type</b>	Diesel
<b>Blow-by (Visual Observation Check)</b>	No
<b>Unusual Noises (Upon Start-up, Idle, Shutdown)</b>	No
<b>Engine Smoke (Upon Start-up, Idle, Shutdown)</b>	Yes
<b>Engine Smoke Notes</b>	Engine smoke observed upon start up
<b>Comments</b>	Black smoke out the exhaust pipe upon start up
<b>Engine Exhaust Color</b>	Black
<b>Battery</b>	2 - Above Average Wear & Tear
<b>Battery Condition</b>	Dusty & dirty appearance
<b>Radiator</b>	3 - Normal Wear & Tear
<b>Radiator Condition</b>	Radiator fins & components appear to be in good working order, no signs of damage or leaks
<b>Belts</b>	3 - Normal Wear & Tear
<b>Belt Condition</b>	Belts appear in good condition & alignment with proper tension

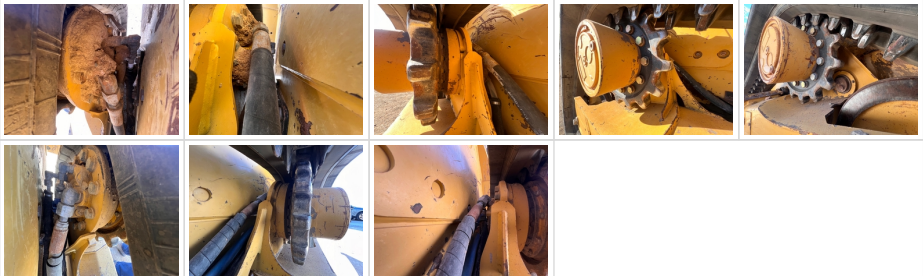
Drivetrain Photos

Hydrostatic Transmission?	No
2 Speed?	No
Hydrostatic Drive Configuration	Other (see comments)
Comments	Drive motors
Drive	Other (see comments)
Other Drive Type	Rubber tracks
Transmission Components	0
Drive Motors	3 - Normal Wear & Tear
Parking Brake	3 - Normal Wear & Tear
Overall Drivetrain Rating	3 - Normal Wear & Tear

Overall Drivetrain Comments	No nowhere in tear no major issues report
-----------------------------	---

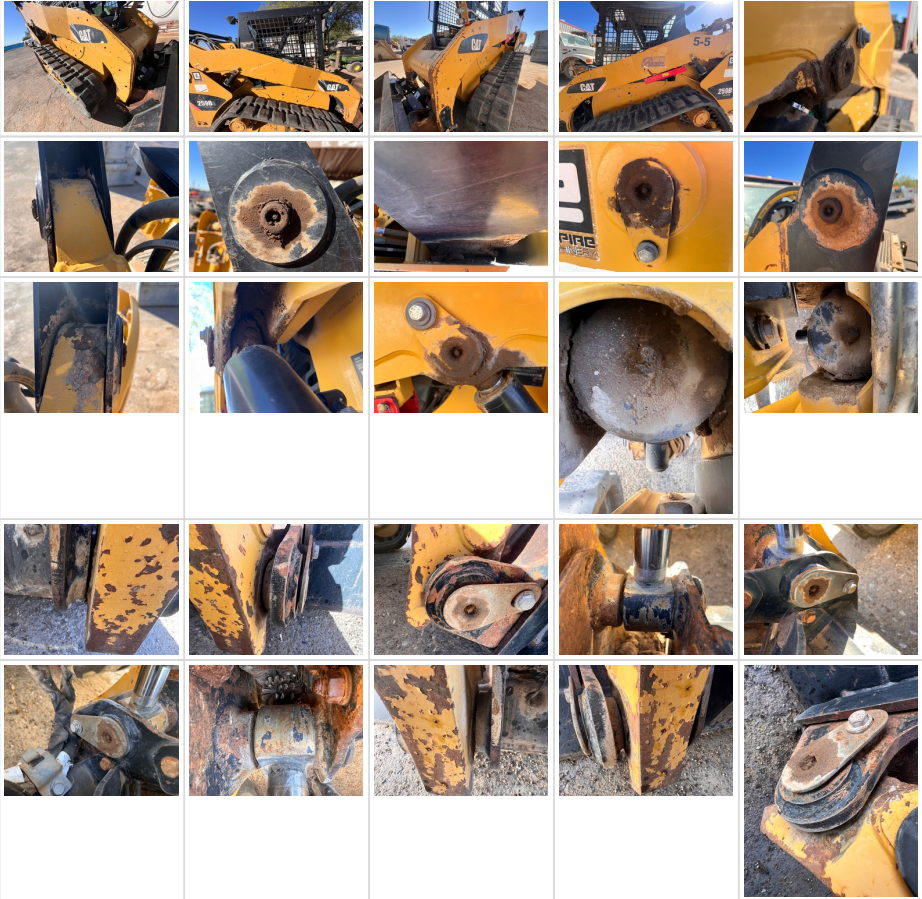
Chassis Photos

Frame	3 - Normal Wear & Tear
Lift Arms	3 - Normal Wear & Tear
Chassis to Arm Pins	3 - Normal Wear & Tear
Quick Coupler	3 - Normal Wear & Tear
Quick Coupler to Arms Pins	3 - Normal Wear & Tear
Overall Chassis	3 - Normal Wear & Tear
Overall Chassis Comments	Normal wear and tear no major issues to report

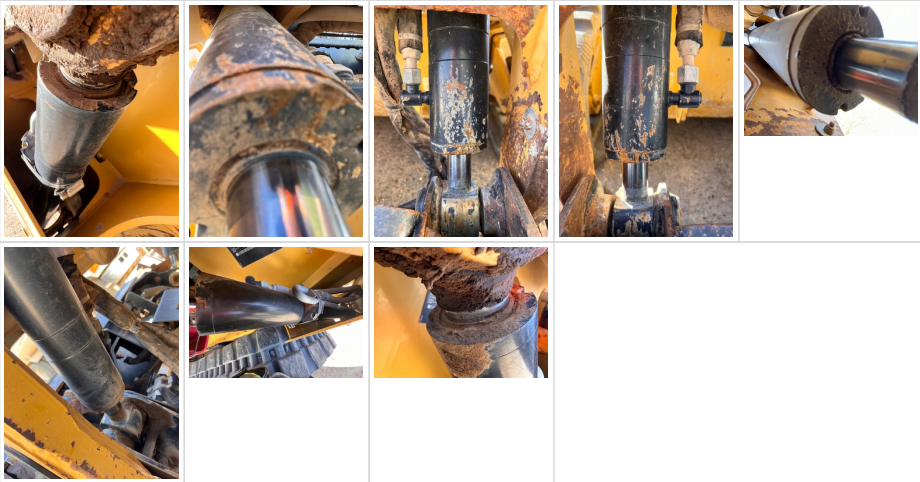
Hydraulic Cylinder Photos

Mounting Pins	3 - Normal Wear & Tear				
Cylinder Oil Leaks	No				
Hydraulic System Overall	3 - Normal Wear & Tear				
Comments	Normal wear and tear no major issues to report
