Inspection Report (Boom Lift)

| B&B Stock Number | A6027349 |
| Make | JLG |
| Model | 600AJ |

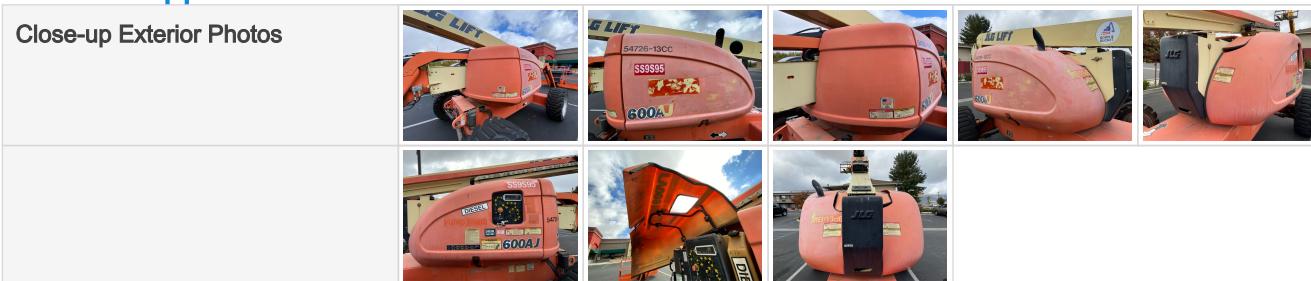
General Appearance Photos

| Inspection Rating Criteria | Rating Scale | Explanation |
|---|---|---|
| Comments | Body panel paint dull | |
| Comments | Overall exterior is in good condition. No major damage seen at exterior panels. | |

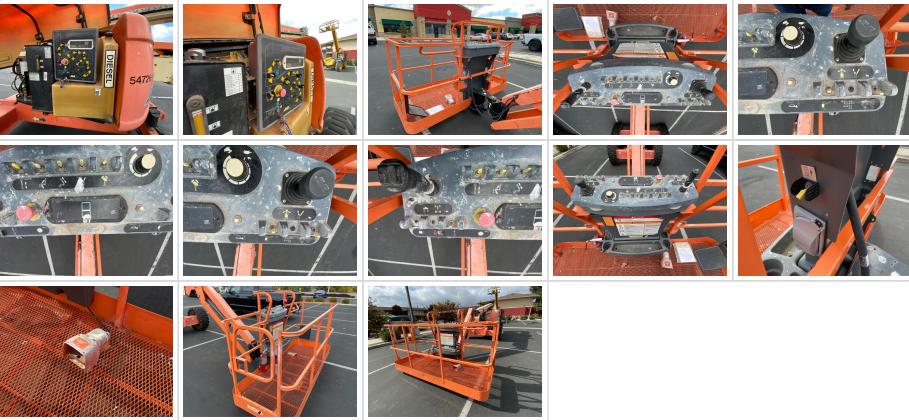
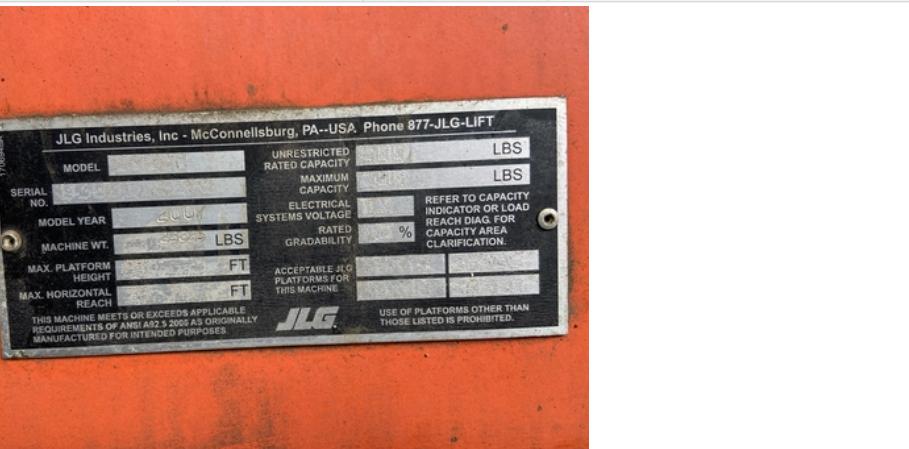
| Control Station Photos | |

| Comments | Monitor Light Indicators hard to see at ground control panel |
| Control Station Overall Condition | Minor cosmetic wear to cabin surfaces, floors, panels, and ceiling |

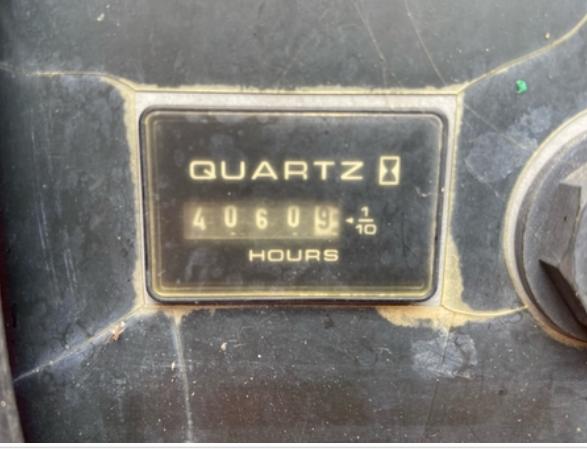
| Hour Meter/Odometer | |

| Hour Meter Condition | Hour meter is functional and in good condition |

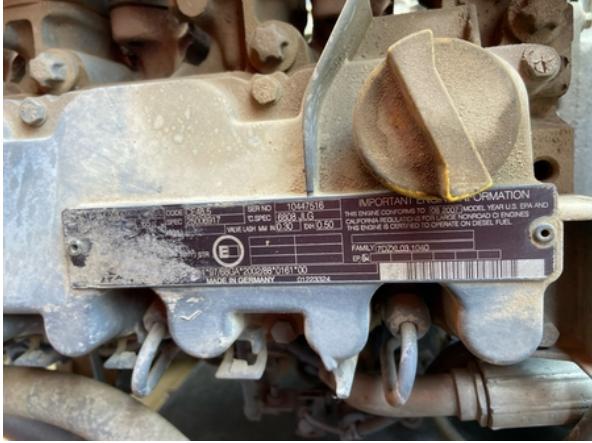
| Engine Data Plate | | | | | |

| Engine Compartment Photos | Battery bracket not installed | | | | |

| | | | Minor seepage buildup seen at front L/S of engine block area. No active leak seen. | | |
