## Inspection Report (Telehandler)

B&B Stock Number	A7097685
Year	2013
Make	JCB
Model	509-42
Serial Number	1404811
Hour Meter Reading	2,798 Hrs.
Previous Application (e.g., earth moving, mining, demolition, etc)	General Construction

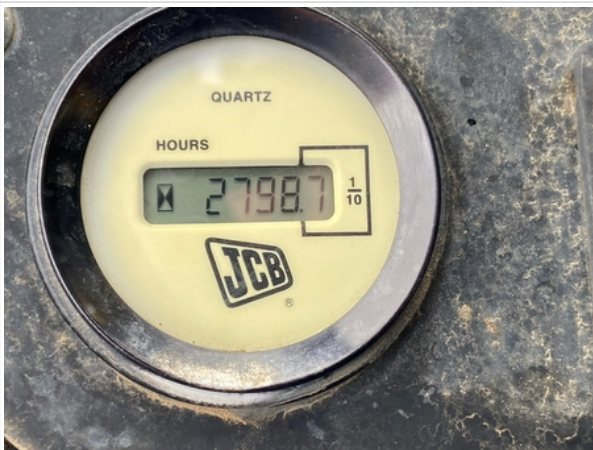
<p>       QUARTZ        HOURS        2798.7 <math>\frac{1}{10}</math>        JCB     </p>
Seat	2 - Above Average Wear & Tear

Seat Condition	Seat(s) has major surface staining or tears
Comments	Bottom seat cushion torn
Cabin Lights	0
Safety Lock Out / Stop	3 - Normal Wear & Tear
Safety Lock Out / Stop Condition	Safety lock out device is present, in good condition, and functional
Controls & Switches	3 - Normal Wear & Tear
Controls & Switches Condition	All switches are installed and functional
Hour Meter Activity	3 - Normal Wear & Tear
Hour Meter Condition	Hour meter is functional and in good condition
Other Gauge Activity	3 - Normal Wear & Tear
Other Gauge Condition	All cockpit gauges are functional and in good condition
Heater & A/C	0
Travel Alarm	3 - Normal Wear & Tear
Travel Alarm Condition	Travel alarm is installed and functioning as expected
Horn	3 - Normal Wear & Tear
Horn Condition	Horn is installed and functioning as expected
Backup Camera	0
Control Station Overall Rating	3 - Normal Wear & Tear
Control Station Overall Condition	Minor cosmetic wear to cabin surfaces, floors, panels, and ceiling
