Inspection Report (Skid Steer)

B&B Stock Number	A6231390
Year	2010
Make	Caterpillar
Model	299c
Serial Number	CAT0299CEJSP01147
Hour Meter Reading	3969.4
Previous Application (e.g., earth moving, mining, demolition, etc)	Earth moving

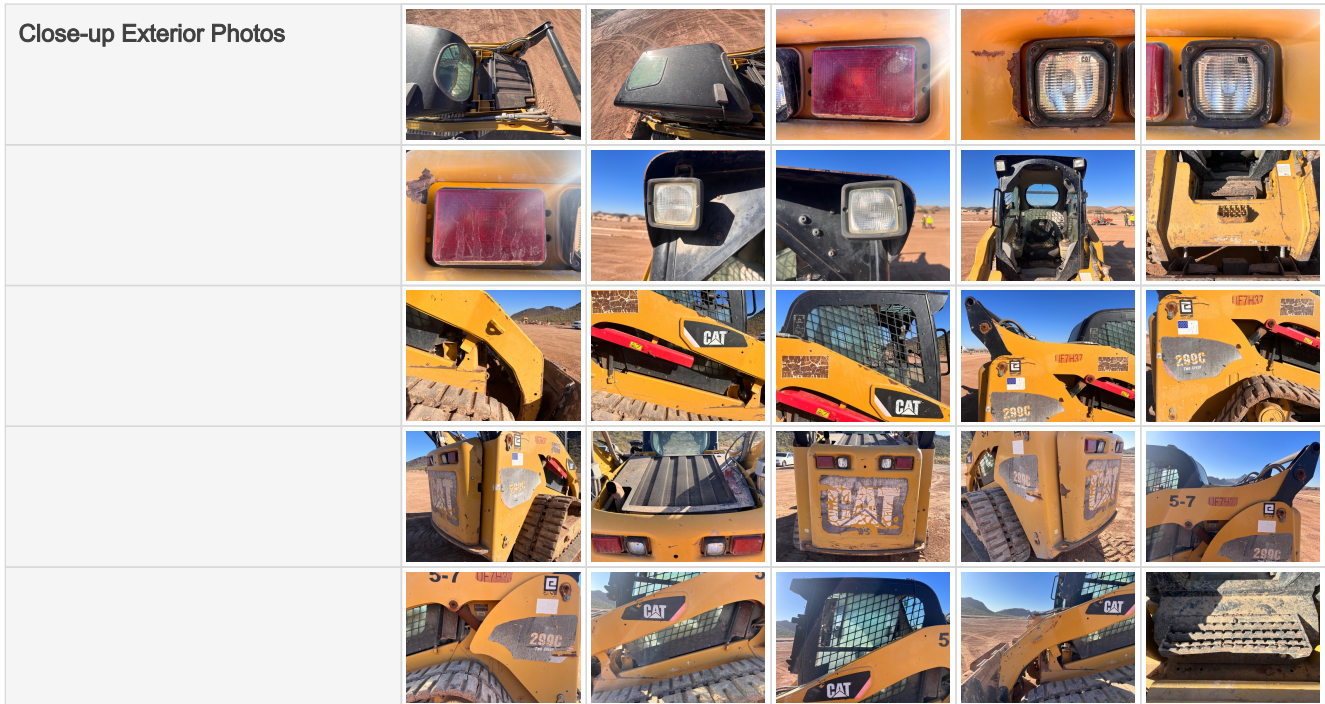
General Appearance Photos

Inspection Rating Criteria	Rating Scale	Explanation
	1 - Service Required	Requires immediate repairs to function as expected.
	2 - Above Average Wear & Tear	Exhibits greater wear than expected given age and usage. While operable, further diagnosis may be needed.
	3 - Normal Wear & Tear	Exhibits wear that is consistent with age and usage. Operation is normal, and as expected.
	4 - Very Light or Minimal Wear	Exhibits very minimal wear. Operation is better than expected given age and usage.
	5 - Like New, Recently Replaced	Excellent condition, free of visible wear or damage. Operation is within factory specifications.
Body Panels	2 - Above Average Wear & Tear	
Body Panel Condition	Areas of surface rust observed, Visible chipped paint or dents	
Comments	Dents/ chipped paint	
Doors / Canopy Latches	1 - Service Required	
Doors / Canopy Latches Condition	Other (see comments)	
Comments	Can door missing	
Steps / Ladders	2 - Above Average Wear & Tear

Steps / Ladders Condition	Bent or broken steps or rungs	
Comments	Bent cab entry step	
Handrails	3 - Normal Wear & Tear	
Handrails Condition	Handrails are fully intact and appear structurally sound	
Glass	3 - Normal Wear & Tear

Glass Condition	Glass intact, no visible damage
Mirrors	3 - Normal Wear & Tear
Mirror Condition	Mirrors present and intact, no visible damage
Exterior Lights	2 - Above Average Wear & Tear
Exterior Lights Condition	One or more exterior lights are non-operational
Overall Exterior	3 - Normal Wear & Tear
Comments	Normal wear and tear / front left headlight and rear right tail light inoperative

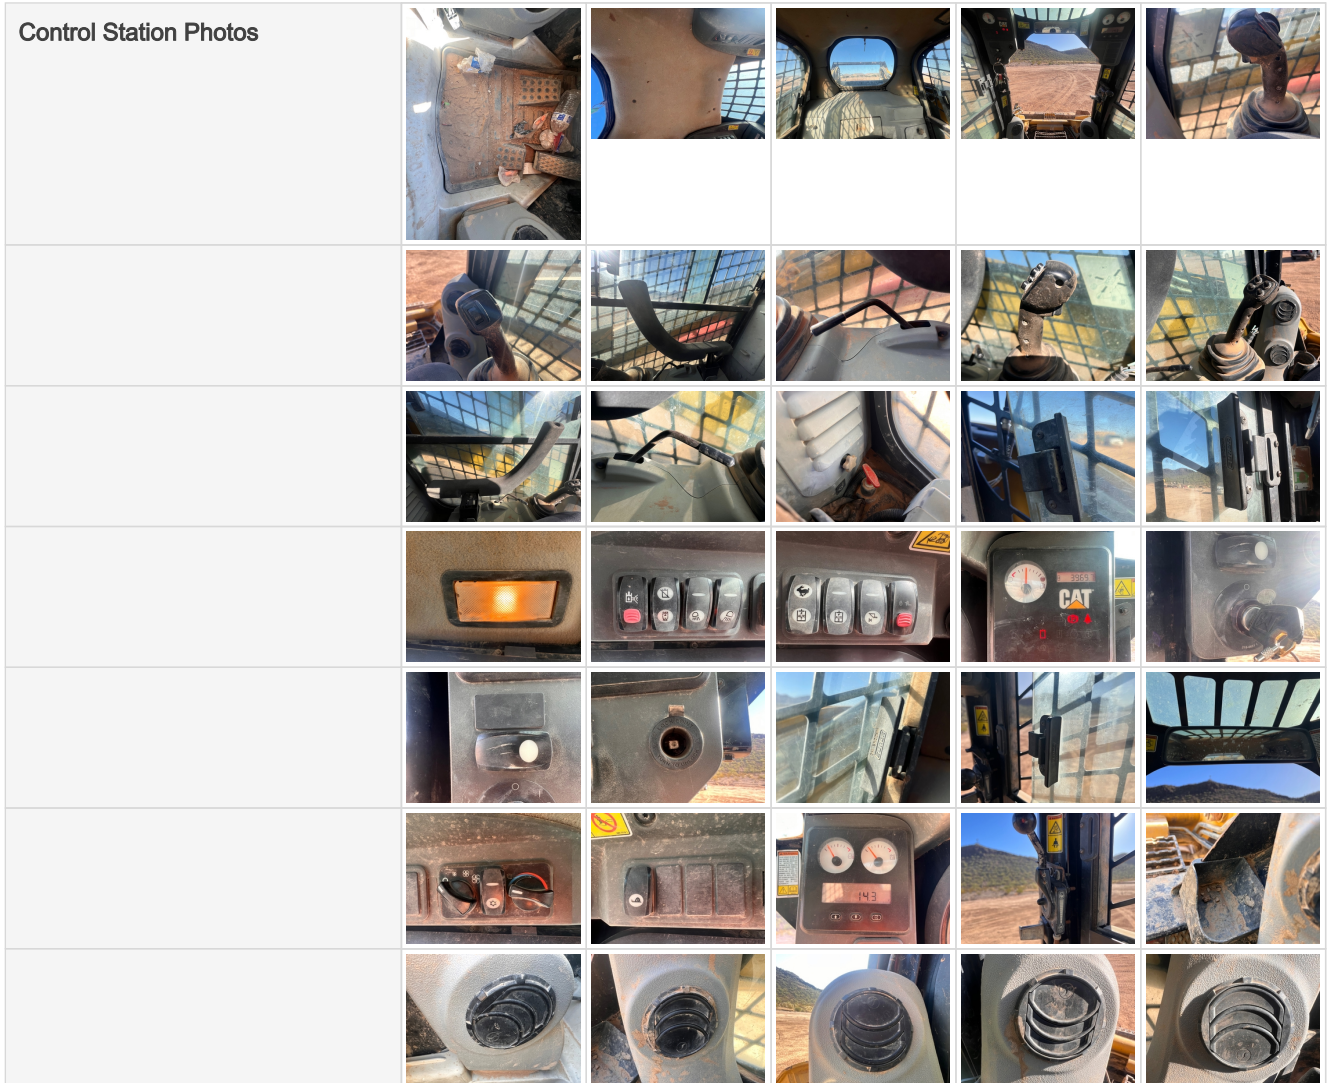
Control Station Photos

Seat	2 - Above Average Wear & Tear
Seat Condition	Seat(s) have minor surface staining or small tears, Seat belt secures properly
Comments	Dusty and dirty seat
Cabin Lights	3 - Normal Wear & Tear
Cabin Lights Condition	Cabin lights are installed with all light covers in place, bulbs are installed and working properly
Safety Lock Out / Stop	2 - Above Average Wear & Tear
Safety Lock Out / Stop Condition	Other (see comments)
Comments	Loose and easy enable while operating

Controls & Switches	2 - Above Average Wear & Tear
Controls & Switches Condition	Switches have good functionality, minor cosmetic damage observed
Comments	Minor cosmetic damage
Hour Meter Activity	3 - Normal Wear & Tear
Hour Meter Condition	Hour meter is functional and in good condition
Other Gauge Activity	3 - Normal Wear & Tear
Other Gauge Condition	All cockpit gauges are functional and in good condition
Heater & A/C	1 - Service Required
Heater & A/C Condition	Fan only, heating and A/C components inoperative
Travel Alarm	3 - Normal Wear & Tear
Travel Alarm Condition	Travel alarm is installed and functioning as expected
Horn	3 - Normal Wear & Tear
Horn Condition	Horn is installed and functioning as expected
Backup Camera	0
Control Station Overall Rating	2 - Above Average Wear & Tear
Control Station Overall Condition	Minor cosmetic wear to cabin surfaces, floors, panels, and ceiling
Comments	Missing cab door/ ac issues / exposed wiring and connections

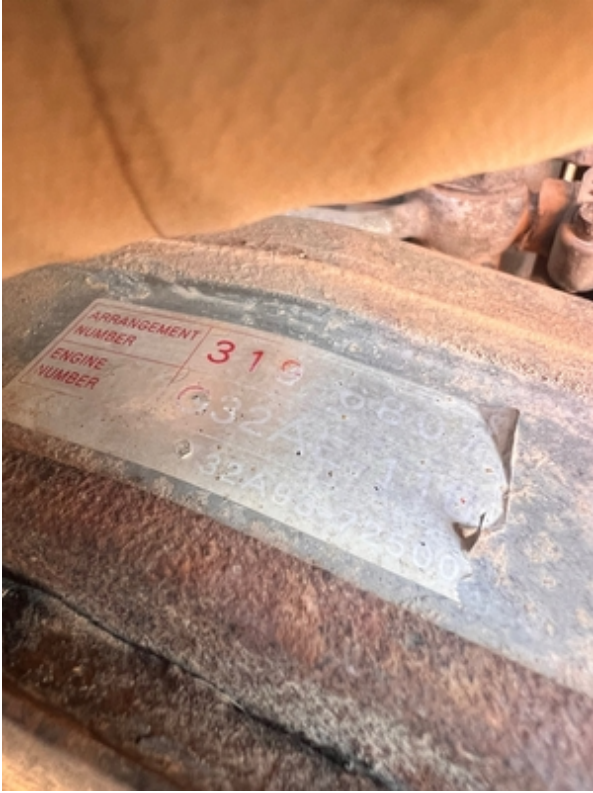
Engine Data Plate

Engine Type (Make, Model, Cylinders, Hp)	Caterpillar c3.4				
Emissions Tier	Tier 4i				
Engine Serial Number	G32AE-118				
Engine Fuel Type	Diesel

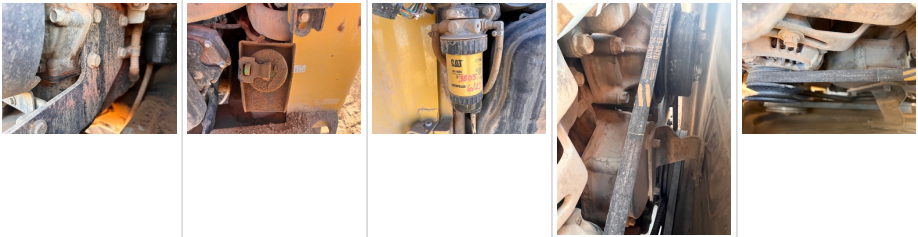
Engine Compartment Photos

Blow-by (Visual Observation Check)	No
Unusual Noises (Upon Start-up, Idle, Shutdown)	No
Engine Smoke (Upon Start-up, Idle, Shutdown)	Yes
Engine Smoke Notes	Engine smoke observed upon start up
Engine Exhaust Color	Black
Battery	3 - Normal Wear & Tear
Battery Condition	Inaccessible, unable to determine condition
Radiator	2 - Above Average Wear & Tear
Radiator Condition	Other (see comments)
Comments	Dusty and dirty
Belts	3 - Normal Wear & Tear
Belt Condition	Belts appear in good condition & alignment with proper tension
Hoses	2 - Above Average Wear & Tear
Hose Condition	Cracking, stiff, or charred hoses, Dried seepages observed
Water Pump	3 - Normal Wear & Tear
Water Pump Condition	No unusual pump noises heard
Cooling System Leaks	No
Coolant Appearance	3 - Normal Wear & Tear
Coolant Appearance Notes	Normal Translucent appearance, no visual signs of contamination
Oil Leaks	No
Oil Appearance	3 - Normal Wear & Tear

Oil Appearance Notes	Appropriate oil level
Fuel Leaks	No
Equipped with DPF (Diesel Particulate Filter)	Yes
DPF Condition	3 - Normal Wear & Tear
Requires DEF (Diesel Exhaust Fluid)	No
Overall Engine Rating	3 - Normal Wear & Tear
Overall Engine Appearance	Areas of dried seepage seen on engine hoses & components
Overall Engine Comments	Normal wear and tear dried seepage on hoses and filters

What Needs Work	<ul style="list-style-type: none"> -rubber tracks -left lift cylinder leak -dried seepage inside engine compartment 	
Date/Time	11-10-2023	
Inspector Name	Javier Bocanegra
