# Inspection Report (Telehandler)

B&B Stock Number	A6577409
Year	2013
Make	Caterpillar
Model	TH514C
Serial Number	unknown
Hour Meter Reading	5095
Previous Application (e.g., earth moving, mining, demolition, etc)	rental equipment

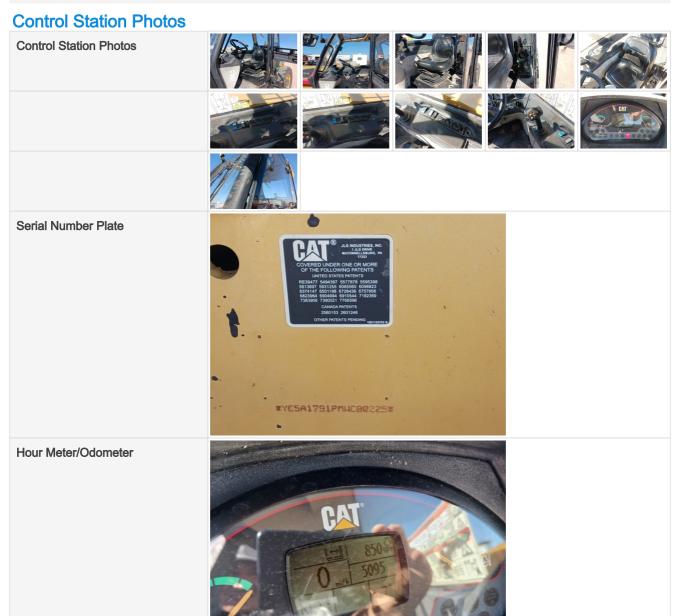
#### **Control Station**

Seat	3 - Normal Wear & Tear
Seat Condition	Seat(s) in good condition, no stains or tears in upholstery, Seat adjustment controls move through full range of travel, Seat belt shows limited functionality or does not secure properly
Cabin Lights	0
Safety Lock Out / Stop	3 - Normal Wear & Tear
Safety Lock Out / Stop Condition	Safety lock out device is present, in good condition, and functional
Controls & Switches	3 - Normal Wear & Tear
Controls & Switches Condition	All switches are installed and functional
Hour Meter Activity	3 - Normal Wear & Tear
Hour Meter Condition	Hour meter is functional and in good condition
Other Gauge Activity	3 - Normal Wear & Tear
Other Gauge Condition	All cockpit gauges are functional and in good condition
Heater & A/C	3 - Normal Wear & Tear
Heater & A/C Condition	Other (see comments)
Comments	The AC works, but it's not as cold as it should be
Travel Alarm	3 - Normal Wear & Tear

Travel Alarm Condition	Travel alarm is installed and functioning as expected
Horn	3 - Normal Wear & Tear
Horn Condition	Horn is installed and functioning as expected
Backup Camera	0
Control Station Overall Rating	3 - Normal Wear & Tear
Control Station Overall Condition	Good cabin appearance, solid floors, panels, and ceiling
