Inspection Report (On-Highway Service Truck)

| B&B Stock Number | A1838822 |
| Make | Frightliner |
| Model | M2 |

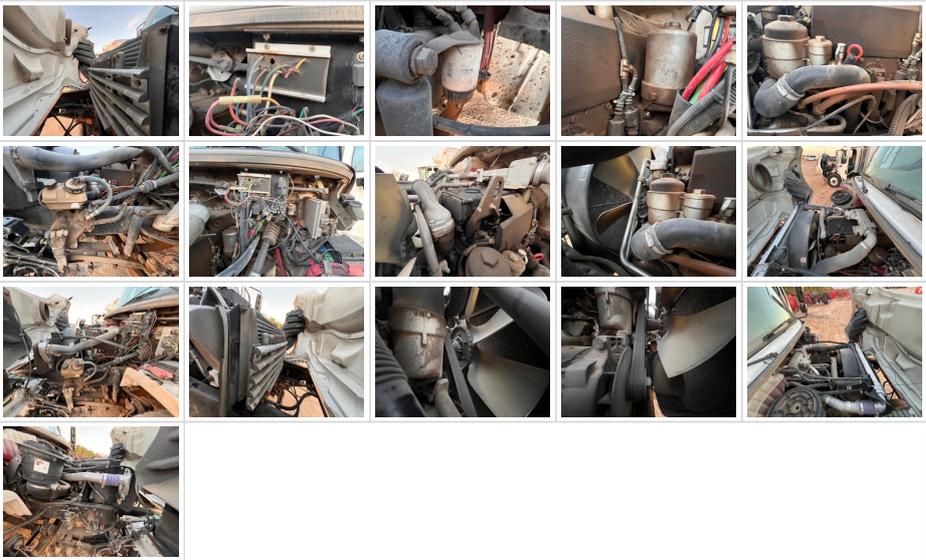
| Engine Compartment Photos | | | | | |

| Oil Leaks | Yes |
| Oil Leak Notes | Dried oil seepages seen, Wetness & discoloration observed, Wet areas with drops forming due to oil leakage |
| Comments | Wetness found near bottom of engine |
| Overall Engine Appearance | Areas of dried seepage seen on engine hoses & components |
| Overall Engine Comments | Normal wear and tear with minor leaks |
