## Inspection Report (Off-Highway Carrier or Service)

B&B Stock Number	A4645759
Year	2022
Make	Terramac
Model	RT9
Serial Number	9L00412
Hour Meter Reading	119hrs
Previous Application (e.g., earth moving, mining, demolition, etc)	The machine was used to carry sand blasting rigs into areas that vehicles could not get to.

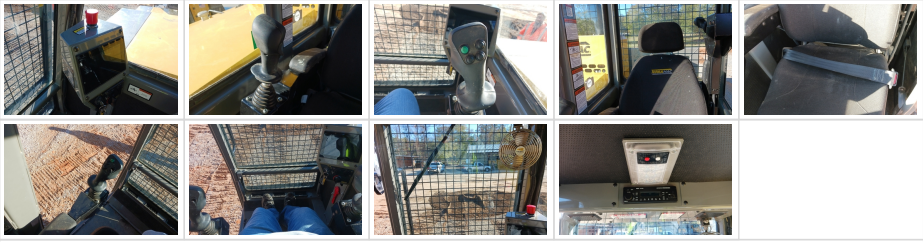
Control Station Photos

Other Gauge Activity	5 - Like New, Recently Replaced
Heater & A/C	5 - Like New, Recently Replaced
Travel Alarm	5 - Like New, Recently Replaced
Horn	5 - Like New, Recently Replaced
Backup Camera	5 - Like New, Recently Replaced
Control Station Overall Rating	5 - Like New, Recently Replaced

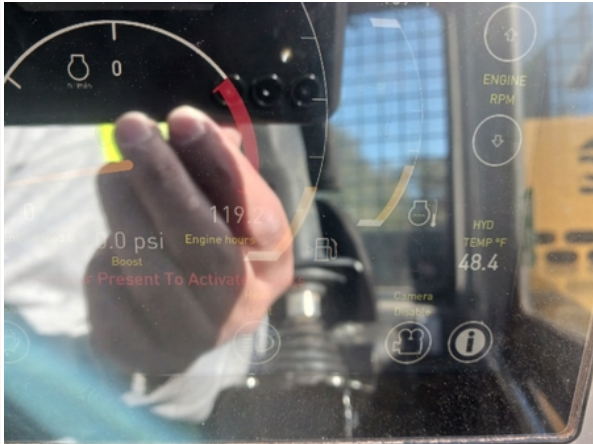
Hour Meter/Odometer

Seat	5 - Like New, Recently Replaced
Cabin Lights	5 - Like New, Recently Replaced
Safety Lock Out / Stop	5 - Like New, Recently Replaced
Controls & Switches	5 - Like New, Recently Replaced
Hour Meter Activity	5 - Like New, Recently Replaced
Hour Meter Condition	Hour meter is functional and in good condition

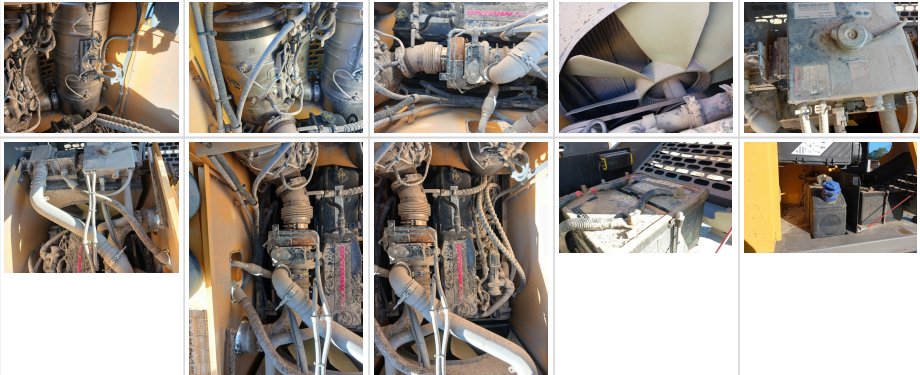
Engine Compartment Photos

Unusual Noises (Upon Start-up, Idle, Shutdown)	No
Engine Smoke (Upon Start-up, Idle, Shutdown)	No
Engine Exhaust Color	Clear
Battery	4 - Very Light or Minimal Wear
Battery Condition	Clean & dry appearance, tight connections
Radiator	4 - Very Light or Minimal Wear
Radiator Condition	Radiator fins & components appear to be in good working order, no signs of damage or leaks
Belts	4 - Very Light or Minimal Wear
Belt Condition	Belts appear in good condition & alignment with proper tension
Hoses	4 - Very Light or Minimal Wear
Hose Condition	Firm, pliant hoses with no signs of wear or leaks
Water Pump	4 - Very Light or Minimal Wear
Water Pump Condition	No unusual pump noises heard
Cooling System Leaks	No
Coolant Appearance	4 - Very Light or Minimal Wear
Coolant Appearance Notes	Normal Translucent appearance, no visual signs of contamination
Oil Leaks	No
Oil Appearance	4 - Very Light or Minimal Wear
Oil Appearance Notes	Clean oil appearance, no signs of cross contamination, Appropriate oil level

Fuel Leaks	No
Equipped with DPF (Diesel Particulate Filter)	Yes
DPF Condition	4 - Very Light or Minimal Wear
DPF Condition Notes	Filter housing is intact with no signs of damage or malfunction, DPF indicator is not illuminated
Requires DEF (Diesel Exhaust Fluid)	Yes
DEF Tank	4 - Very Light or Minimal Wear
DEF Tank Condition	Area around DEF tank cap is clean, fluid is clear & appears free of contaminants
Overall Engine Rating	4 - Very Light or Minimal Wear
Overall Engine Appearance	Clean & dry
Overall Engine Comments	The engine is in good working order

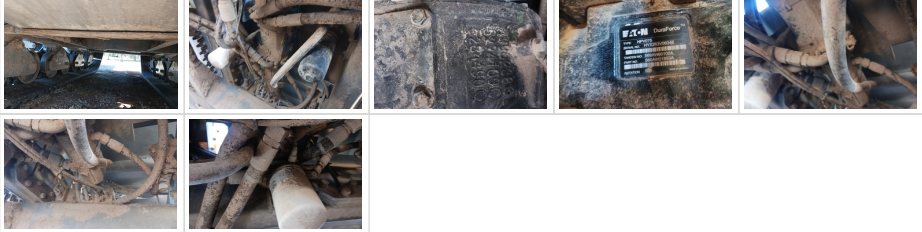
Drivetrain Photos

Hydrostatic Transmission?	Yes
2 Speed?	Yes
Hydrostatic Drive Configuration	Other (see comments)
Comments	unable to verify
Drive	2WD
Transmission Components	4 - Very Light or Minimal Wear
Transmission Condition	Good forward and reverse function, No unusual noises or vibrations
Drive Motors	4 - Very Light or Minimal Wear
Parking Brake	4 - Very Light or Minimal Wear
Parking Brake Function	Good brake function
Overall Drivetrain Rating	4 - Very Light or Minimal Wear
Overall Drivetrain Comments	The drivetrain is in good condition

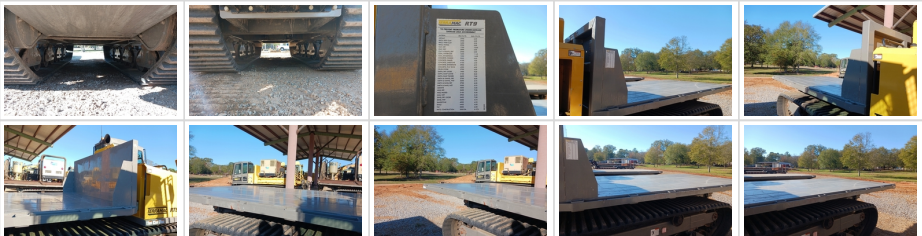
Chassis Photos

Turntable Bearing	0
Frame	4 - Very Light or Minimal Wear
Bottom Covers	4 - Very Light or Minimal Wear
Carrier Body	4 - Very Light or Minimal Wear
Overall Chassis	4 - Very Light or Minimal Wear
Overall Chassis Comments	The chassis is good

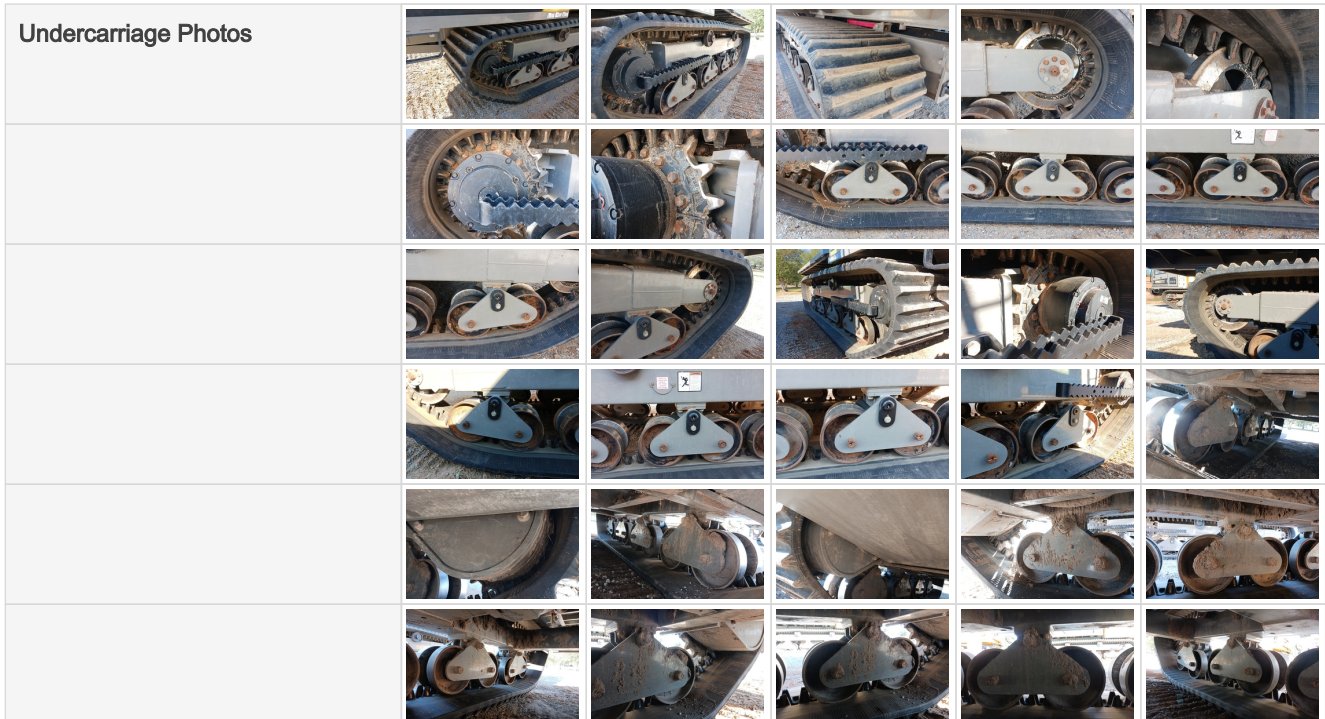
#### Undercarriage Photos

Track Width (inches)	2ft 3.5in
Track Length (inches)	14ft 11in and 10ft 5in track on ground
Roller Frames	4 - Very Light or Minimal Wear
Track Belt	4 - Very Light or Minimal Wear
Rubber Belt Drive Lugs	4 - Very Light or Minimal Wear
Track Tensioners	4 - Very Light or Minimal Wear
Front Idlers	4 - Very Light or Minimal Wear
Rear Idlers	4 - Very Light or Minimal Wear
Track Rollers	4 - Very Light or Minimal Wear
Sprockets	4 - Very Light or Minimal Wear
Overall Undercarriage Rating	4 - Very Light or Minimal Wear
Left Track Belt - Percent Remaining Estimate	90%
Right Track Belt - Percent Remaining Estimate	90%
Overall Comments	The undercarriage is in good working order
