## Inspection Report (Off-Highway Carrier or Service)

B&B Stock Number	A5913734
Year	2021
Make	Terramac
Model	RT9
Serial Number	9EK00601
Hour Meter Reading	64.3 hrs
Previous Application (e.g., earth moving, mining, demolition, etc)	This machine was used to carry a sandblasting rig into difficult to reach areas.

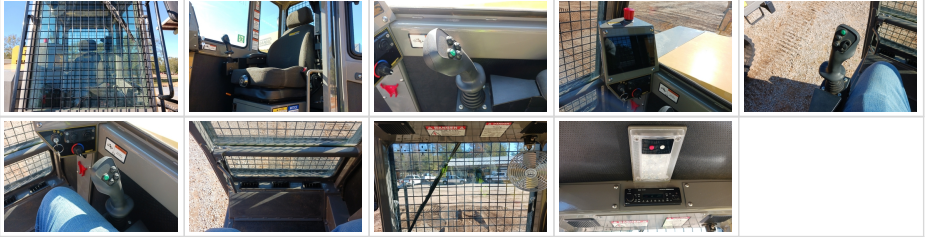
Control Station Photos

Seat	5 - Like New, Recently Replaced
Cabin Lights	5 - Like New, Recently Replaced
Safety Lock Out / Stop	5 - Like New, Recently Replaced
Controls & Switches	5 - Like New, Recently Replaced
Hour Meter Activity	5 - Like New, Recently Replaced
Hour Meter Condition	Hour meter is functional and in good condition

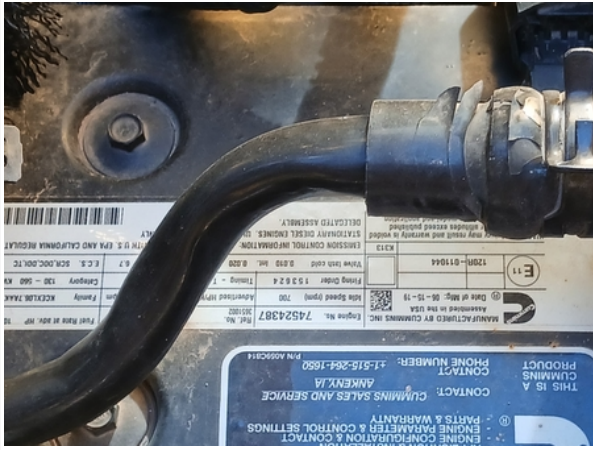
Engine Data Plate

<b>Engine Type (Make, Model, Cylinders, Hp)</b>	Cummins, QSB6.7, 225Hp
<b>Emissions Tier</b>	Tier 4F
<b>Engine Serial Number</b>	74524387
<b>Engine Fuel Type</b>	Diesel
<b>Blow-by (Visual Observation Check)</b>	Yes
<b>Unusual Noises (Upon Start-up, Idle, Shutdown)</b>	No
<b>Engine Smoke (Upon Start-up, Idle, Shutdown)</b>	No
<b>Engine Exhaust Color</b>	Clear
<b>Battery</b>	4 - Very Light or Minimal Wear
<b>Battery Condition</b>	Clean & dry appearance, tight connections
<b>Radiator</b>	4 - Very Light or Minimal Wear
<b>Radiator Condition</b>	Radiator fins & components appear to be in good working order, no signs of damage or leaks
<b>Belts</b>	4 - Very Light or Minimal Wear
<b>Belt Condition</b>	Belts appear in good condition & alignment with proper tension
<b>Hoses</b>	4 - Very Light or Minimal Wear
<b>Hose Condition</b>	Firm, pliant hoses with no signs of wear or leaks
<b>Water Pump</b>	4 - Very Light or Minimal Wear

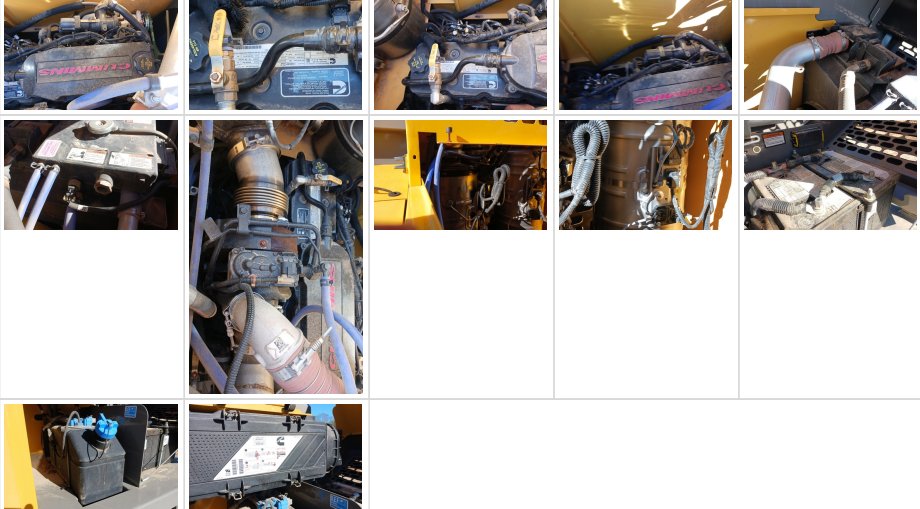
Engine Compartment Photos

<b>Water Pump Condition</b>	No unusual pump noises heard
<b>Cooling System Leaks</b>	No
<b>Coolant Appearance</b>	4 - Very Light or Minimal Wear
<b>Coolant Appearance Notes</b>	Normal Translucent appearance, no visual signs of contamination
<b>Oil Leaks</b>	No
<b>Oil Appearance</b>	4 - Very Light or Minimal Wear
<b>Oil Appearance Notes</b>	Clean oil appearance, no signs of cross contamination, Appropriate oil level
<b>Fuel Leaks</b>	No
<b>Equipped with DPF (Diesel Particulate Filter)</b>	Yes
<b>DPF Condition</b>	4 - Very Light or Minimal Wear
<b>DPF Condition Notes</b>	Filter housing is intact with no signs of damage or malfunction, DPF indicator is not illuminated
<b>Requires DEF (Diesel Exhaust Fluid)</b>	Yes
<b>DEF Tank</b>	4 - Very Light or Minimal Wear

DEF Tank Condition	Area around DEF tank cap is clean, fluid is clear & appears free of contaminants
Overall Engine Rating	4 - Very Light or Minimal Wear
Overall Engine Appearance	Clean & dry
Overall Engine Comments	The engine is in good working order

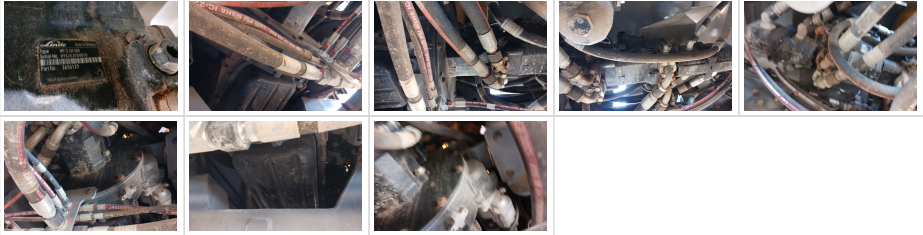
Drivetrain Photos

Hydrostatic Transmission?	Yes				
2 Speed?	Yes				
Hydrostatic Drive Configuration	Other (see comments)				
Comments	unable to verify				
Drive	2WD				
Transmission Components	5 - Like New, Recently Replaced				
Transmission Condition	Good forward and reverse function, No unusual noises or vibrations				
Drive Motors	5 - Like New, Recently Replaced				
Parking Brake	5 - Like New, Recently Replaced				
Parking Brake Function	Good brake function				
Overall Drivetrain Rating	4 - Very Light or Minimal Wear				
Overall Drivetrain Comments	The drivetrain is in good working order

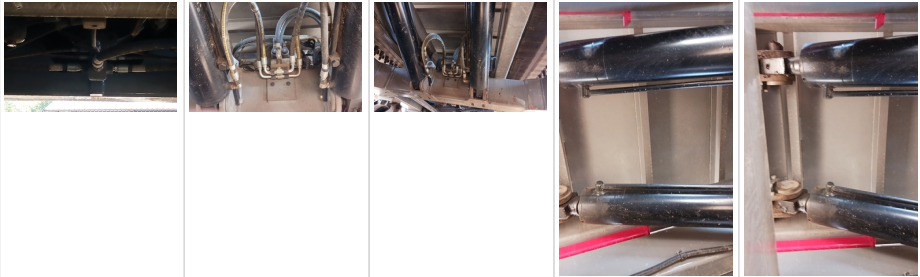
Hydraulic System Photos

Wet or Damp Hydraulic Lines / Fittings	No
Hydraulic Lines/Fittings	4 - Very Light or Minimal Wear
Hydraulic Lines / Fittings Condition	Hydraulic lines & fittings are clean and in good condition
Hydraulic Pump(s)	5 - Like New, Recently Replaced
Unusual Noises	No
Hydraulic Pump Notes	No unusual noises heard during operation

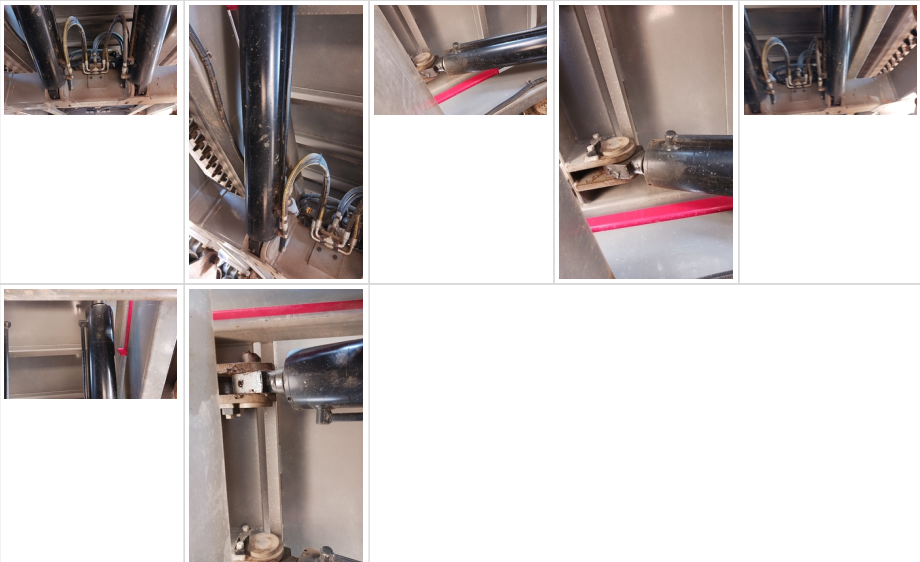
Hydraulic Cylinder Photos

Mounting Pins	4 - Very Light or Minimal Wear
Cylinder Oil Leaks	No
Hydraulic System Overall	4 - Very Light or Minimal Wear
Comments	The hydraulic system is in good working order

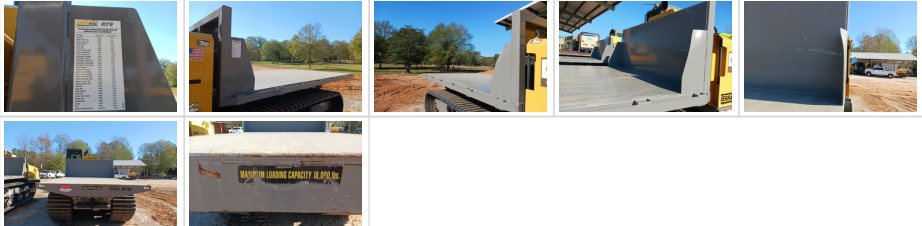
Attachment Type	Flatbed
Attachment Make	Terramac RT9
Attachment Size / Specs	7ft 10in wide and 15ft long
Attachment Condition	3 - Normal Wear & Tear
Comments	Max carrying capacity of 18,000lbs
Attachment Photos
