General Info

B&B Stock Number	A8652557
Year	2018
Make	Caterpillar
Model	299D2
Serial Number	CAT0299DTFD203523
Hour Meter Reading	2027.4
Previous Application (e.g., earth moving, mining, demolition, etc)	Unknown

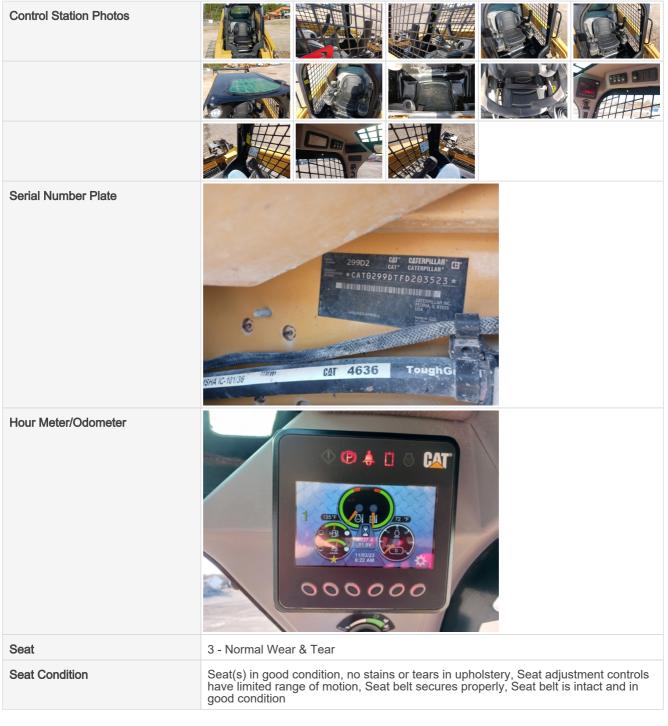
Control Station Photos

Cabin Lights	3 - Normal Wear & Tear		
Cabin Lights Condition	Cabin lights are installed with all light covers in place, bulbs are installed and working properly		
Safety Lock Out / Stop	3 - Normal Wear & Tear		
Safety Lock Out / Stop Condition	Safety lock out device is present, in good condition, and functional		
Controls & Switches	3 - Normal Wear & Tear		
Controls & Switches Condition	All switches are installed and functional		
Hour Meter Activity	3 - Normal Wear & Tear		
Hour Meter Condition	Hour meter is functional and in good condition		
Other Gauge Activity	3 - Normal Wear & Tear		
Other Gauge Condition	All cockpit gauges are functional and in good condition		
Heater & A/C	0		
Travel Alarm	3 - Normal Wear & Tear		
Travel Alarm Condition	Travel alarm is installed and functioning as expected		
Horn	3 - Normal Wear & Tear		
Horn Condition	Horn is installed and functioning as expected		
Backup Camera	0

Control Station Overall Rating	3 - Normal Wear & Tear		
Control Station Overall Condition	Good cabin appearance, solid floors, panels, and ceiling

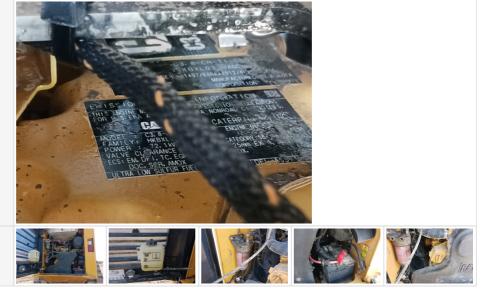
Engine Data Plate

Engine Type (Make, Model, Cylinders, Hp)	Cat, C3.8, 95hp			
Emissions Tier	Tier 4F			
Engine Serial Number	unable to verify			
Engine Fuel Type	Diesel			
Blow-by (Visual Observation Check)	Yes			
Unusual Noises (Upon Start-up, Idle, Shutdown)	No			
Engine Smoke (Upon Start-up, Idle, Shutdown)	No			
Engine Exhaust Color	Clear			
Battery	3 - Normal Wear & Tear			
Battery Condition	Dusty & dirty appearance			
Radiator	3 - Normal Wear & Tear			
Radiator Condition	Radiator fins & components appear to be in good working order, no signs of damage or leaks			
Belts	3 - Normal Wear & Tear			
Belt Condition	Belts appear in good condition & alignment with proper tension			
Hoses	3 - Normal Wear & Tear			
Hose Condition	Firm, pliant hoses with no signs of wear or leaks			
Water Pump	3 - Normal Wear & Tear			
Water Pump Condition	No unusual pump noises heard			
Cooling System Leaks	No			
Coolant Appearance	3 - Normal Wear & Tear
