## Inspection Report (On-Highway Service Truck)

B&B Stock Number	A3412548
Year	2016
Make	Ford
Model	F550
Serial Number	1FDUF5GT0GEB33556
Truck Odometer Reading	169889
Current Inspection / State Cert / DOT	Unable to verify
Previous Application (e.g., earth moving, mining, demolition, etc)	Service truck

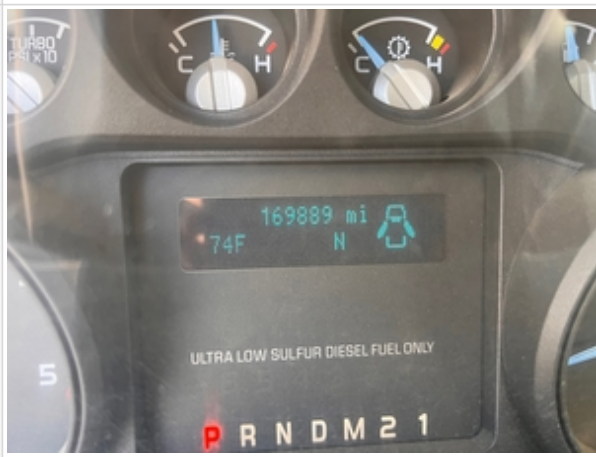
<p>169889 mi 74F N ULTRA LOW SULFUR DIESEL FUEL ONLY P R N D M 2 1</p>
Odometer Activity	3 - Normal Wear & Tear
Odometer Condition	Odometer is working and in good condition
Controls/Switches/Gauges	3 - Normal Wear & Tear
Controls/Switches/Gauges Condition	All switches/gauges are in good condition and functioning
Brake System Type	Hydraulic
Clutch	0
Horn	3 - Normal Wear & Tear
Horn Condition	Horn is functioning as expected
Reverse Alarm / Backup Camera	3 - Normal Wear & Tear
Reverse Alarm / Backup Camera Condition	Reverse alarm working as expected

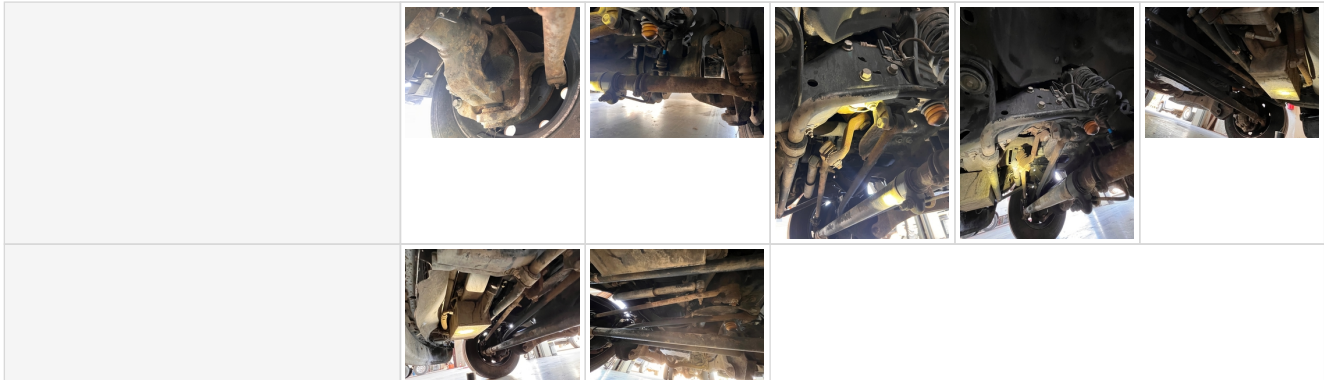
Chassis & Drivetrain Underside Photos

Frame	3 - Normal Wear & Tear
Suspension	3 - Normal Wear & Tear
Steer Axle	3 - Normal Wear & Tear
Steering Components	3 - Normal Wear & Tear
Overall Chassis Condition	3 - Normal Wear & Tear
Overall Chassis Comments	Normal wear and tear

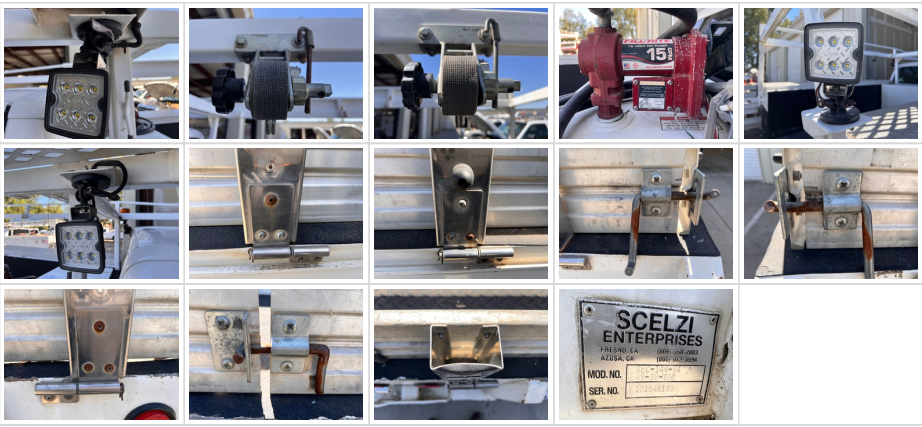
Tool Truck Body Photos

Bed Body	3 - Normal Wear & Tear
Toolboxes	3 - Normal Wear & Tear
Liftgate Function	0
