Inspection Report (Backhoe Loader)

B&B Stock Number	A8749159
Year	2018
Make	Case
Model	580 Super N
Serial Number	JJGN58SNJJC752999
Hour Meter Reading	2621.9
Previous Application (e.g., earth moving, mining, demolition, etc)	used in a rental equipment company

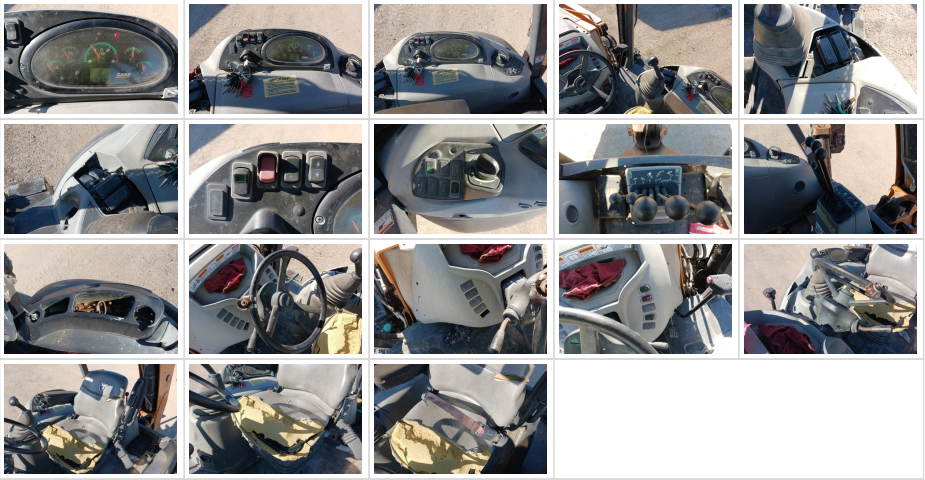
Control Station Photos

Seat	2 - Above Average Wear & Tear
Seat Condition	Seat(s) is damaged due to sun exposure; fading, cracking observed, Seat(s) has major surface staining or tears, Seat adjustment controls move through full range of travel, Seat belt secures properly, Seat belt is intact and in good condition
Cabin Lights	0
Safety Lock Out / Stop	3 - Normal Wear & Tear
Safety Lock Out / Stop Condition	Safety lock out device is present, in good condition, and functional
Controls & Switches	3 - Normal Wear & Tear
Controls & Switches Condition	One or more switches are inoperative or missing
Hour Meter Activity	3 - Normal Wear & Tear
Hour Meter Condition	Hour meter is functional and in good condition
Other Gauge Activity	3 - Normal Wear & Tear
Other Gauge Condition	All cockpit gauges are functional and in good condition
Heater & A/C	0
Travel Alarm	3 - Normal Wear & Tear
Travel Alarm Condition	Travel alarm is installed and functioning as expected

Horn	3 - Normal Wear & Tear
Horn Condition	Horn is installed and functioning as expected
Backup Camera	0
Control Station Overall Rating	2 - Above Average Wear & Tear
Control Station Overall Condition	Minor cosmetic wear to cabin surfaces, floors, panels, and ceiling
Comments	the interior displays an above normal amount of wear and tear

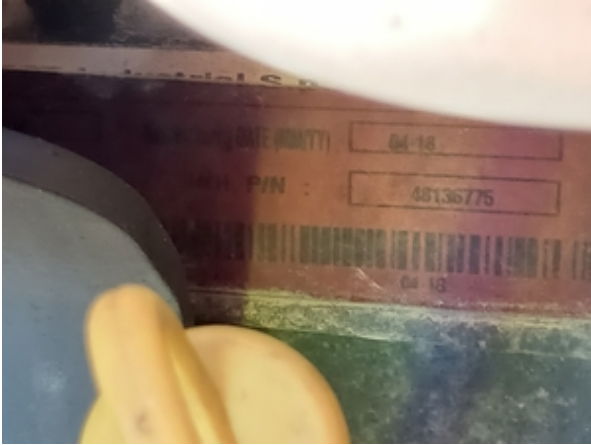
Engine Data Plate

Engine Type (Make, Model, Cylinders, Hp)	Case, 445A/E3, 97Hp				
Emissions Tier	Tier 4F				
Engine Serial Number	unable to verify				
Engine Fuel Type	Diesel				
Blow-by (Visual Observation Check)	N/A				
Unusual Noises (Upon Start-up, Idle, Shutdown)	No				
Engine Smoke (Upon Start-up, Idle, Shutdown)	No				
Engine Exhaust Color	Clear				
Battery	3 - Normal Wear & Tear				
Battery Condition	Dusty & dirty appearance				
Radiator	2 - Above Average Wear & Tear				
Radiator Condition	Signs of corrosion on clamps & hoses				
Belts	2 - Above Average Wear & Tear				
Belt Condition	Areas of slick, glazed appearance on one or more belts

Hoses	2 - Above Average Wear & Tear
Hose Condition	Dried seepages observed, Leaks in one or more hoses or fittings observed
Water Pump	3 - Normal Wear & Tear
Water Pump Condition	No unusual pump noises heard
Cooling System Leaks	No
Coolant Appearance	3 - Normal Wear & Tear
Coolant Appearance Notes	Normal Translucent appearance, no visual signs of contamination
Oil Leaks	No
Oil Appearance	2 - Above Average Wear & Tear
Oil Appearance Notes	Appropriate oil level, Very dark, black & burnt oil appearance
Fuel Leaks	No
Equipped with DPF (Diesel Particulate Filter)	Yes
DPF Condition	3 - Normal Wear & Tear
DPF Condition Notes	Filter housing is intact with no signs of damage or malfunction, DPF indicator is not illuminated
Requires DEF (Diesel Exhaust Fluid)	Yes
DEF Tank	3 - Normal Wear & Tear
DEF Tank Condition	Area around DEF tank cap is clean, fluid is clear & appears free of contaminants
Overall Engine Rating	2 - Above Average Wear & Tear

Overall Engine Appearance	Active leaks/pooling observed in & around engine compartment, Areas of surface corrosion seen on some engine components, Very dirty, Areas of dried seepage seen on engine hoses & components
Overall Engine Comments	The engine has an active leak, pooling of fluids can be seen throughout the engine bay.

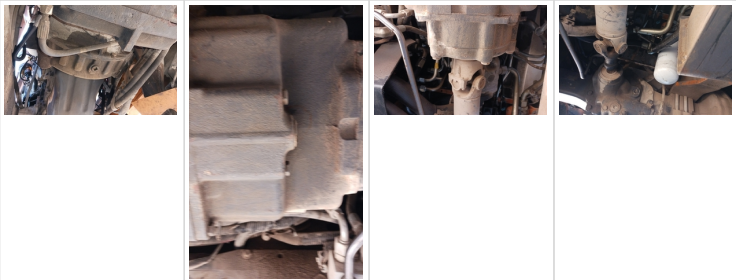
Drivetrain Photos

Drive Type	2WD
Transmission Components	3 - Normal Wear & Tear
Transmission Condition	Good forward and reverse function, No unusual noises or vibrations
Drive Motors	0
Parking Brake	3 - Normal Wear & Tear
Parking Brake Function	Good brake function
Overall Drivetrain Rating	2 - Above Average Wear & Tear
Overall Drivetrain Comments	The drivetrain is in working order, but leaks were seen throughout the drivetrain systems

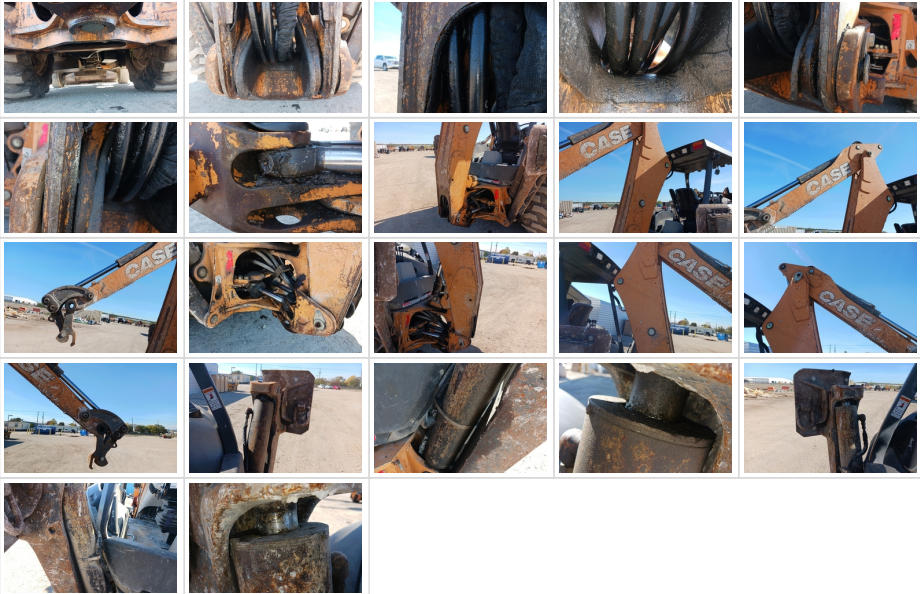
Chassis Photos

Frame	3 - Normal Wear & Tear				
Stance	3 - Normal Wear & Tear				
Front Axle Appearance	2 - Above Average Wear & Tear				
Rear Axle Appearance	2 - Above Average Wear & Tear				
Oscillating Pin Appearance	3 - Normal Wear & Tear				
Lift Arm	2 - Above Average Wear & Tear				
Chassis to Arm Pins	3 - Normal Wear & Tear				
Tilt Linkage	3 - Normal Wear & Tear				
Tilt Linkage Pins & Bushings	3 - Normal Wear & Tear				
Bucket to Arm Pins	3 - Normal Wear & Tear				
Boom	2 - Above Average Wear & Tear				
Stick	2 - Above Average Wear & Tear				
Stick Extension Wear Guides	2 - Above Average Wear & Tear

Boom Lock	3 - Normal Wear & Tear
Swing Tower Pivot	3 - Normal Wear & Tear
Boom Base Pin & Bushings	2 - Above Average Wear & Tear
Boom to Stick Pin & Bushings	2 - Above Average Wear & Tear
Stick to Bucket Pin & Bushings	2 - Above Average Wear & Tear
Outriggers	2 - Above Average Wear & Tear
Overall Chassis	2 - Above Average Wear & Tear
