Inspection Report (Boom Lift)

B&B Stock Number	A3279882
Year	2008
Make	Genie
Model	s125
Serial Number	S12508-2447
Hour Meter Reading	5096

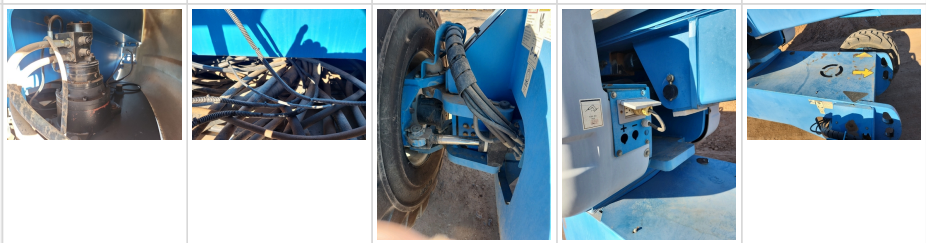
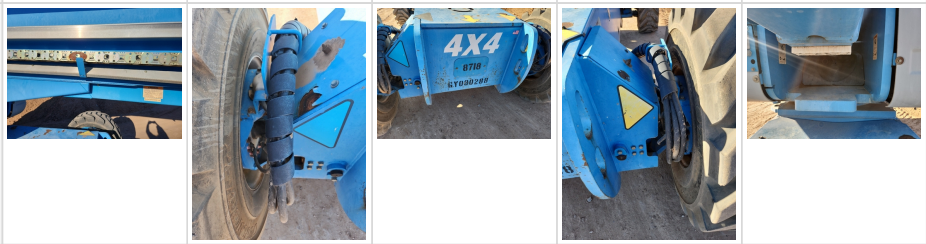
Close-up Exterior Photos

Comments	1 compartment latch broken	
Steps / Ladders	0	
Handrails	3 - Normal Wear & Tear	
Handrails Condition	Handrails are fully intact and appear structurally sound, Other (see comments)	
Comments	paint worn off

Glass	0
Mirrors	0
Exterior Lights	0
Overall Exterior	3 - Normal Wear & Tear
Comments	Structurally solid unit. Has some surface rust and minor dent,

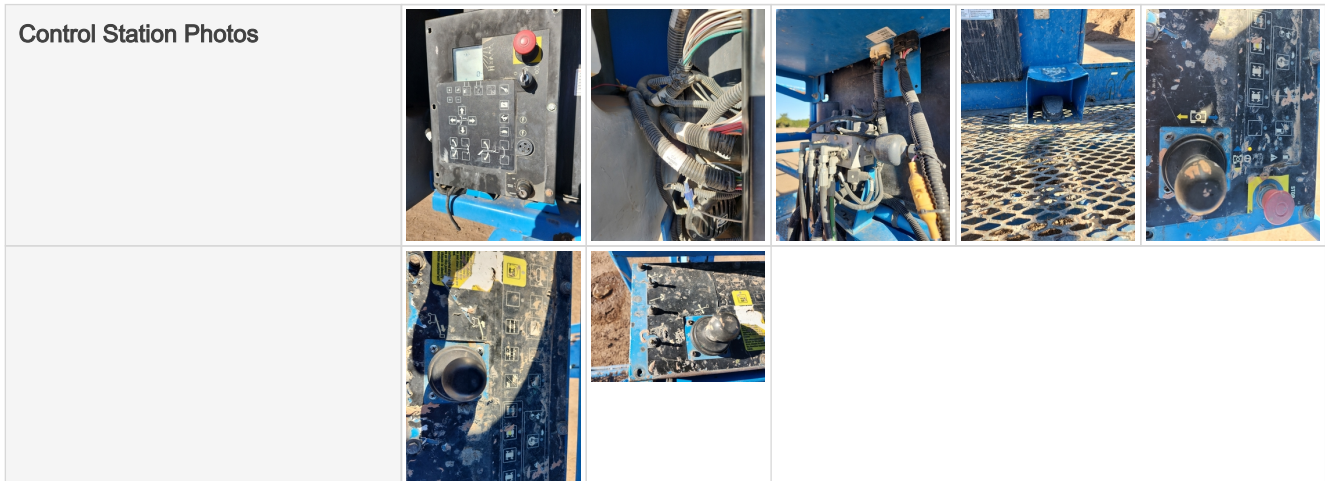
Control Station Photos

Backup Camera	0
Control Station Overall Rating	3 - Normal Wear & Tear
Control Station Overall Condition	Minor cosmetic wear to cabin surfaces, floors, panels, and ceiling
Comments	all controls function properly with minor wear and tear

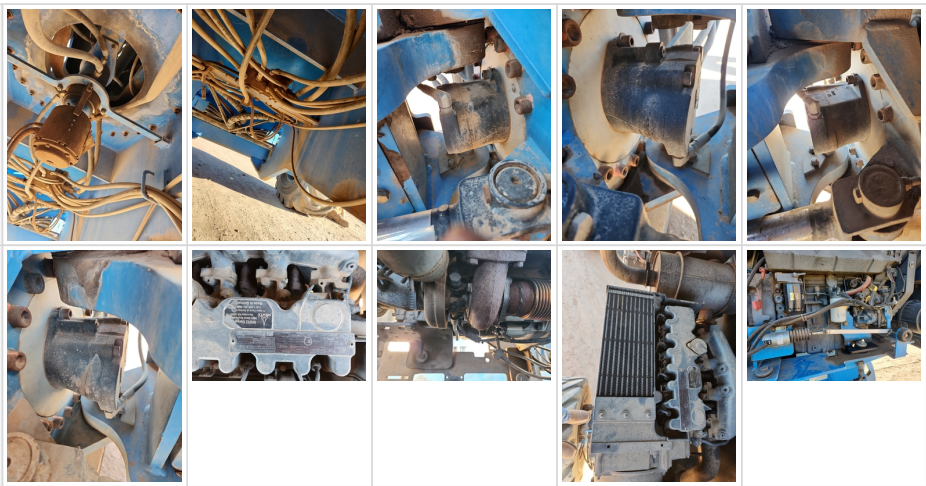
Drivetrain Photos

Hydrostatic Transmission?	No				
2 Speed?	No				
Drive	4WD				
Drive Motors	3 - Normal Wear & Tear				
Parking Brake	0				
Overall Drivetrain Rating	3 - Normal Wear & Tear				
Overall Drivetrain Comments	Good condition. Independent hydraulic drive.

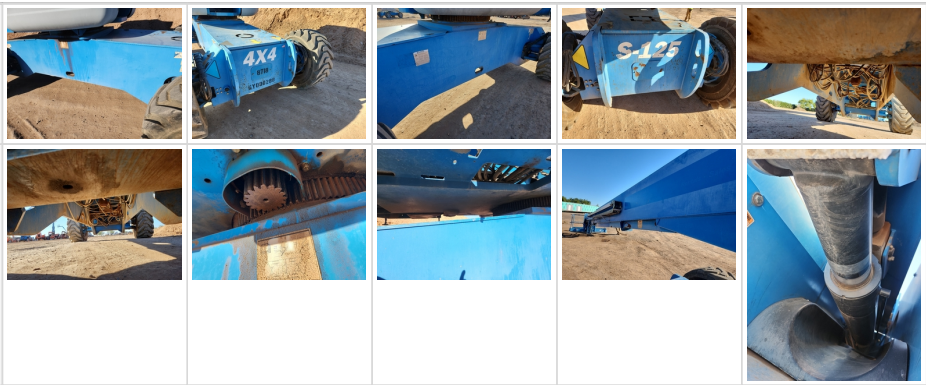
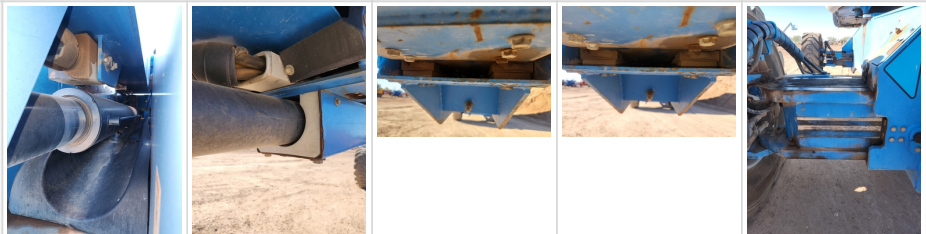
Chassis Photos

Frame	4 - Very Light or Minimal Wear
Stance	4 - Very Light or Minimal Wear
Swing Table	3 - Normal Wear & Tear
Boom	3 - Normal Wear & Tear
Boom Wear Guides	4 - Very Light or Minimal Wear
Jib	3 - Normal Wear & Tear
Front Axle Appearance	0
Rear Axle Appearance	0

Overall Chassis	3 - Normal Wear & Tear	
Overall Chassis Comments	Good overall. Normal wear and tear. Paint peeling, surface rust. Minor dents, scratches. Tires foam filled.
