## Inspection Report (Off-Highway Carrier or Service)

B&B Stock Number	A2964922
Year	2017
Make	John Deere
Model	460E
Serial Number	1DW460ETAHF681396
Hour Meter Reading	5974.1
Previous Application (e.g., earth moving, mining, demolition, etc)	This machine was previously used in civil construction

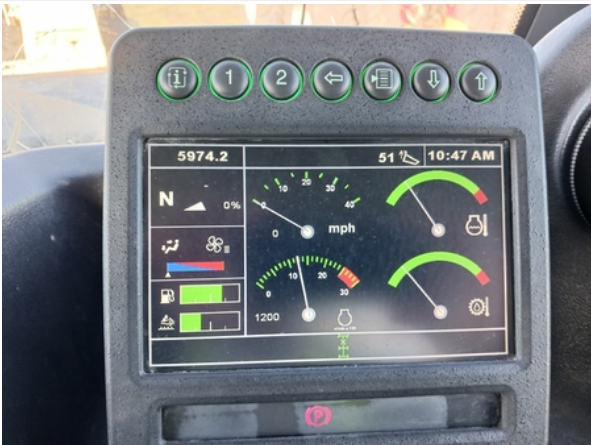
Hour Meter/Odometer

Seat	3 - Normal Wear & Tear
Seat Condition	Seat(s) have minor surface staining or small tears, Seat adjustment controls move through full range of travel, Seat belt secures properly, Seat belt is intact and in good condition
Comments	The operators seat is fine. on the passengers chair the backrest needs to be held in place by a wire.
Cabin Lights	3 - Normal Wear & Tear
Cabin Lights Condition	Cabin lights are installed with all light covers in place, bulbs are installed and working properly
Safety Lock Out / Stop	3 - Normal Wear & Tear
Safety Lock Out / Stop Condition	Safety lock out device is present, in good condition, and functional
Controls & Switches	3 - Normal Wear & Tear
Controls & Switches Condition	All switches are installed and functional
Hour Meter Activity	3 - Normal Wear & Tear
Hour Meter Condition	Hour meter is functional and in good condition

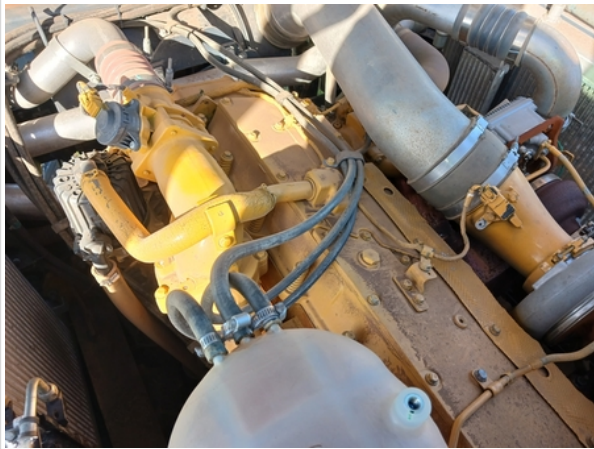
Engine Data Plate

Engine Type (Make, Model, Cylinders, Hp)	John Deere, PowerTech 6135, 481 Hp
Emissions Tier	Tier 4F
Engine Serial Number	unable to verify
Engine Fuel Type	Diesel
Blow-by (Visual Observation Check)	Yes
Unusual Noises (Upon Start-up, Idle, Shutdown)	No
Engine Smoke (Upon Start-up, Idle, Shutdown)	No
Engine Exhaust Color	Clear
Battery	3 - Normal Wear & Tear
Battery Condition	Dusty & dirty appearance
Radiator	3 - Normal Wear & Tear
Radiator Condition	Radiator fins & components appear to be in good working order, no signs of damage or leaks
Belts	3 - Normal Wear & Tear
Belt Condition	Belts appear in good condition & alignment with proper tension
Hoses	3 - Normal Wear & Tear
Hose Condition	Firm, pliant hoses with no signs of wear or leaks
Water Pump	3 - Normal Wear & Tear
Water Pump Condition	No unusual pump noises heard
Cooling System Leaks	No
Coolant Appearance	3 - Normal Wear & Tear
Coolant Appearance Notes	Normal Translucent appearance, no visual signs of contamination

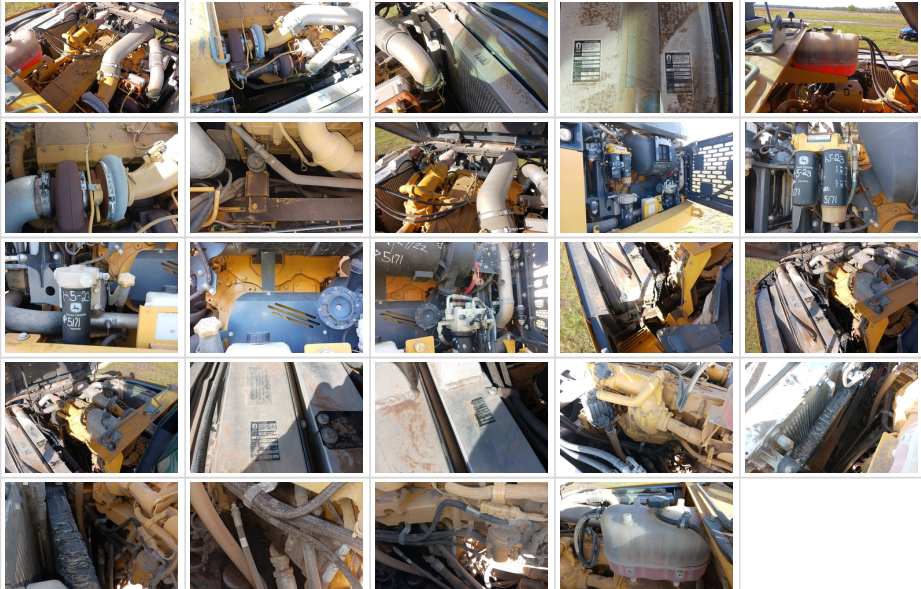
Engine Compartment Photos

DEF Tank Condition	Area around DEF tank cap is clean, fluid is clear & appears free of contaminants
Overall Engine Rating	3 - Normal Wear & Tear
Overall Engine Appearance	Dusty & dry
Overall Engine Comments	The right-hand side radiator had some dented fins on it. The engine started right up and is fully functional.

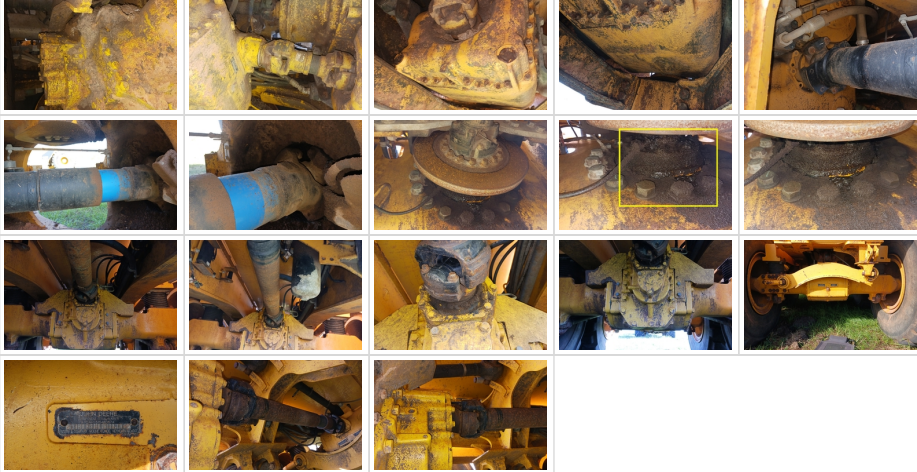
Drivetrain Photos

Hydrostatic Transmission?	N/A
2 Speed?	N/A
Drive Type	Other (see comments)
Other Drive Type	6x4 with differential lock for the 2 front tires
Transmission Components	3 - Normal Wear & Tear
Transmission Condition	Good forward and reverse function, No unusual noises or vibrations, Other (see comments)
Comments	Transmission type - Countershaft, Final Drive - Planetary - Outboard. The transmission is hydraulic, and ZF is the manufacturer
Drive Motors	0
Parking Brake	3 - Normal Wear & Tear
Parking Brake Function	Good brake function
Overall Drivetrain Rating	3 - Normal Wear & Tear
Overall Drivetrain Comments	The drivetrain is fully functional
