## Inspection Report (Off-Highway Carrier or Service)

B&B Stock Number	A3449512
Year	2017
Make	John Deere
Model	410E
Serial Number	1DW410ETEHF679215
Hour Meter Reading	7486.3
Previous Application (e.g., earth moving, mining, demolition, etc)	This machine was used in civil construction

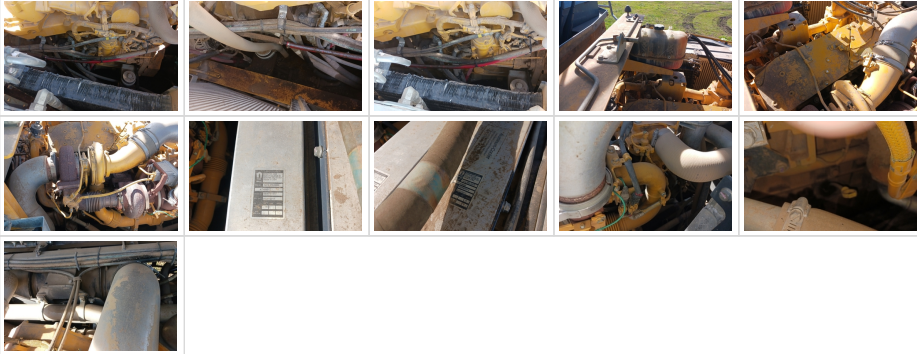
Engine Compartment Photos

Battery Condition	Dusty & dirty appearance
Radiator	3 - Normal Wear & Tear
Radiator Condition	Radiator fins & components appear to be in good working order, no signs of damage or leaks
Belts	3 - Normal Wear & Tear
Belt Condition	Belts appear in good condition & alignment with proper tension
Hoses	3 - Normal Wear & Tear
Hose Condition	Firm, pliant hoses with no signs of wear or leaks
Water Pump	3 - Normal Wear & Tear
Water Pump Condition	No unusual pump noises heard
Cooling System Leaks	No
Coolant Appearance	2 - Above Average Wear & Tear
Coolant Appearance Notes	Dark, opaque appearance
Oil Leaks	No
Oil Appearance	3 - Normal Wear & Tear
Oil Appearance Notes	Appropriate oil level, Very dark, black & burnt oil appearance
Fuel Leaks	No
Equipped with DPF (Diesel Particulate Filter)	Yes
DPF Condition	1 - Service Required
DPF Condition Notes	Other (see comments)
Comments	This machine is having issues with the Regeneration system. John deere needs a laptop to get the machine to start the regen process

Requires DEF (Diesel Exhaust Fluid)	Yes
DEF Tank	3 - Normal Wear & Tear
DEF Tank Condition	Area around DEF tank cap is clean, fluid is clear & appears free of contaminants
Overall Engine Rating	2 - Above Average Wear & Tear
Overall Engine Appearance	Dusty & dry
Overall Engine Comments	The engine works fine, but there is a regeneration issue. John deere has to come out with a laptop to get the machine to go into regen mode.

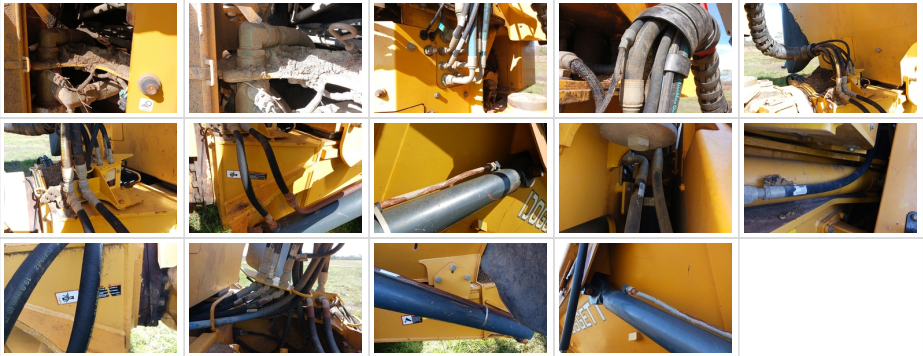
Hydraulic System Photos

Wet or Damp Hydraulic Lines / Fittings	No
Hydraulic Lines/Fittings	3 - Normal Wear & Tear
Hydraulic Lines / Fittings Condition	Other (see comments)
Comments	some cracking was seen on a few hoses, and areas of rust were seen on the line going to the lift cylinders to the dump body.
Hydraulic Pump(s)	3 - Normal Wear & Tear
Unusual Noises	No
Hydraulic Pump Notes	No unusual noises heard during operation

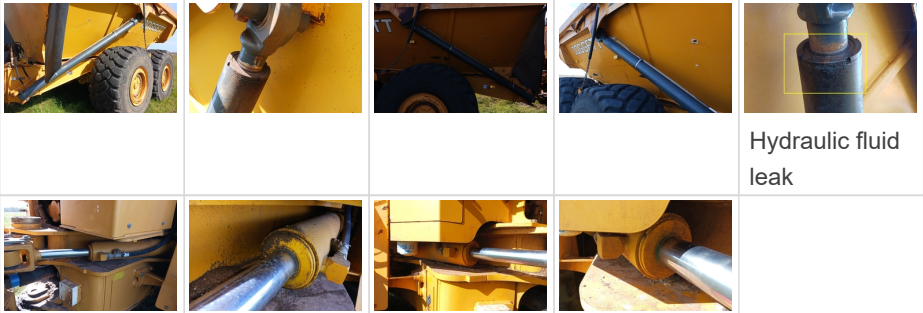
Hydraulic Cylinder Photos

Hydraulic fluid leak
Mounting Pins	3 - Normal Wear & Tear
Cylinder Oil Leaks	No
Comments	some leaks were seen on the hydraulic cylinder
Hydraulic System Overall	3 - Normal Wear & Tear
Comments	The overall hydraulic system is functional
