Inspection Report (Off-Highway Carrier or Service)

B&B Stock Number	A7724951
Year	2016
Make	John Deere
Model	410E
Serial Number	1DW410ETVGF677084
Hour Meter Reading	7287.0
Previous Application (e.g., earth moving, mining, demolition, etc)	This machine was used in civil construction

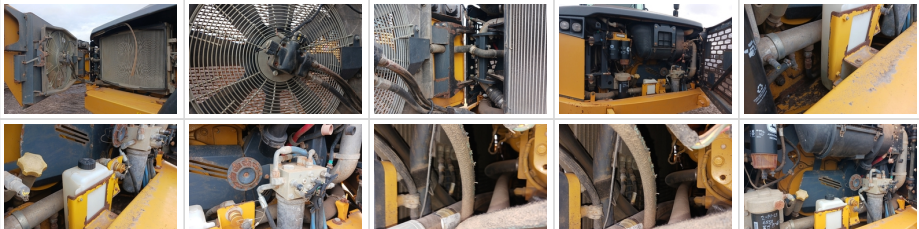
Engine Compartment Photos

Coolant Appearance Notes	Normal Translucent appearance, no visual signs of contamination
Oil Leaks	No
Oil Appearance	3 - Normal Wear & Tear
Oil Appearance Notes	Appropriate oil level, Very dark, black & burnt oil appearance
Fuel Leaks	No
Equipped with DPF (Diesel Particulate Filter)	N/A
Requires DEF (Diesel Exhaust Fluid)	No
Overall Engine Rating	3 - Normal Wear & Tear
Overall Engine Appearance	Dusty & dry
Overall Engine Comments	The engine started right up without issues.

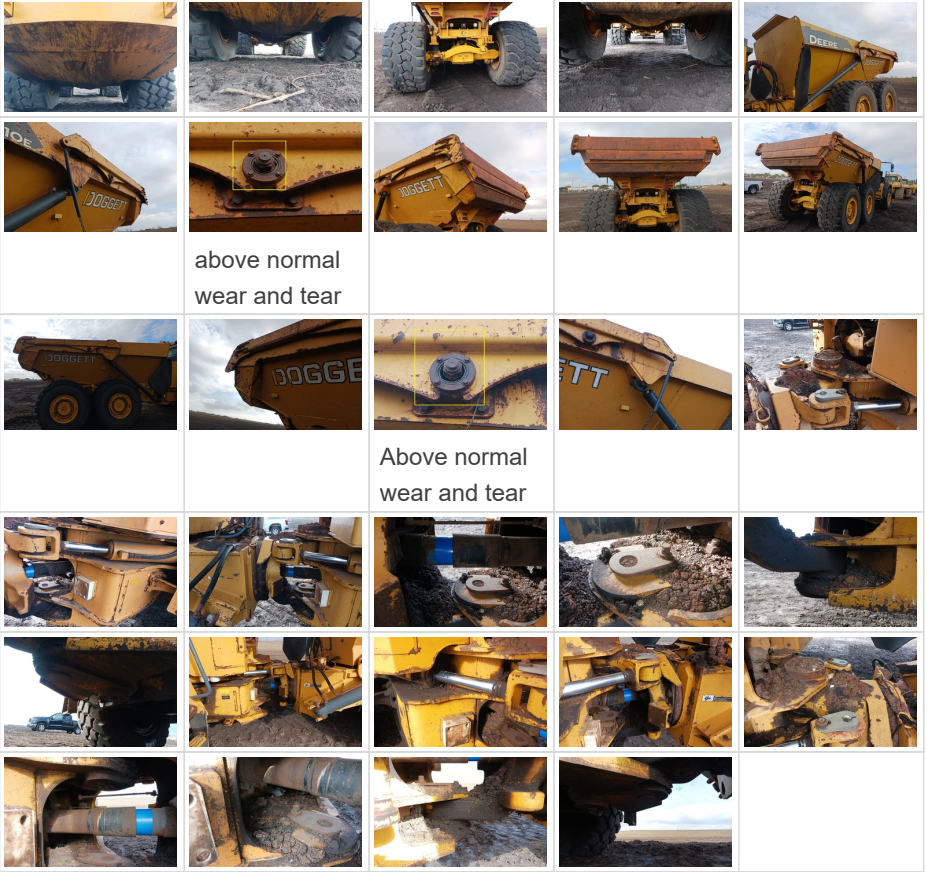
Chassis Photos

<p>above normal wear and tear</p>
	<p>Above normal wear and tear</p>
Turntable Bearing	3 - Normal Wear & Tear
Frame	3 - Normal Wear & Tear
Bottom Covers	3 - Normal Wear & Tear
Carrier Body	3 - Normal Wear & Tear
Overall Chassis	3 - Normal Wear & Tear
Overall Chassis Comments	Areas of rust were seen throughout chassis but it is in good working order.
