## Inspection Report (Vibratory Compactor)

B&B Stock Number	A2167504
Year	2015
Make	Volvo
Model	DD110B
Serial Number	VCED11DBHOS285125
Hour Meter Reading	2187
Previous Application (e.g., earth moving, mining, demolition, etc)	used for paving

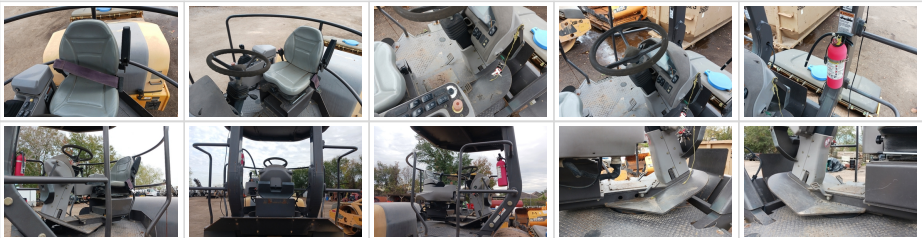
Control Station Photos

Control Station Type	Open Cab (OROPS)
Option List	Unable to Confirm
Seat	3 - Normal Wear & Tear
Seat Condition	Seat(s) have minor surface staining or small tears, Seat adjustment controls move through full range of travel, Seat belt secures properly, Seat belt is intact and in good condition
Cabin Lights	0
Safety Lock Out / Stop	3 - Normal Wear & Tear
Safety Lock Out / Stop Condition	Safety lock out device is present, in good condition, and functional
Controls & Switches	3 - Normal Wear & Tear
Controls & Switches Condition	All switches are installed and functional
Hour Meter Activity	3 - Normal Wear & Tear
Hour Meter Condition	Hour meter is functional and in good condition
Other Gauge Activity	3 - Normal Wear & Tear
Other Gauge Condition	All cockpit gauges are functional and in good condition
Heater & A/C	0
Travel Alarm	0
Horn	3 - Normal Wear & Tear
Horn Condition	Horn is installed and functioning as expected

Backup Camera	0
Control Station Overall Rating	3 - Normal Wear & Tear
Control Station Overall Condition	Good cabin appearance, solid floors, panels, and ceiling

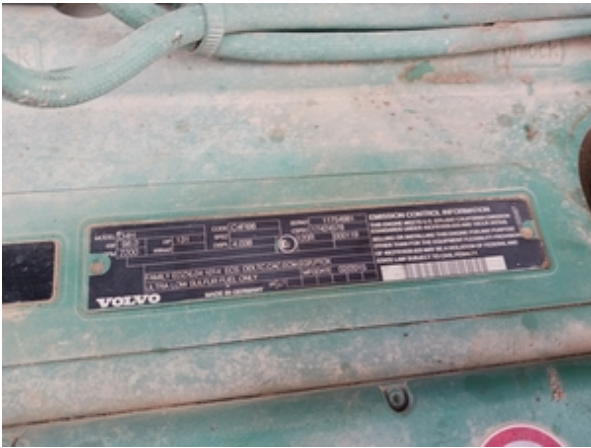
Engine Data Plate

Engine Type (Make, Model, Cylinders, Hp)	Volvo, D4H, 4 cylinder, 131Hp
Emissions Tier	Tier 4i
Engine Serial Number	11854981
Engine Fuel Type	Diesel
Blow-by (Visual Observation Check)	N/A
Unusual Noises (Upon Start-up, Idle, Shutdown)	No
Engine Smoke (Upon Start-up, Idle, Shutdown)	No
Engine Exhaust Color	Clear
Battery	3 - Normal Wear & Tear
Battery Condition	Dusty & dirty appearance
Radiator	3 - Normal Wear & Tear
Radiator Condition	Radiator fins & components appear to be in good working order, no signs of damage or leaks
Belts	3 - Normal Wear & Tear
Belt Condition	Belts appear in good condition & alignment with proper tension
Hoses	3 - Normal Wear & Tear
Hose Condition	Firm, pliant hoses with no signs of wear or leaks
Water Pump	3 - Normal Wear & Tear
Water Pump Condition	No unusual pump noises heard

Cooling System Leaks	No
Coolant Appearance	3 - Normal Wear & Tear
Coolant Appearance Notes	Normal Translucent appearance, no visual signs of contamination
Oil Leaks	No
Oil Appearance	3 - Normal Wear & Tear
Oil Appearance Notes	Very dark, black & burnt oil appearance, Appropriate oil level
Fuel Leaks	No
Equipped with DPF (Diesel Particulate Filter)	Yes
DPF Condition	3 - Normal Wear & Tear
Requires DEF (Diesel Exhaust Fluid)	No
Overall Engine Rating	3 - Normal Wear & Tear
Overall Engine Appearance	Dusty & dry
Overall Engine Comments	The engine is in good working order

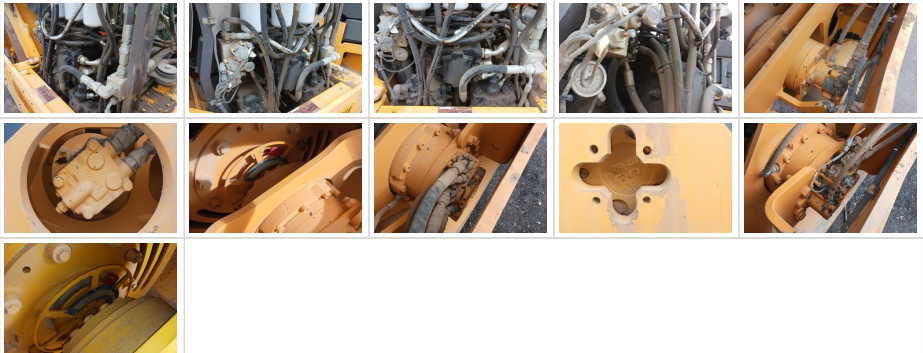
Drivetrain Photos

Hydrostatic Transmission?	Yes
Speeds	Variable Speed
Drive Type	Other (see comments)
Other Drive Type	This machine has a closed-loop hydrostatic, parallel circuit to both drums
Transmission Components	3 - Normal Wear & Tear
Transmission Condition	Good forward and reverse function, No unusual noises or vibrations
Drive Motors	3 - Normal Wear & Tear
Parking Brake	3 - Normal Wear & Tear
Parking Brake Function	Good brake function
Overall Drivetrain Rating	3 - Normal Wear & Tear

Overall Drivetrain Comments	The drivetrain is good working order
-----------------------------	--------------------------------------

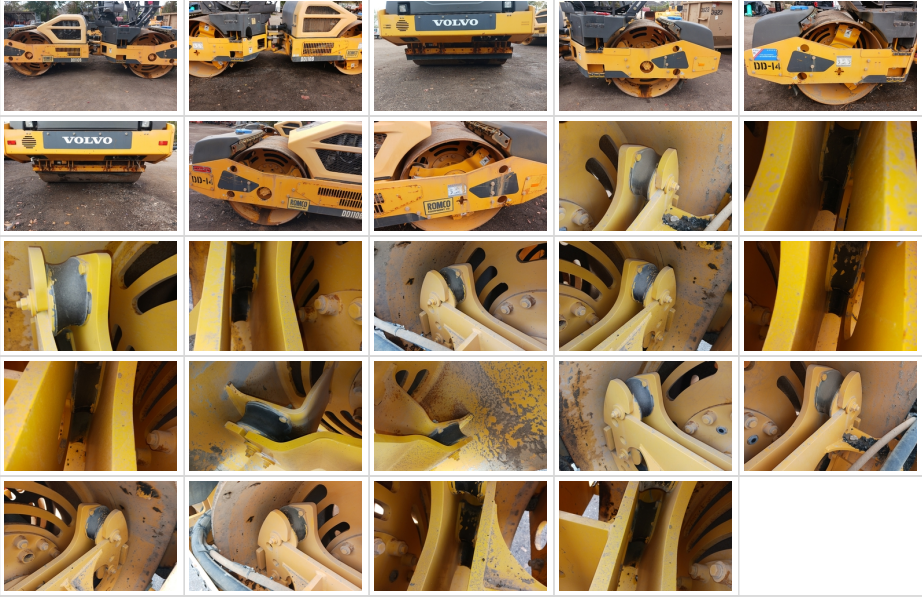
Chassis Photos

Frame	3 - Normal Wear & Tear
Stance	3 - Normal Wear & Tear
Drum(s) Condition	3 - Normal Wear & Tear
Vibratory Rubber Mounts (Front & Rear)	3 - Normal Wear & Tear
Drum Scraper	3 - Normal Wear & Tear
Overall Chassis	3 - Normal Wear & Tear
Overall Chassis Comments	The chassis is in good working order

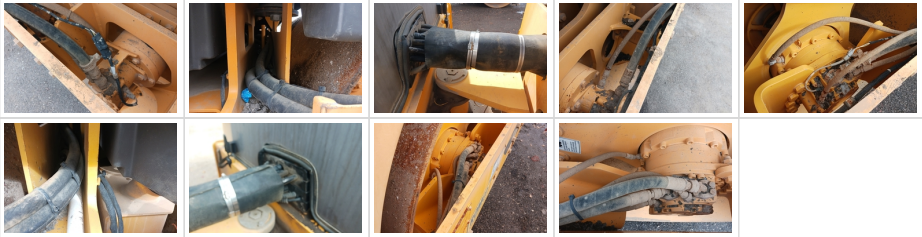
Hydraulic System Photos

Wet or Damp Hydraulic Lines / Fittings	No
Hydraulic Lines/Fittings	3 - Normal Wear & Tear
Hydraulic Lines / Fittings Condition	Hydraulic lines & fittings are clean and in good condition
Hydraulic Pump(s)	3 - Normal Wear & Tear

Unusual Noises	No
Hydraulic Pump Notes	No unusual noises heard during operation

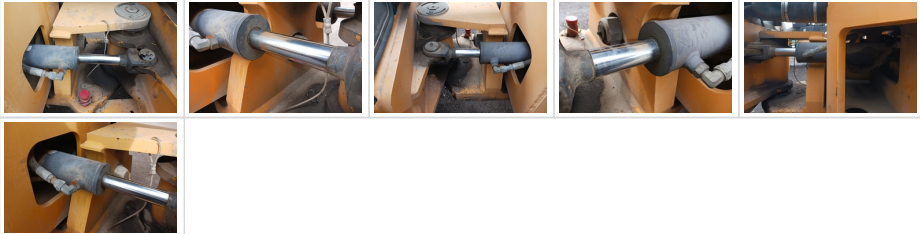
Hydraulic Cylinder Photos

Mounting Pins	3 - Normal Wear & Tear				
Cylinder Oil Leaks	No				
Comments	Hydraulic cylinders are in good condition				
Hydraulic System Overall	3 - Normal Wear & Tear				
Comments	The overall hydraulic system is fully functional and operational
