Inspection Report (Vibratory Compactor)

B&B Stock Number	A1298511
Year	2013
Make	Volvo
Model	DD110B
Serial Number	VCED110BC0S285046
Hour Meter Reading	4145
Previous Application (e.g., earth moving, mining, demolition, etc)	This machine was used in civil construction to pave asphalt

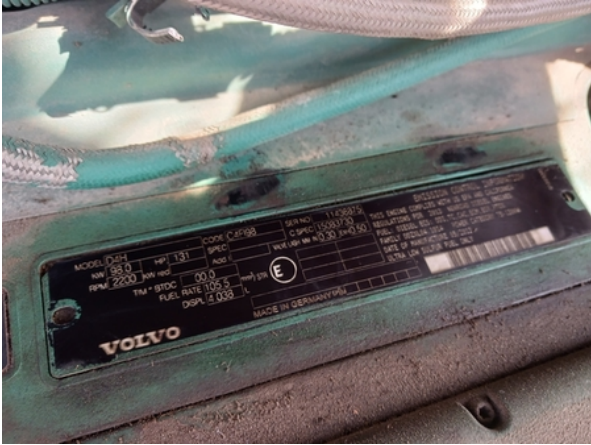
Engine Data Plate

Belt Condition	Belts appear in good condition & alignment with proper tension
Hoses	3 - Normal Wear & Tear
Hose Condition	Firm, pliant hoses with no signs of wear or leaks
Water Pump	3 - Normal Wear & Tear
Water Pump Condition	No unusual pump noises heard
Cooling System Leaks	No
Coolant Appearance	3 - Normal Wear & Tear
Coolant Appearance Notes	Normal Translucent appearance, no visual signs of contamination
Oil Leaks	No
Oil Appearance	3 - Normal Wear & Tear
Oil Appearance Notes	Very dark, black & burnt oil appearance, Appropriate oil level
Fuel Leaks	No
Equipped with DPF (Diesel Particulate Filter)	Yes
DPF Condition	3 - Normal Wear & Tear
DPF Condition Notes	Filter housing is intact with no signs of damage or malfunction, DPF indicator is not illuminated
Requires DEF (Diesel Exhaust Fluid)	No
Overall Engine Rating	3 - Normal Wear & Tear
Overall Engine Appearance	Very dirty
Overall Engine Comments	Signs of leaks were seen, and the locking mechanism to hold the engine open is not working

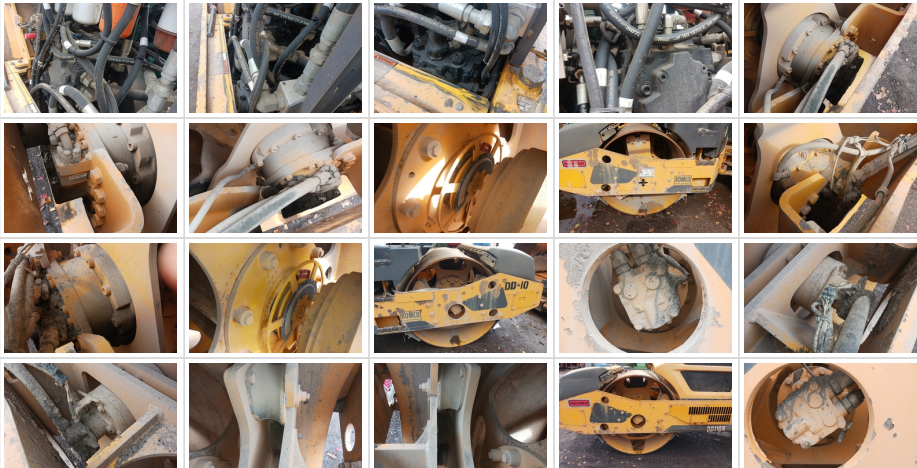
Drivetrain Photos

Hydrostatic Transmission?	Yes
Speeds	Variable Speed
Drive Type	Other (see comments)
Other Drive Type	Drive motors. This machine is a closed-loop hydrostatic, with a parallel circuit to both drums
Transmission Components	3 - Normal Wear & Tear
Transmission Condition	Good forward and reverse function, No unusual noises or vibrations
Drive Motors	3 - Normal Wear & Tear
Parking Brake	3 - Normal Wear & Tear
Parking Brake Function	Good brake function
Overall Drivetrain Rating	3 - Normal Wear & Tear
Overall Drivetrain Comments	The drivetrain is in good working order

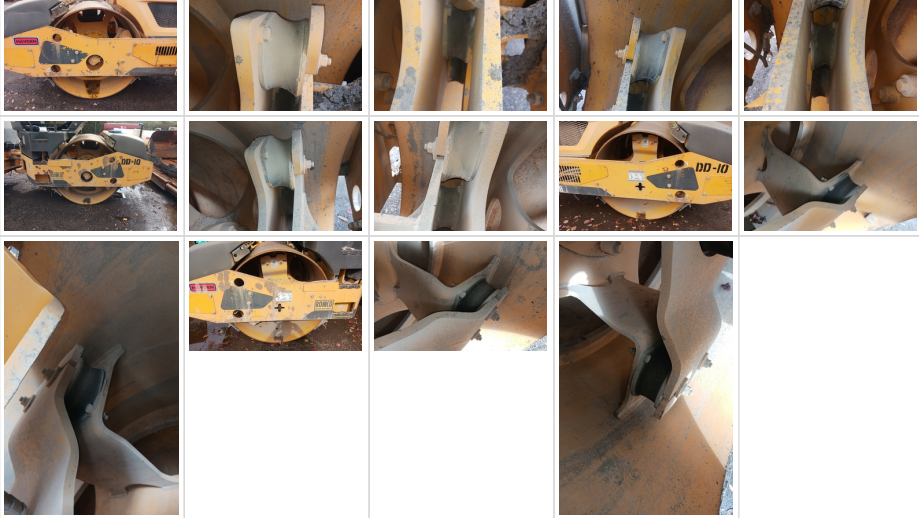
Chassis Photos

Frame	3 - Normal Wear & Tear
Stance	3 - Normal Wear & Tear
Drum(s) Condition	3 - Normal Wear & Tear
Vibratory Rubber Mounts (Front & Rear)	3 - Normal Wear & Tear
Drum Scraper	2 - Above Average Wear & Tear
Comments	Above normal wear and tear was seen on the drum scraper
Overall Chassis	3 - Normal Wear & Tear
Overall Chassis Comments	The chassis is in good working order
