Inspection Report (Telehandler)

B&B Stock Number	A6397496
Year	2014
Make	Toyota
Model	8FGCU25
Serial Number	52919
Hour Meter Reading	7780.2
Previous Application (e.g., earth moving, mining, demolition, etc)	This machine was only used indoors to move material around as needed.

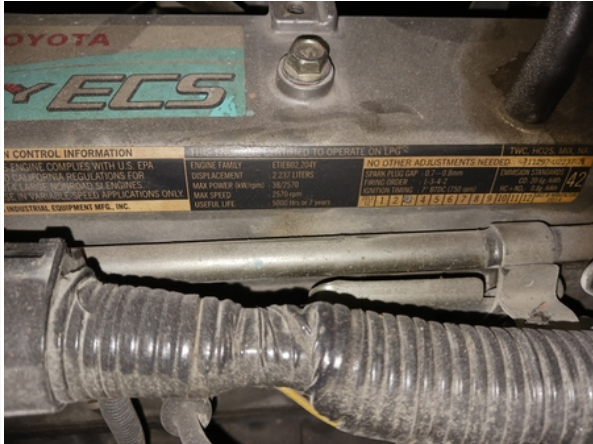
Engine Data Plate

Engine Type (Make, Model, Cylinders, Hp)	Toyota, 4Y ECS, 4 cylinder, 48-51Hp				
Emissions Tier	Undetermined				
Engine Serial Number	4Y*2487540				
Engine Fuel Type	LPG				
Blow-by (Visual Observation Check)	N/A				
Unusual Noises (Upon Start-up, Idle, Shutdown)	No

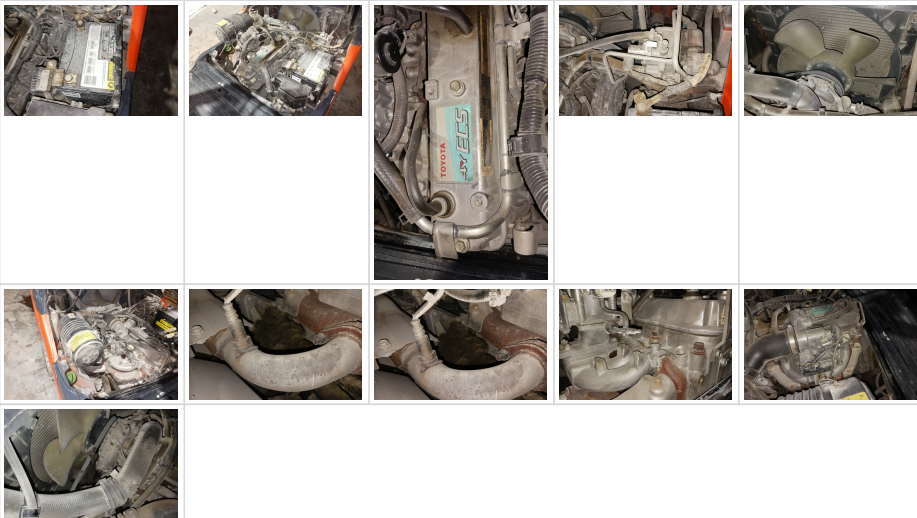
Engine Compartment Photos

Fuel Leaks	No
Equipped with DPF (Diesel Particulate Filter)	No
Requires DEF (Diesel Exhaust Fluid)	No
Overall Engine Rating	3 - Normal Wear & Tear
Overall Engine Appearance	Dusty & dry
Overall Engine Comments	The engine is in good working order
