Inspection Report (Excavator)

| B&B Stock Number | A9158355 |
| Make | Hitachi |
| Model | ZX50U |

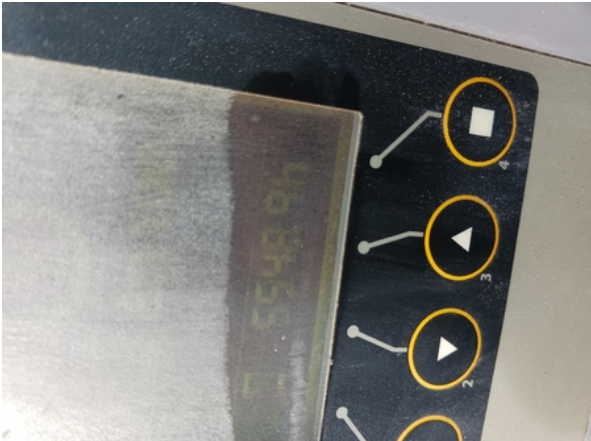
| Hour Meter/Odometer | |

| Hour Meter Condition | Hour meter is functional, with some minor wear and/or cosmetic damage, Other (see comments) |
| Comments | It is difficult to see the screen. |

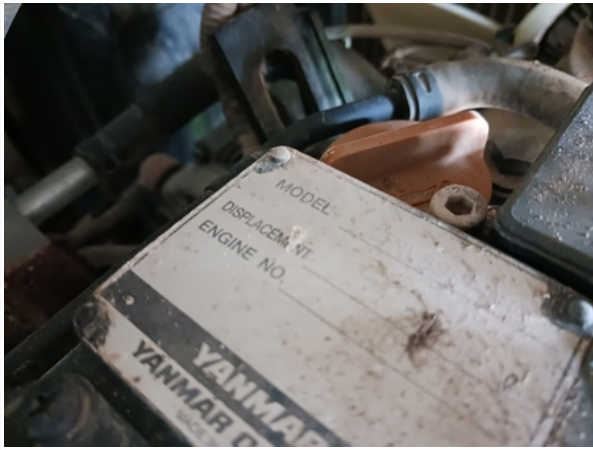
| Engine Data Plate | | | | | |

| Engine Type (Make, Model, Cylinders, Hp) | Yanmar, 4TNV88, 39Hp | | | | |

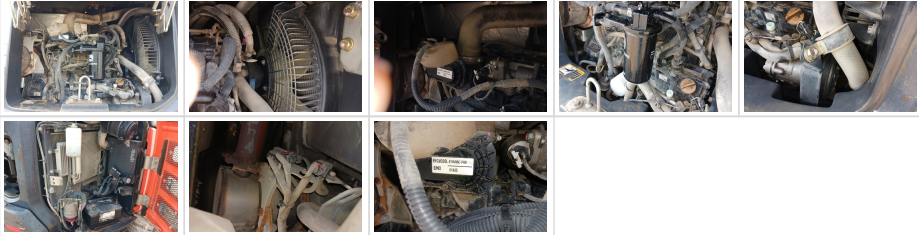
| Engine Compartment Photos | | | | | |

| Overall Engine Rating | 3 - Normal Wear & Tear |
| Overall Engine Appearance | Dusty & dry |
| Overall Engine Comments | The engine is in good working condition |

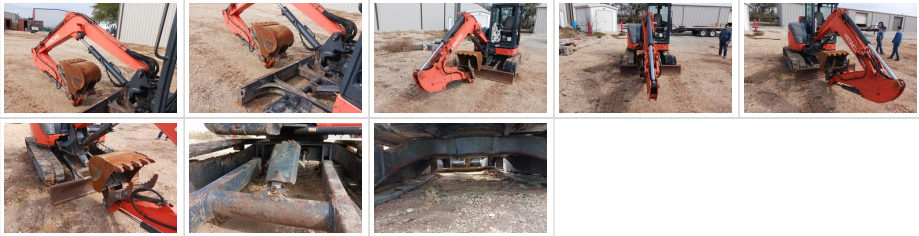
| Chassis Photos | |

| Overall Chassis | 3 - Normal Wear & Tear |
| Overall Chassis Comments | The chassis is in good working condition |

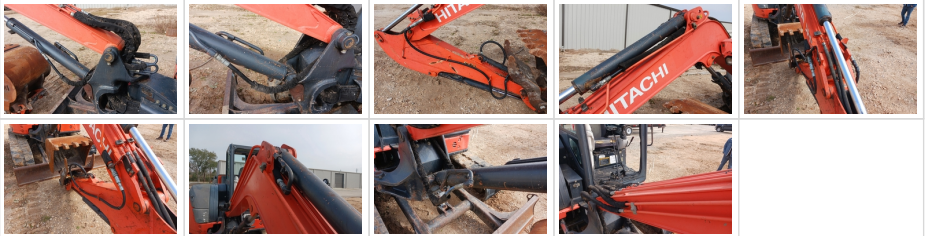
| Hydraulic System Photos | | | | | |

| Hydraulic Lines / Fittings Condition | Hydraulic lines & fittings are clean and in good condition | | | | |

| Hydraulic System Overall | 3 - Normal Wear & Tear |
| Comments | The overall hydraulic system is in good working order |

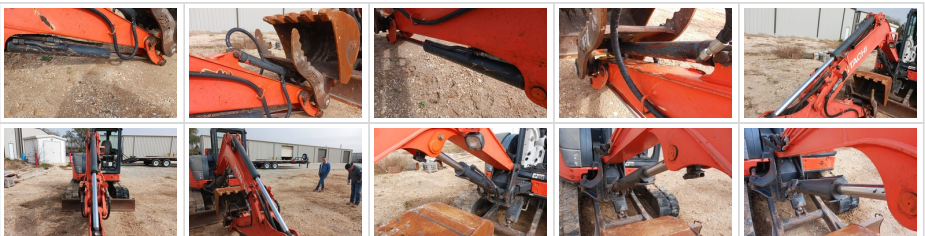
| Hydraulic Cylinder Photos | | | | | |

| Cylinder Oil Leaks | Yes | | | | |

| Comments | Small leak seen on the boom cylinder |
