Inspection Report (Paver)

B&B Stock Number	A4333610
Year	2007
Make	Roadtec
Model	RP195
Serial Number	JTF01003
Hour Meter Reading	est 7700hrs
Previous Application (e.g., earth moving, mining, demolition, etc)	This machine used in asphalt paving

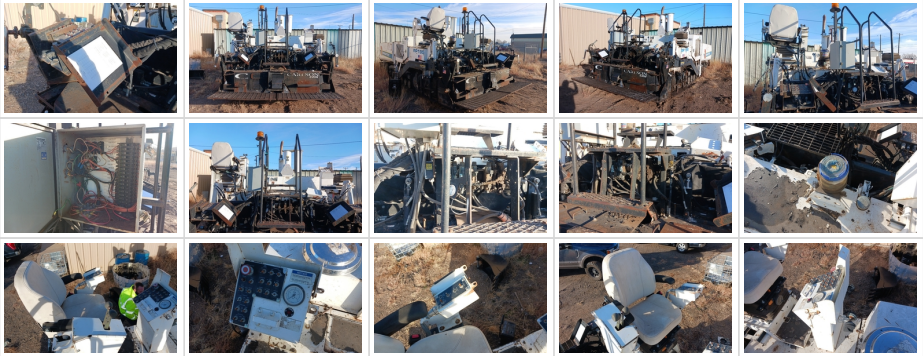
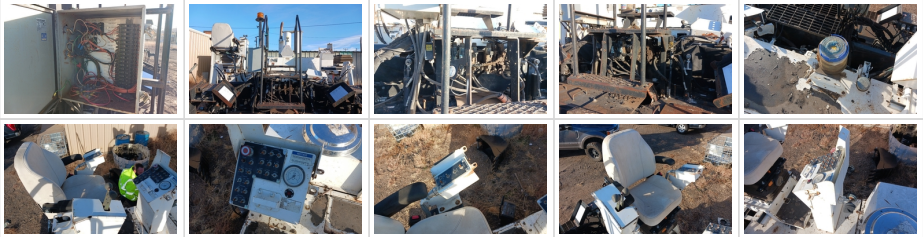
The control is loose and is missing its cover.

<p>The right-hand side operators control box</p>
Serial Number Plate

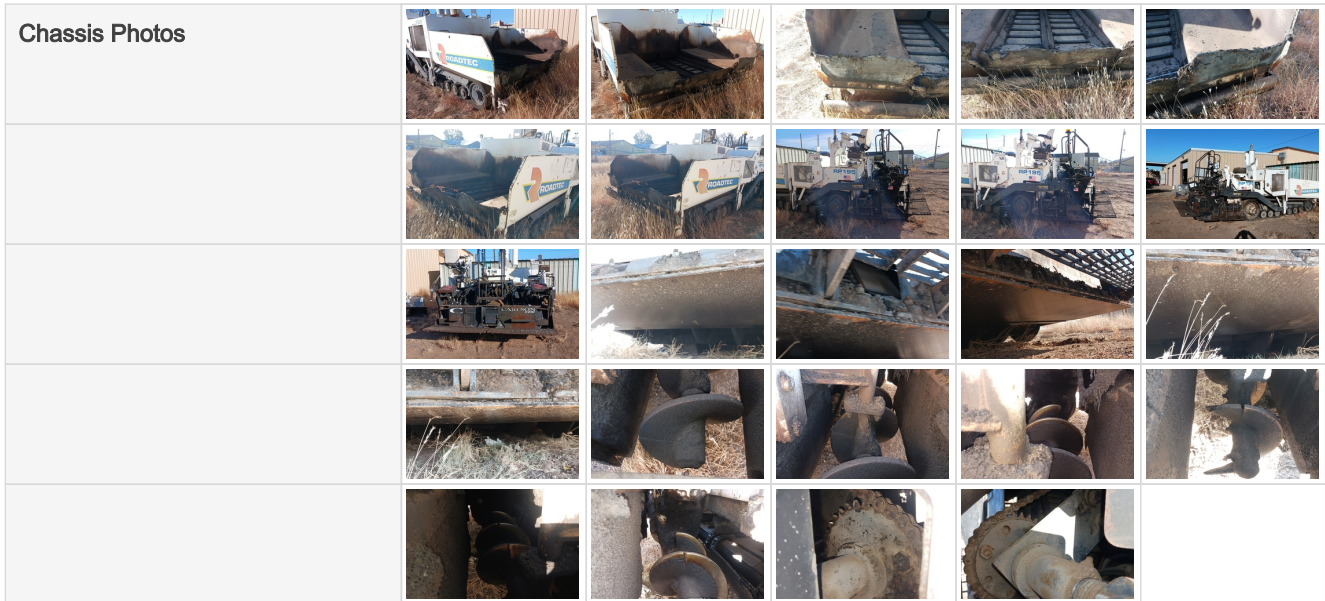
This area of damage/missing rubber was seen on 2 rollers on the left-hand side of the track.

Damage/missing rubber seen on the left-hand side rollers.

Track Width (inches)	1ft 6.5in
Track Length (inches)	12ft 7in
Roller Frames	2 - Above Average Wear & Tear
Track Belt	3 - Normal Wear & Tear
Rubber Belt Drive Lugs	3 - Normal Wear & Tear
Track Tensioners	3 - Normal Wear & Tear
Front Idlers	3 - Normal Wear & Tear
Rear Idlers	3 - Normal Wear & Tear
Track Rollers	3 - Normal Wear & Tear
Sprockets	3 - Normal Wear & Tear
Overall Undercarriage Rating	3 - Normal Wear & Tear
Left Track Belt - Percent Remaining Estimate	70%
Right Track Belt - Percent Remaining Estimate	70%
Overall Comments	The rubber tracks themselves are in good working order, but areas of damage/missing rubber was seen on the left-hand side track.
