Inspection Report (Excavator)

B&B Stock Number	A9088814
Year	2017
Make	Volvo
Model	EC160
Serial Number	VCEC160EA00310262
Hour Meter Reading	5009.3hrs
Previous Application (e.g., earth moving, mining, demolition, etc)	used in civil construction

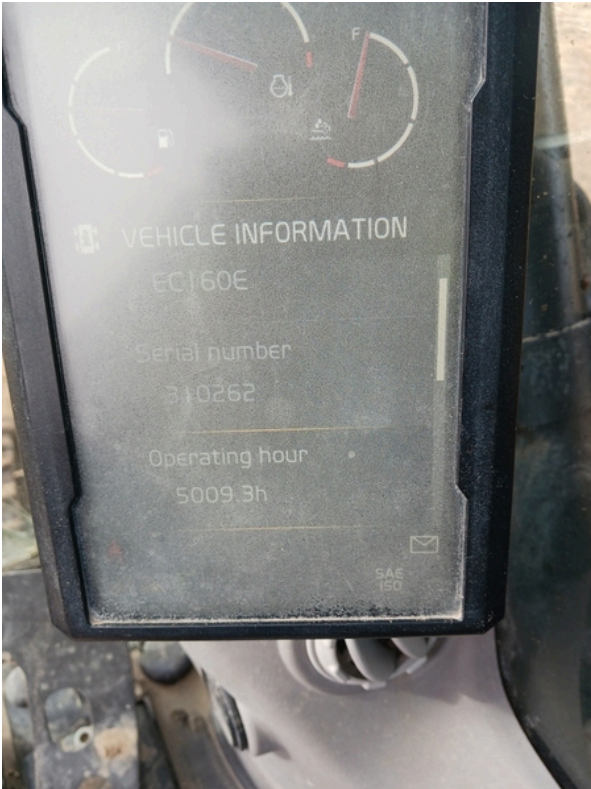
Hour Meter/Odometer

Controls & Switches Condition	Other (see comments)
Hour Meter Activity	3 - Normal Wear & Tear
Hour Meter Condition	Hour meter is functional and in good condition
Other Gauge Activity	2 - Above Average Wear & Tear
Other Gauge Condition	Gauges are functional, with some wear and/or cosmetic damage
Comments	The display screen is a little hard to read.
Heater & A/C	3 - Normal Wear & Tear
Heater & A/C Condition	Only cooling functionality works, Heater and A/C work as expected
Travel Alarm	3 - Normal Wear & Tear
Travel Alarm Condition	Travel alarm is installed and functioning as expected
Horn	3 - Normal Wear & Tear
Horn Condition	Horn is installed and functioning as expected
Backup Camera	3 - Normal Wear & Tear
Backup Camera Condition	Back up camera is installed and functioning as expected
Control Station Overall Rating	3 - Normal Wear & Tear
Control Station Overall Condition	Minor cosmetic wear to cabin surfaces, floors, panels, and ceiling

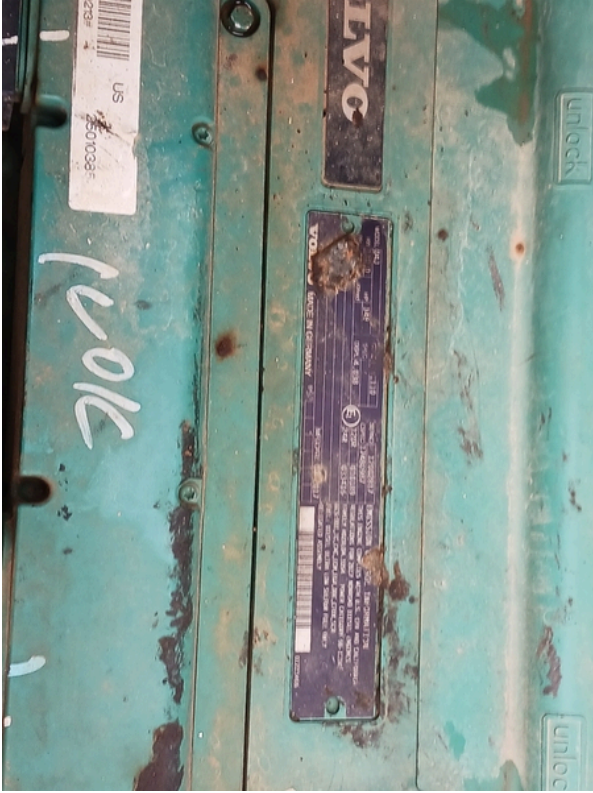
Engine Data Plate

Engine Type (Make, Model, Cylinders, Hp)	Volvo, D4J, 148hp,
Emissions Tier	Tier 4F
Engine Serial Number	12002817
Engine Fuel Type	Diesel
Blow-by (Visual Observation Check)	N/A
Unusual Noises (Upon Start-up, Idle, Shutdown)	No
Engine Smoke (Upon Start-up, Idle, Shutdown)	No
Engine Exhaust Color	Clear
Battery	3 - Normal Wear & Tear
Battery Condition	Dusty & dirty appearance
Radiator	3 - Normal Wear & Tear

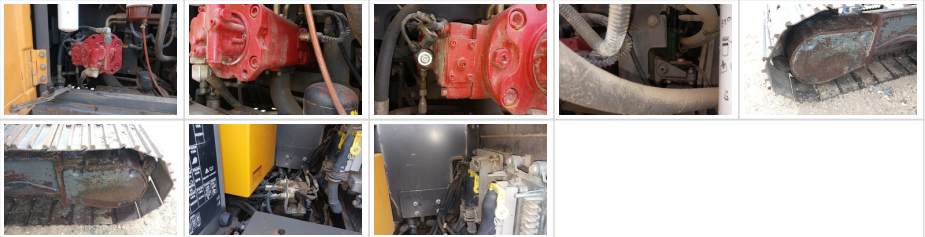
Drivetrain Photos

Transmission Components	3 - Normal Wear & Tear
Transmission Condition	Other (see comments), Good forward and reverse function
Drive Motors	3 - Normal Wear & Tear
Parking Brake	3 - Normal Wear & Tear
Parking Brake Function	Good brake function
Overall Drivetrain Rating	3 - Normal Wear & Tear
Overall Drivetrain Comments	The drivetrain is in good operating condition

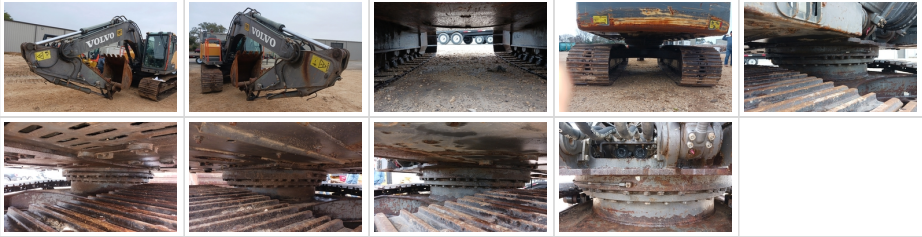
Chassis Photos

Boom Condition	3 - Normal Wear & Tear				
Stick Condition	3 - Normal Wear & Tear				
Boom Base Pin & Bushings	3 - Normal Wear & Tear				
Boom to Stick Pin & Bushings	3 - Normal Wear & Tear				
Stick to Bucket Pin & Bushings	3 - Normal Wear & Tear				
Turntable Bearing	3 - Normal Wear & Tear				
Bottom Covers	3 - Normal Wear & Tear				
Overall Chassis	3 - Normal Wear & Tear				
Overall Chassis Comments	The chassis is in good working order

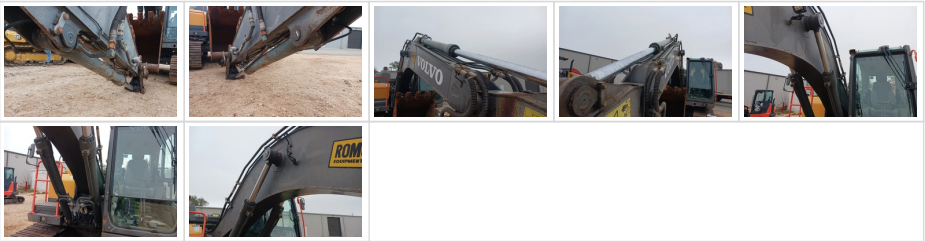
Hydraulic Cylinder Photos

Mounting Pins	3 - Normal Wear & Tear			
Cylinder Oil Leaks	No			
Hydraulic System Overall	3 - Normal Wear & Tear			
Comments	The hydraulic components appear to be in good condition, and while no unusual noises were heard during operation. The pump and system overall need further diagnosis to determine the cause and full extent of the loss of power under load
