Inspection Report (Skid Steer/Track Loader)

A1940132
2017
John Deere
333G
1T0333GMKHF311823
1498.7
Earth moving
Pine State of Jehovah's Witnesses Papé Machinery Construction & Forestry Papé Machinery Construction & Forestry Lat: 37.517942999999995 Long: -121.94246700000001

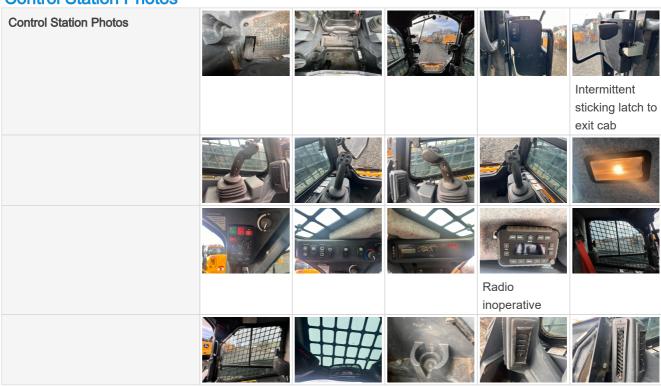
Control Station Photos

Control Station Overall Condition	Good cabin appearance, solid floors, panels, and ceiling

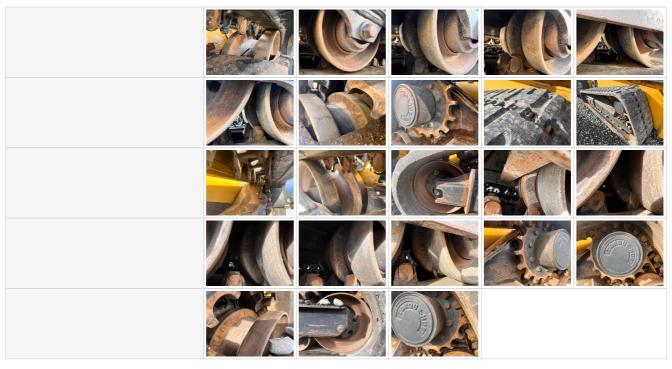
Undercarriage Photos

inspection Foints	
Track Width (inches)	18"
Track Length (inches)	80"
Roller Frames	3 - Normal Wear & Tear
Track Belt	2 - Above Average Wear & Tear
Comments	Slices to track
Rubber Belt Drive Lugs	2 - Above Average Wear & Tear
Comments	Worn
Track Tensioners	3 - Normal Wear & Tear
Front Idlers	3 - Normal Wear & Tear
Rear Idlers	3 - Normal Wear & Tear
Sprockets	3 - Normal Wear & Tear
Overall Undercarriage Rating	3 - Normal Wear & Tear
Left Track Belt - Percent Remaining Estimate	30%
Right Track Belt - Percent Remaining Estimate	30%
Overall Comments	Normal wear and tear Both tracks worn
