Inspection Report (Excavator)

B&B Stock Number	A4192793
Year	2022
Make	John Deere
Model	50G
Serial Number	1FF050GXLNH296620
Hour Meter Reading	200.6
Previous Application (e.g., earth moving, mining, demolition, etc)	Earth moving

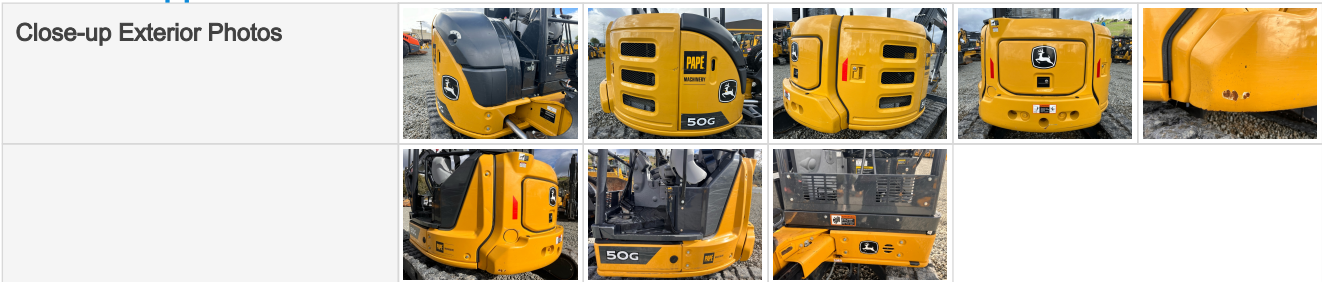
General Appearance Photos

Inspection Rating Criteria	Rating Scale	Explanation
	1 - Service Required	Requires immediate repairs to function as expected.
	2 - Above Average Wear & Tear	Exhibits greater wear than expected given age and usage. While operable, further diagnosis may be needed.
	3 - Normal Wear & Tear	Exhibits wear that is consistent with age and usage. Operation is normal, and as expected.
	4 - Very Light or Minimal Wear	Exhibits very minimal wear. Operation is better than expected given age and usage.
	5 - Like New, Recently Replaced	Excellent condition, free of visible wear or damage. Operation is within factory specifications.
Body Panels	3 - Normal Wear & Tear	
Doors / Canopy Latches	0	
Steps / Ladders	4 - Very Light or Minimal Wear	
Handrails	4 - Very Light or Minimal Wear	
Glass	0	
Mirrors	0	
Exterior Lights	4 - Very Light or Minimal Wear	
Overall Exterior	3 - Normal Wear & Tear	
Comments	Dent to right side, panel and scuff marks to exterior panels

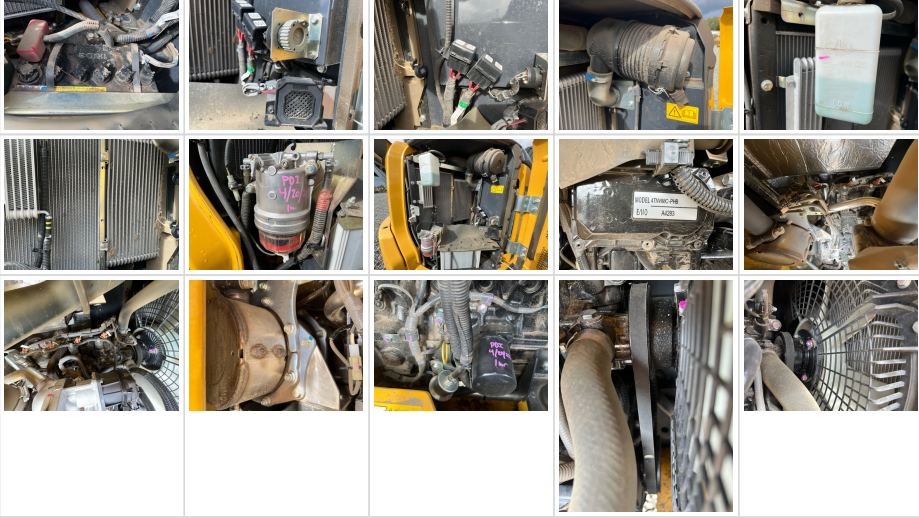
Engine Compartment Photos

Unusual Noises (Upon Start-up, Idle, Shutdown)	No
Engine Smoke (Upon Start-up, Idle, Shutdown)	No
Engine Exhaust Color	Clear
Battery	3 - Normal Wear & Tear
Battery Condition	Dusty & dirty appearance
Radiator	3 - Normal Wear & Tear
Radiator Condition	Radiator fins & components appear to be in good working order, no signs of damage or leaks
Belts	4 - Very Light or Minimal Wear
Belt Condition	Belts appear in good condition & alignment with proper tension
Hoses	4 - Very Light or Minimal Wear
Hose Condition	Firm, pliant hoses with no signs of wear or leaks
Water Pump	4 - Very Light or Minimal Wear
Water Pump Condition	No unusual pump noises heard
Cooling System Leaks	No
Coolant Appearance	4 - Very Light or Minimal Wear
Coolant Appearance Notes	Normal Translucent appearance, no visual signs of contamination
Oil Leaks	No
Oil Appearance	4 - Very Light or Minimal Wear
Oil Appearance Notes	Clean oil appearance, no signs of cross contamination

Fuel Leaks	No
Equipped with DPF (Diesel Particulate Filter)	Yes
DPF Condition	4 - Very Light or Minimal Wear
DPF Condition Notes	Filter housing is intact with no signs of damage or malfunction, DPF indicator is not illuminated
Requires DEF (Diesel Exhaust Fluid)	No
Overall Engine Rating	4 - Very Light or Minimal Wear
Overall Engine Appearance	Dusty & dry
Overall Engine Comments	Like new appearance, OEM filter still installed, no major issues to report at this time

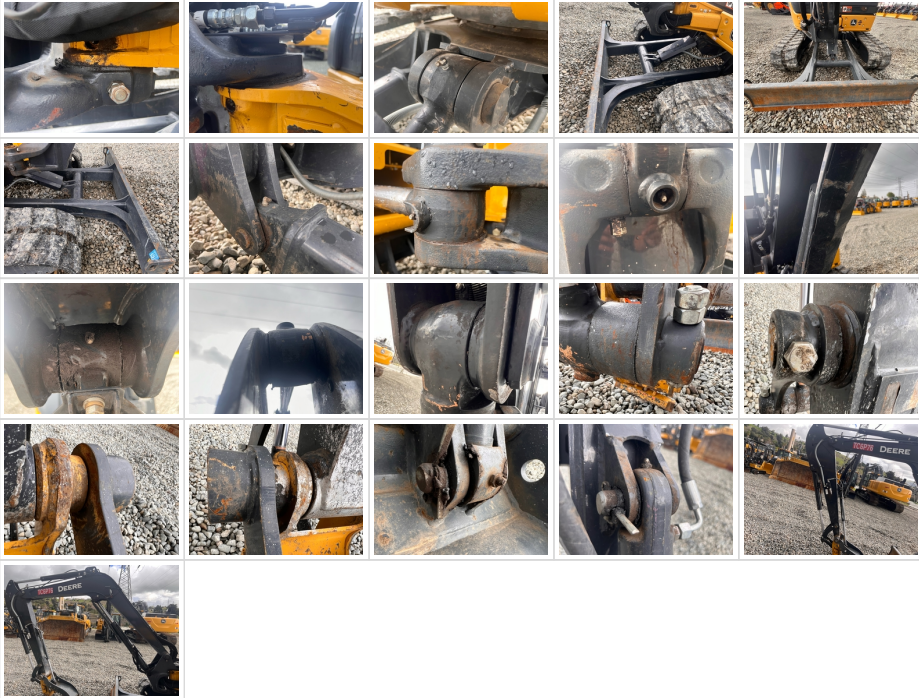
Chassis Photos

Boom Condition	4 - Very Light or Minimal Wear
Stick Condition	4 - Very Light or Minimal Wear
Boom Base Pin & Bushings	4 - Very Light or Minimal Wear
Boom to Stick Pin & Bushings	4 - Very Light or Minimal Wear
Stick to Bucket Pin & Bushings	4 - Very Light or Minimal Wear
Turntable Bearing	4 - Very Light or Minimal Wear
Bottom Covers	4 - Very Light or Minimal Wear

Overall Chassis	4 - Very Light or Minimal Wear
Overall Chassis Comments	Like new appearance, no major issues to report
