## Inspection Report (On-Highway Truck Cab + Chassis)

B&B Stock Number	A1733512
Year	2016
Make	International
Model	Prostar
Serial Number	1HSDHSNR7GH380759
Odometer Reading	507151
Current Inspection / State Cert / DOT	unable to determine
Previous Application (e.g., earth moving, mining, demolition, etc)	This machine was used to haul fuel

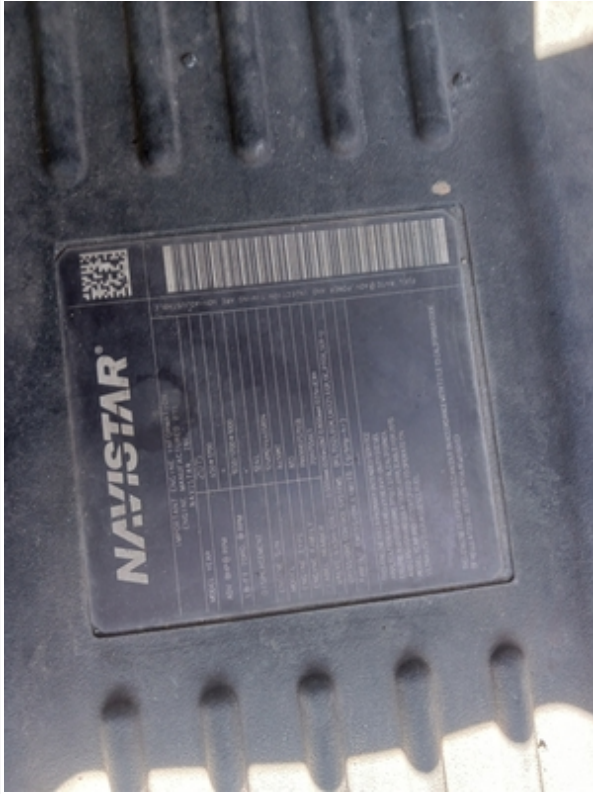
Engine Data Plate

Engine Type (Make, Model, Cylinders, Hp)	Navistar, A450MT, 12.4 L
Emissions Tier	Tier 4F
Engine Serial Number	124KM2Y4405804
Engine Fuel Type	Diesel
Blow-by (Visual Observation Check)	N/A
Unusual Noises (Upon Start-up, Idle, Shutdown)	No
Engine Smoke (Upon Start-up, Idle, Shutdown)	No
Engine Exhaust Color	Clear
Battery	3 - Normal Wear & Tear
Battery Condition	Dusty & dirty appearance
Radiator	3 - Normal Wear & Tear
Radiator Condition	Radiator fins & components appear to be in good working order, no signs of damage or leaks
Belts	2 - Above Average Wear & Tear
Belt Condition	Cracks, missing grooves, or separating layers on one or more belts
Hoses	3 - Normal Wear & Tear
Hose Condition	Firm, pliant hoses with no signs of wear or leaks
Water Pump	3 - Normal Wear & Tear
Water Pump Condition	No unusual pump noises heard
Cooling System Leaks	No
Coolant Appearance	3 - Normal Wear & Tear

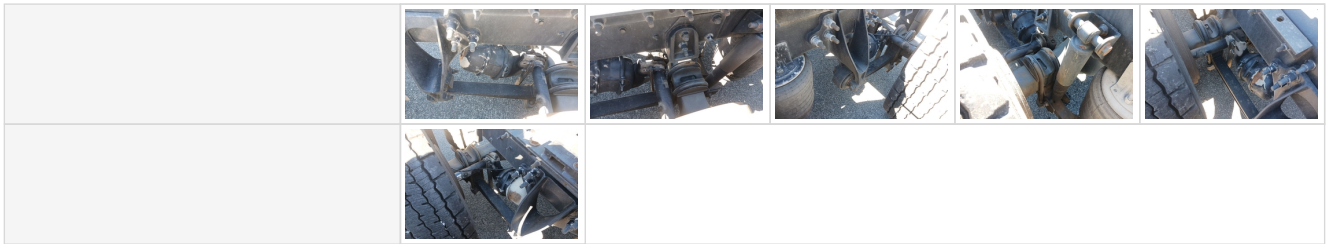
An active leak on the 1st drive axel was seen.

Frame	3 - Normal Wear & Tear
Suspension	3 - Normal Wear & Tear
Steer Axle	3 - Normal Wear & Tear
Steering Components	3 - Normal Wear & Tear
Overall Chassis Condition	3 - Normal Wear & Tear
Overall Chassis Comments	An active leak was seen on the 1st drive axel
