Inspection Report (On-Highway Truck Cab + Chassis)

B&B Stock Number	A2184637
Year	2011
Make	Freightliner
Model	Cascadia
Serial Number	1FUJGBDVXBLAY3287
Odometer Reading	521854
Current Inspection / State Cert / DOT	unable to determine
Previous Application (e.g., earth moving, mining, demolition, etc)	This machine was previously used to haul fuel

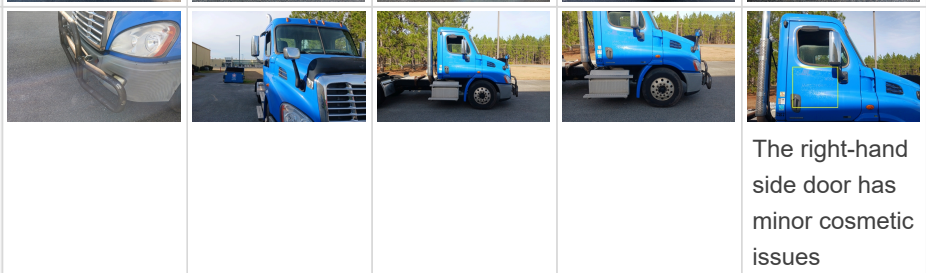
<p>The right-hand side door has minor cosmetic issues</p>

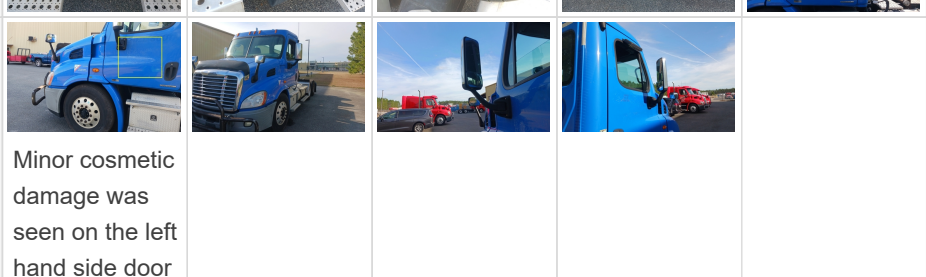
<p>Minor cosmetic damage was seen on the left hand side door</p>

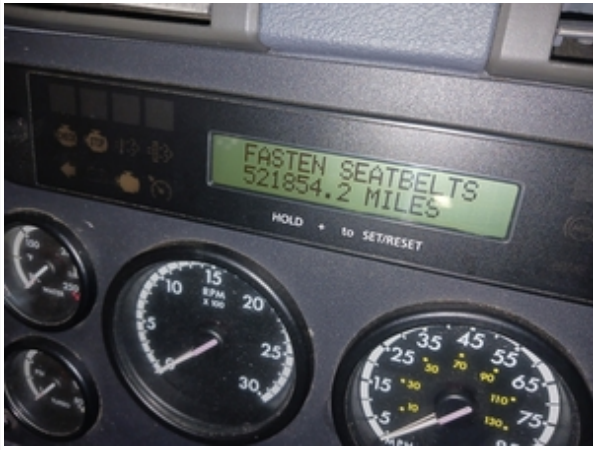
Odometer Photo

Odometer Activity	3 - Normal Wear & Tear
Odometer	Odometer is working and in good condition
Controls/Switches/Gauges	3 - Normal Wear & Tear
Controls/Switches/Gauges	All switches/gauges are in good condition and functioning

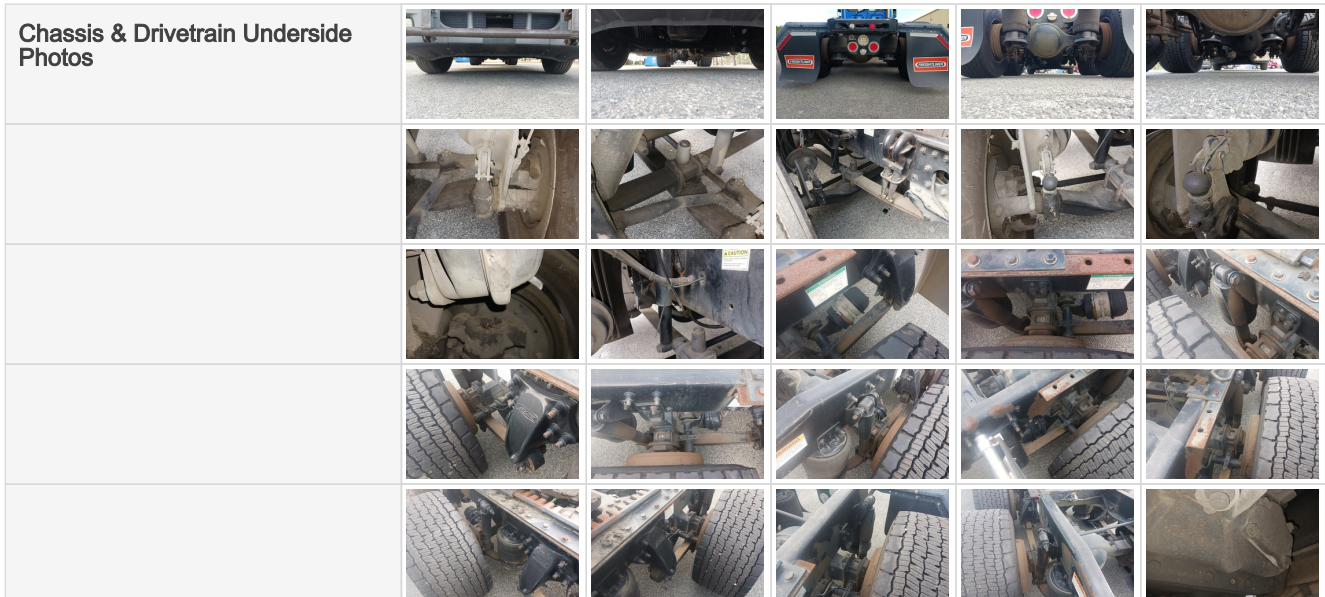
active leak seen near the transmission

Transmission Info (Make/Model)	Eaton
Transmission	3 - Normal Wear & Tear
Transmission Condition	No unusual noises or vibrations, Other (see comments)
Comments	some small leaks were coming from the transmission oil pan
PTO	3 - Normal Wear & Tear
Rear Differential	3 - Normal Wear & Tear
Rear Differential Condition	Dry housing appearance, no unusual noises heard during operation
Front Differential	3 - Normal Wear & Tear
Front Differential Condition	Dry housing appearance, no unusual noises heard during operation
