## Inspection Report (On-Highway Truck Cab + Chassis)

B&B Stock Number	A1588823
Year	2011
Make	Volvo
Model	VNM63T
Serial Number	4V4NC9EH9BN533264
Odometer Reading	140753.1
Current Inspection / State Cert / DOT	unable to determine
Previous Application (e.g., earth moving, mining, demolition, etc)	This machine was used to haul fuel

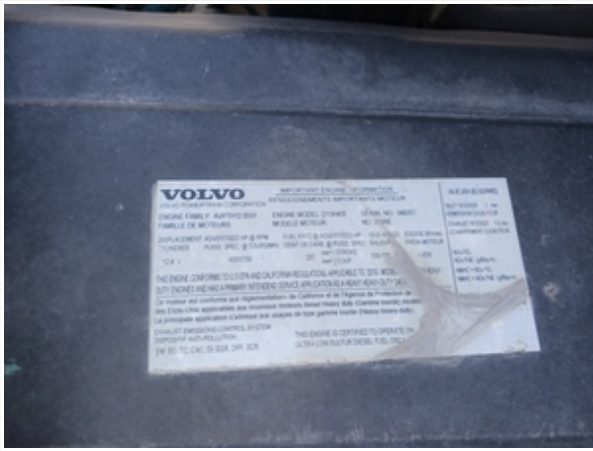
Engine Data Plate

<b>Engine Type (Make, Model, Cylinders, Hp)</b>	Volvo, D13, 12.8L, 435Hp
<b>Emissions Tier</b>	Tier 4F
<b>Engine Serial Number</b>	949357
<b>Engine Fuel Type</b>	Diesel
<b>Blow-by (Visual Observation Check)</b>	N/A
<b>Unusual Noises (Upon Start-up, Idle, Shutdown)</b>	No
<b>Engine Smoke (Upon Start-up, Idle, Shutdown)</b>	No
<b>Engine Exhaust Color</b>	Clear
<b>Battery</b>	3 - Normal Wear & Tear
<b>Battery Condition</b>	Dusty & dirty appearance
<b>Radiator</b>	3 - Normal Wear & Tear
<b>Radiator Condition</b>	Radiator fins & components appear to be in good working order, no signs of damage or leaks
<b>Belts</b>	3 - Normal Wear & Tear
<b>Belt Condition</b>	Belts appear in good condition & alignment with proper tension
<b>Hoses</b>	3 - Normal Wear & Tear
<b>Hose Condition</b>	Firm, pliant hoses with no signs of wear or leaks
<b>Water Pump</b>	3 - Normal Wear & Tear

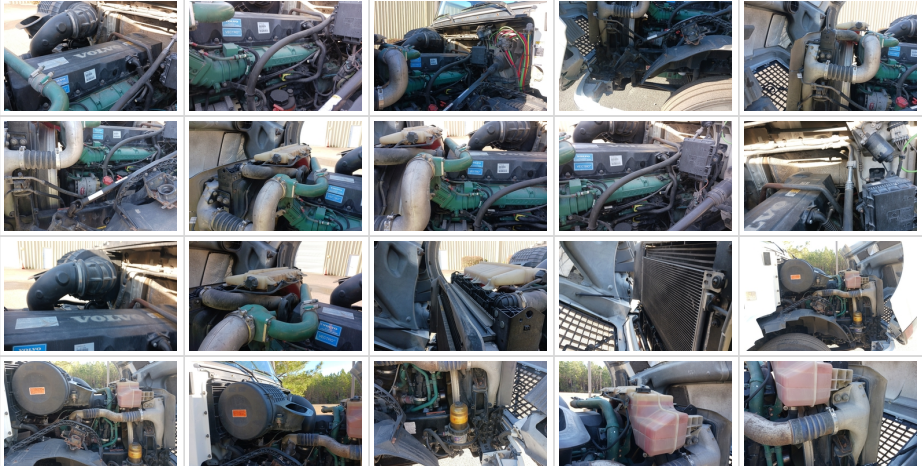
Engine Compartment Photos

Equipped with DPF (Diesel Particulate Filter)	Yes
DPF Condition	3 - Normal Wear & Tear
DPF Condition Notes	Filter housing is intact with no signs of damage or malfunction, DPF indicator is not illuminated
Requires DEF (Diesel Exhaust Fluid)	Yes
DEF Tank	3 - Normal Wear & Tear
DEF Tank Condition	Area around DEF tank cap is clean, fluid is clear & appears free of contaminants
Overall Engine Rating	3 - Normal Wear & Tear
Overall Engine Appearance	Dusty & dry
Overall Engine Comments	The ending is in good working order and fully functional

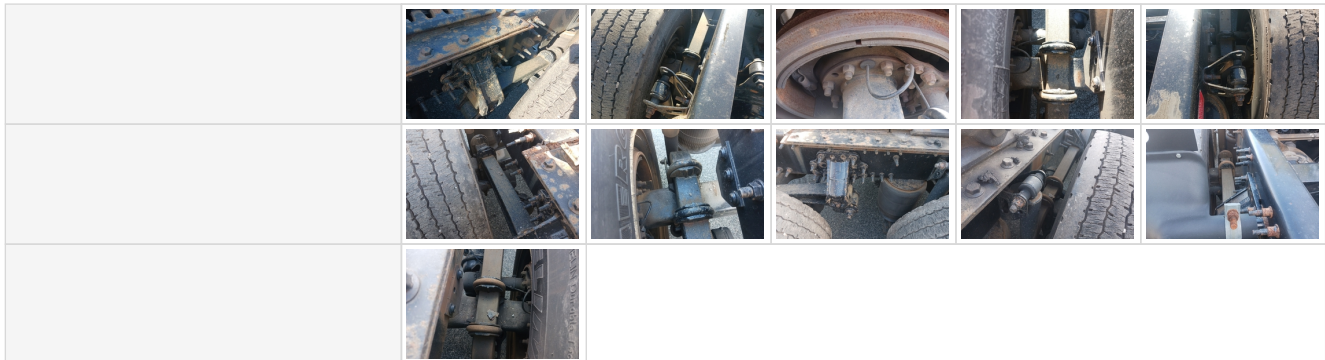
Chassis & Drivetrain Underside Photos

Frame	3 - Normal Wear & Tear
Suspension	3 - Normal Wear & Tear
Steer Axle	3 - Normal Wear & Tear
Steering Components	3 - Normal Wear & Tear
Overall Chassis Condition	3 - Normal Wear & Tear
Overall Chassis Comments	The chassis is in good working order
