Inspection Report (On-Highway Truck Cab + Chassis)

B&B Stock Number	A2666850
Year	2016
Make	International
Model	Prostar
Serial Number	1HSDHSNROGH003416
Odometer Reading	577984
Current Inspection / State Cert / DOT	unable to determine
Previous Application (e.g., earth moving, mining, demolition, etc)	This machine was used to transport fuel

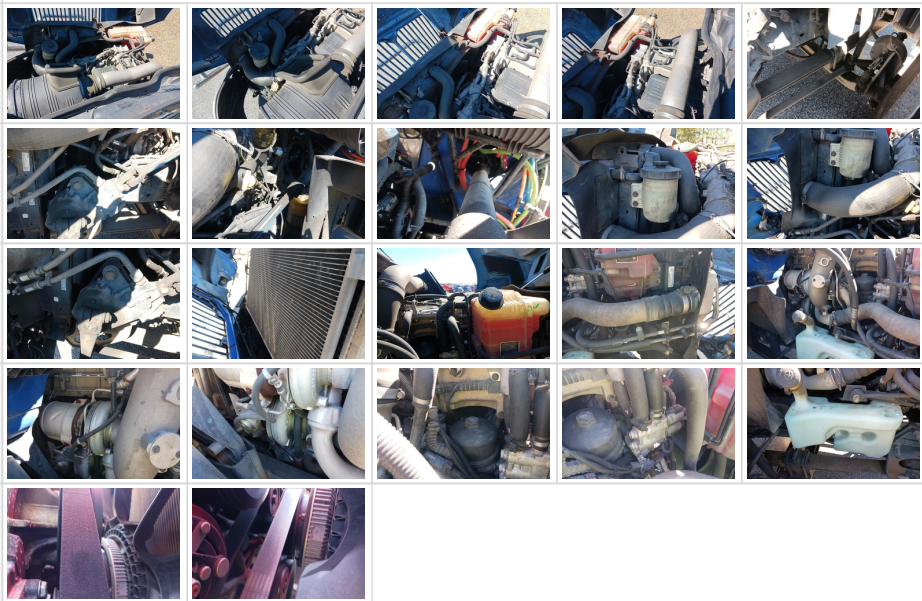
Engine Data Plate	 
Engine Compartment Photos

Oil Appearance Notes	Appropriate oil level, Very dark, black & burnt oil appearance
Fuel Leaks	No
Equipped with DPF (Diesel Particulate Filter)	Yes
DPF Condition	3 - Normal Wear & Tear
DPF Condition Notes	Filter housing is intact with no signs of damage or malfunction, DPF indicator is not illuminated
Requires DEF (Diesel Exhaust Fluid)	Yes
DEF Tank	3 - Normal Wear & Tear
Overall Engine Rating	3 - Normal Wear & Tear
Overall Engine Appearance	Dusty & dry
Overall Engine Comments	The belts to the engine had some frayed areas. That information was passed along to the seller. The seller said they are going to replace the belts. Everything else is fully operational, displaying signs of normal wear and tear.

What Needs Work	The belts on the engine are both worn, but the seller said he would replace them. The honk does not work, and the driver side seat belt has frays on it.	
Any Additional Info from the Seller?	This truck was used for hauling fuel	
Date/Time	02-07-2024	
Inspector Name	Steven Mesa

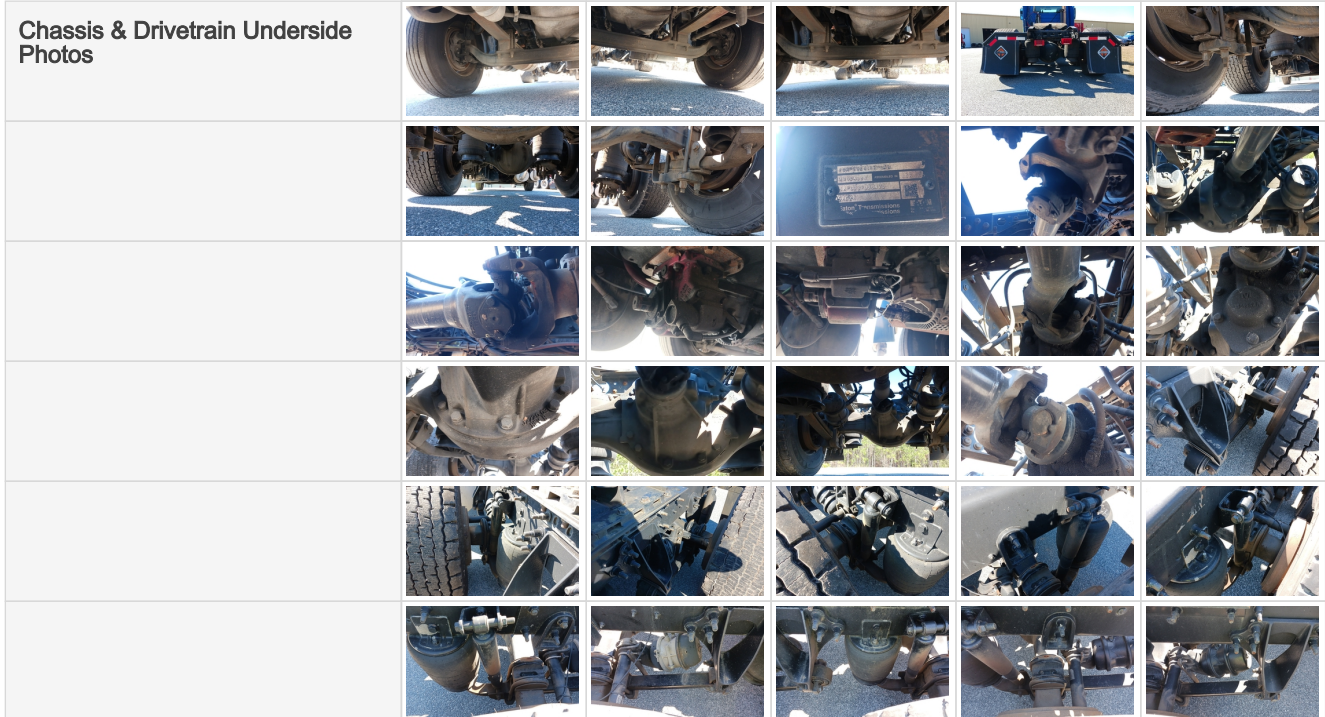
Chassis & Drivetrain Photos

Frame	3 - Normal Wear & Tear
Suspension	3 - Normal Wear & Tear
Steer Axle	3 - Normal Wear & Tear
Steering Components	3 - Normal Wear & Tear
Overall Chassis Condition	3 - Normal Wear & Tear
Overall Chassis Comments	The chassis is in good condition, showing signs of normal wear and tear.

Air Brake System Leaks	Yes
Air Brake Hose Condition	3 - Normal Wear & Tear
Overall Drivetrain Condition	3 - Normal Wear & Tear
Overall Drivetrain Comments	The drivetrain is in good condition, showing signs of normal wear and tear.
