## Inspection Report (Forklift)

B&B Stock Number	A3176348
Year	2014
Make	Hyundai
Model	40D-9F
Serial Number	HHKHFFV34LK0000065
Hour Meter Reading	11116.2
Previous Application (e.g., earth moving, mining, demolition, etc)	Warehouse

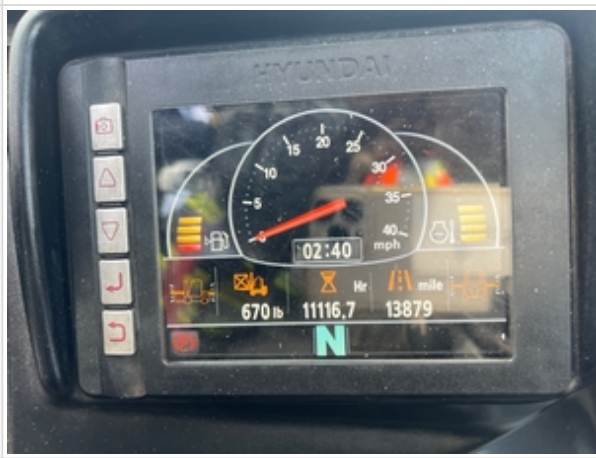
<b>Hour Meter/Odometer</b>

Safety Lock Out / Stop	0
Controls & Switches	3 - Normal Wear & Tear
Controls & Switches Condition	All switches are installed and functional
Hour Meter Activity	3 - Normal Wear & Tear
Hour Meter Condition	Hour meter is functional and in good condition
Other Gauge Activity	3 - Normal Wear & Tear
Other Gauge Condition	All cockpit gauges are functional and in good condition
Heater & A/C	2 - Above Average Wear & Tear
Heater & A/C Condition	Fan vents are damaged, Heater and A/C work as expected
Travel Alarm	0
Horn	3 - Normal Wear & Tear
Horn Condition	Horn is installed and functioning as expected
Backup Camera	1 - Service Required
Backup Camera Condition	Back up camera is installed but inoperative or has reduced functionality
Control Station Overall Rating	3 - Normal Wear & Tear
Control Station Overall Condition	Good cabin appearance, solid floors, panels, and ceiling

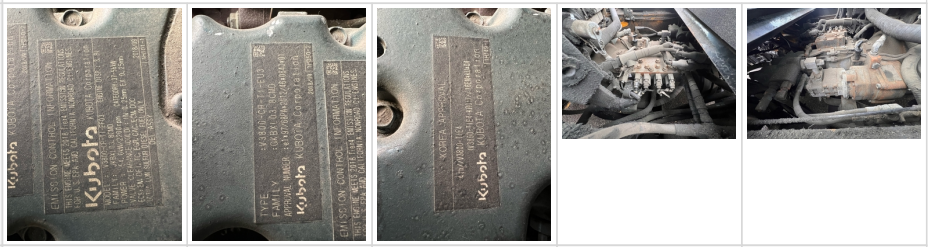
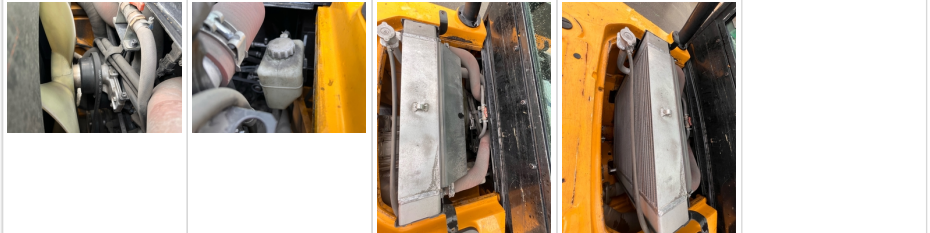
Overall Engine Rating	3 - Normal Wear & Tear
Overall Engine Appearance	Areas of dried seepage seen on engine hoses & components
Overall Engine Comments	Normal wear and tear no major issues to report

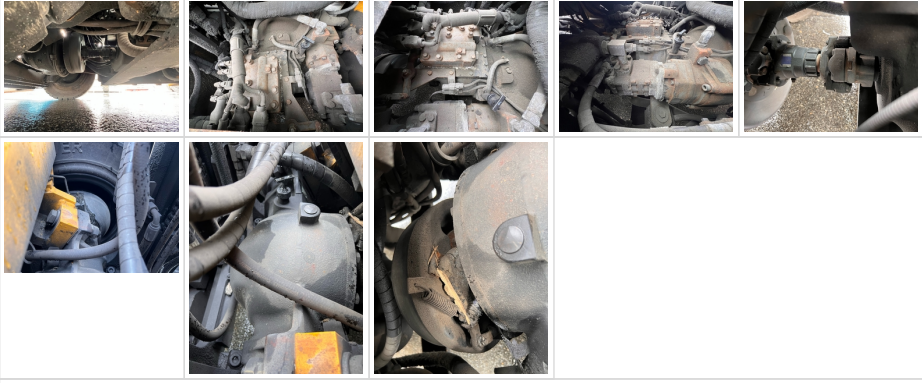
Drivetrain Photos

Hydrostatic Transmission?	No
Transmission Info (Make/Model/Speeds)	Unable to verify
Drive Type	2WD
Transmission Components	3 - Normal Wear & Tear
Parking Brake	3 - Normal Wear & Tear
Overall Drivetrain Rating	3 - Normal Wear & Tear
Overall Drivetrain Comments	Normal wear and tear no major issues to report
Front Axle	3 - Normal Wear & Tear
Rear Axle	3 - Normal Wear & Tear

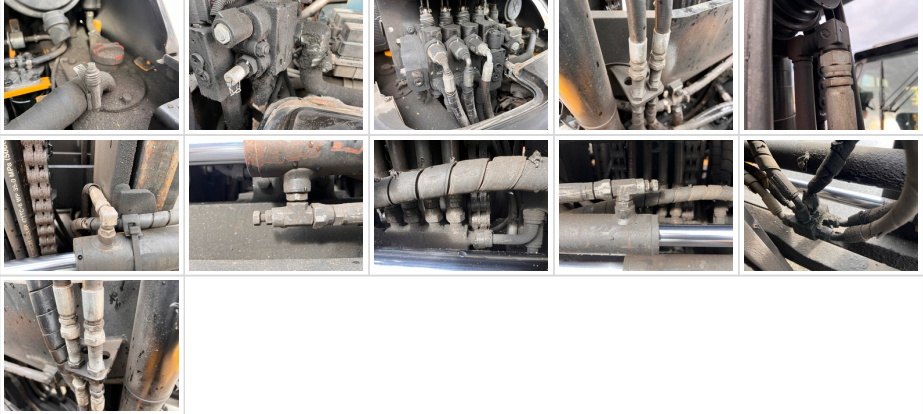
Hydraulic System Photos

Wet or Damp Hydraulic Lines / Fittings	No
Hydraulic Lines/Fittings	3 - Normal Wear & Tear
Hydraulic Lines / Fittings Condition	Dried seepages observed
Hydraulic Pump(s)	3 - Normal Wear & Tear
Unusual Noises	No
Hydraulic Pump Notes	No unusual noises heard during operation

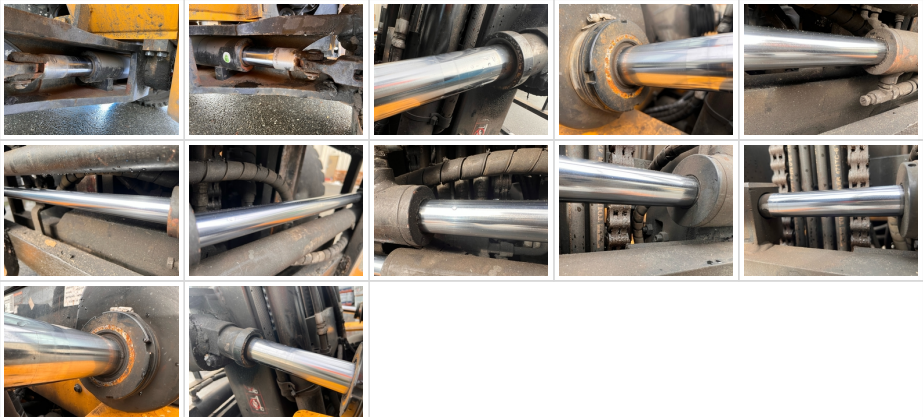
Hydraulic Cylinder Photos

Mounting Pins	3 - Normal Wear & Tear
Cylinder Oil Leaks	No
Hydraulic System Overall	3 - Normal Wear & Tear
Comments	Normal wear and tear with signs of dried seepage
