Inspection Report (Forklift)

B&B Stock Number	A9188481
Year	2014
Make	Hyster
Model	H155FT
Serial Number	K006V02469M
Hour Meter Reading	18967
Previous Application (e.g., earth moving, mining, demolition, etc)	Warehouse

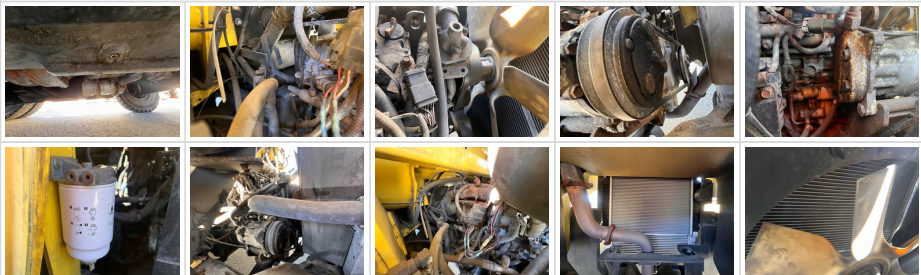
Engine Compartment Photos

Engine Type (Make, Model, Cylinders, Hp)	Kubota, V3800
Emissions Tier	Tier 4F
Engine Serial Number	Unable to verify
Engine Fuel Type	Diesel
Blow-by (Visual Observation Check)	No
Unusual Noises (Upon Start-up, Idle, Shutdown)	No
Engine Smoke (Upon Start-up, Idle, Shutdown)	Yes
Engine Smoke Notes	Engine smoke observed upon start up
Engine Exhaust Color	White
Battery	3 - Normal Wear & Tear
Battery Condition	Inaccessible, unable to determine condition
Radiator	3 - Normal Wear & Tear
Radiator Condition	Radiator fins & components appear to be in good working order, no signs of damage or leaks
Belts	2 - Above Average Wear & Tear
Belt Condition	Belts appear in good condition & alignment with proper tension
Hoses	3 - Normal Wear & Tear
Hose Condition	Firm, pliant hoses with no signs of wear or leaks
Water Pump	3 - Normal Wear & Tear
Water Pump Condition	No unusual pump noises heard

Oil Appearance Notes	Appropriate oil level
Fuel Leaks	No
Equipped with DPF (Diesel Particulate Filter)	Yes
DPF Condition	3 - Normal Wear & Tear
DPF Condition Notes	Filter housing is intact with no signs of damage or malfunction, DPF indicator is not illuminated
Requires DEF (Diesel Exhaust Fluid)	No
Overall Engine Rating	3 - Normal Wear & Tear
Overall Engine Appearance	Dusty & dry
Overall Engine Comments	Unknown check engine light

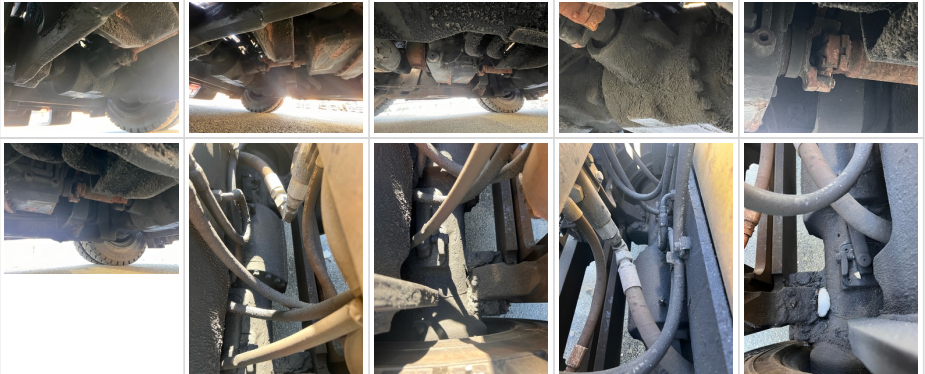
Drivetrain Photos

Hydrostatic Transmission?	No
Transmission Info (Make/Model/Speeds)	Unable to verify
Drive Type	2WD
Transmission Components	2 - Above Average Wear & Tear
Transmission Condition	Other (see comments)
Comments	Dried seepage observed
Parking Brake	3 - Normal Wear & Tear
Overall Drivetrain Rating	3 - Normal Wear & Tear
Overall Drivetrain Comments	Normal wear and tear with dried seepage observed
Front Axle	2 - Above Average Wear & Tear
Comments	Dried seepage around front axle
Rear Axle	0

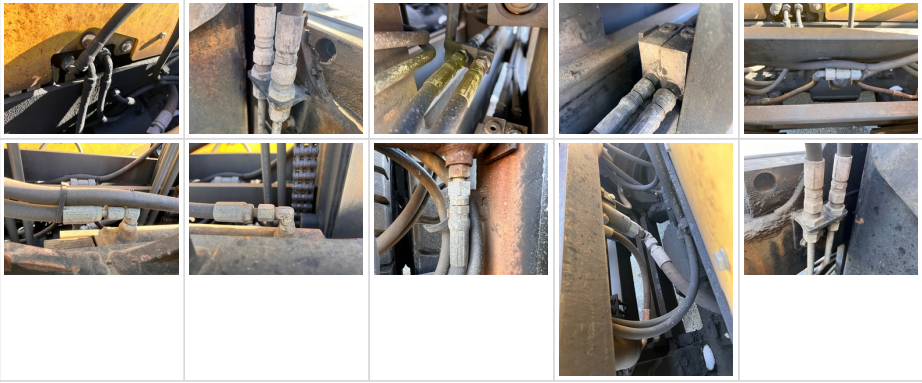
Hydraulic System Photos

Wet or Damp Hydraulic Lines / Fittings	No
Hydraulic Lines/Fittings	3 - Normal Wear & Tear
Hydraulic Lines / Fittings Condition	Hydraulic lines & fittings are clean and in good condition
Hydraulic Pump(s)	3 - Normal Wear & Tear
Unusual Noises	No
Hydraulic Pump Notes	No unusual noises heard during operation

Hydraulic Cylinder Photos	 
Mounting Pins	3 - Normal Wear & Tear
Cylinder Oil Leaks	Yes
Comments	Both mast tilt cylinders leaking at wiper seal

Hydraulic System Overall	3 - Normal Wear & Tear
Comments	Normal wear and tear, both mast tilt cylinders leaking at wiper seal
