## Inspection Report (Forklift)

B&B Stock Number	A5261562
Year	2014
Make	Hyundai
Model	110D-9
Serial Number	HHKHFT21OG0000013
Hour Meter Reading	14508.7
Previous Application (e.g., earth moving, mining, demolition, etc)	Warehouse

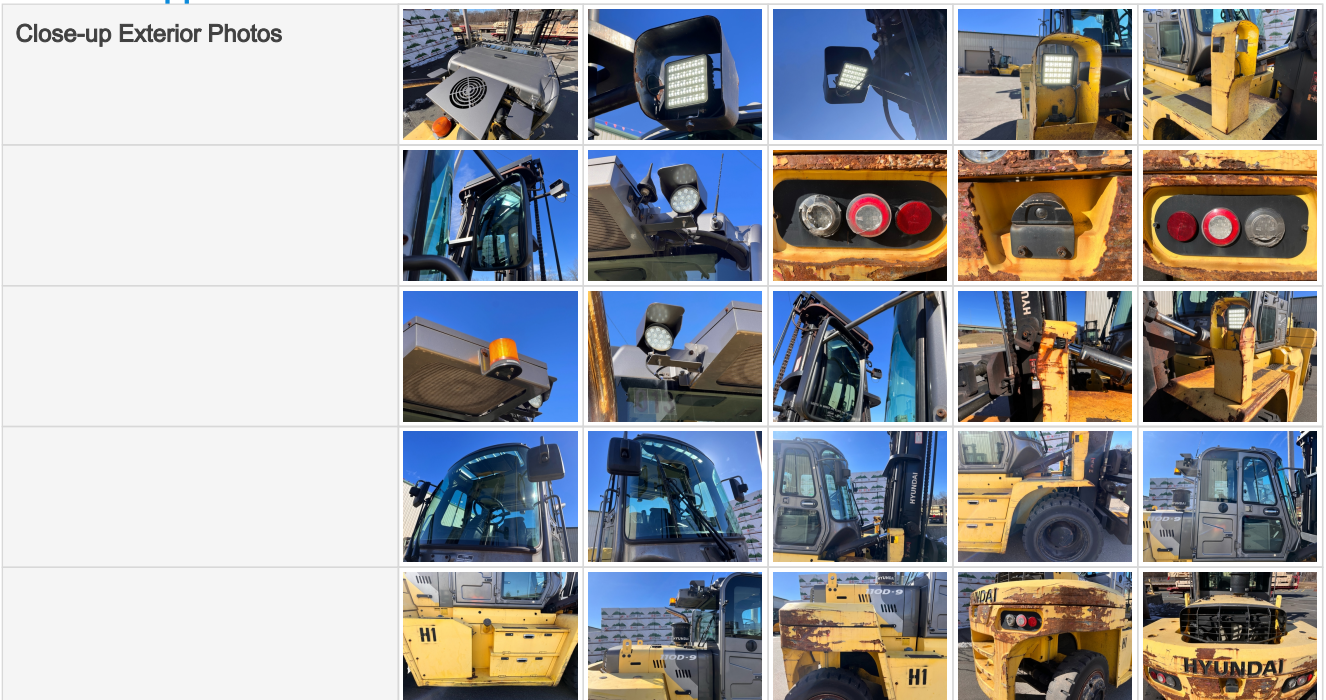
### General Appearance Photos

Steps / Ladders Condition	Steps/ladders are fully intact and appear structurally sound	
Handrails	3 - Normal Wear & Tear	
Handrails Condition	Handrails are fully intact and appear structurally sound	
Glass	3 - Normal Wear & Tear	
Glass Condition	Glass intact, no visible damage	
Mirrors	3 - Normal Wear & Tear	
Mirror Condition	Mirrors present and intact, no visible damage	
Exterior Lights	3 - Normal Wear & Tear	
Exterior Lights Condition	No visible damage, lighting system is operational	
Overall Exterior	3 - Normal Wear & Tear	
Comments	Bent left light guard, Chipped paint throughout machine, Areas of surface rust observed, bent right mast light

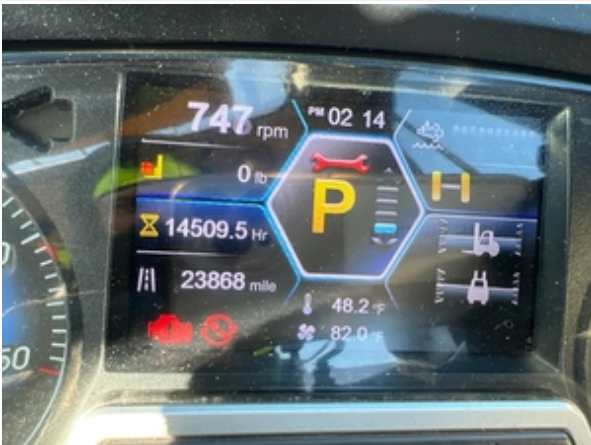
Unknown check engine lights error

Engine	2 - Above Average Wear & Tear
Comments	Check engine light on
Transmission/Drivetrain	3 - Normal Wear & Tear
Travel (Forward/Reverse/Steering)	3 - Normal Wear & Tear
Brakes	4 - Very Light or Minimal Wear
Hydraulic System	3 - Normal Wear & Tear
Electric Operating System	3 - Normal Wear & Tear
Controls	3 - Normal Wear & Tear
Safety Systems	3 - Normal Wear & Tear
Core Functions	3 - Normal Wear & Tear
Attachments	3 - Normal Wear & Tear

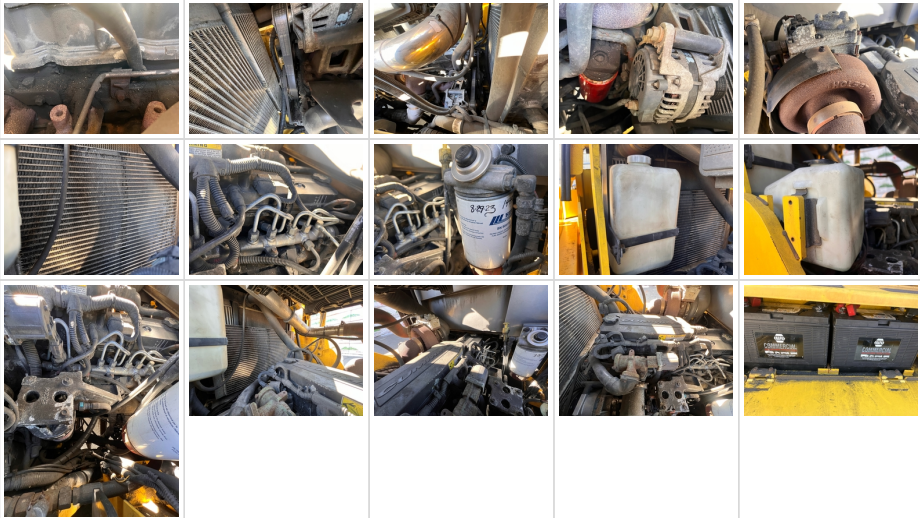
Engine Compartment Photos

Engine Smoke Notes	Engine smoke observed upon start up
Engine Exhaust Color	White
Battery	3 - Normal Wear & Tear
Battery Condition	Clean & dry appearance, tight connections
Radiator	3 - Normal Wear & Tear
Radiator Condition	Radiator fins & components appear to be in good working order, no signs of damage or leaks
Belts	3 - Normal Wear & Tear
Belt Condition	Belts appear in good condition & alignment with proper tension
Hoses	3 - Normal Wear & Tear
Hose Condition	Firm, pliant hoses with no signs of wear or leaks
Water Pump	3 - Normal Wear & Tear
Water Pump Condition	No unusual pump noises heard
Cooling System Leaks	No
Coolant Appearance	2 - Above Average Wear & Tear
Coolant Appearance Notes	Other (see comments)
Comments	Low coolant
Oil Leaks	No
Oil Appearance	3 - Normal Wear & Tear
Fuel Leaks	No
Equipped with DPF (Diesel Particulate Filter)	Yes
DPF Condition	3 - Normal Wear & Tear
DPF Condition Notes	Filter housing is intact with no signs of damage or malfunction, DPF indicator is not illuminated

Requires DEF (Diesel Exhaust Fluid)	Yes
DEF Tank	3 - Normal Wear & Tear
DEF Tank Condition	Area around DEF tank cap is clean, fluid is clear & appears free of contaminants
Overall Engine Rating	3 - Normal Wear & Tear
Overall Engine Appearance	Areas of dried seepage seen on engine hoses & components
Overall Engine Comments	Normal wear and tear low coolant observed

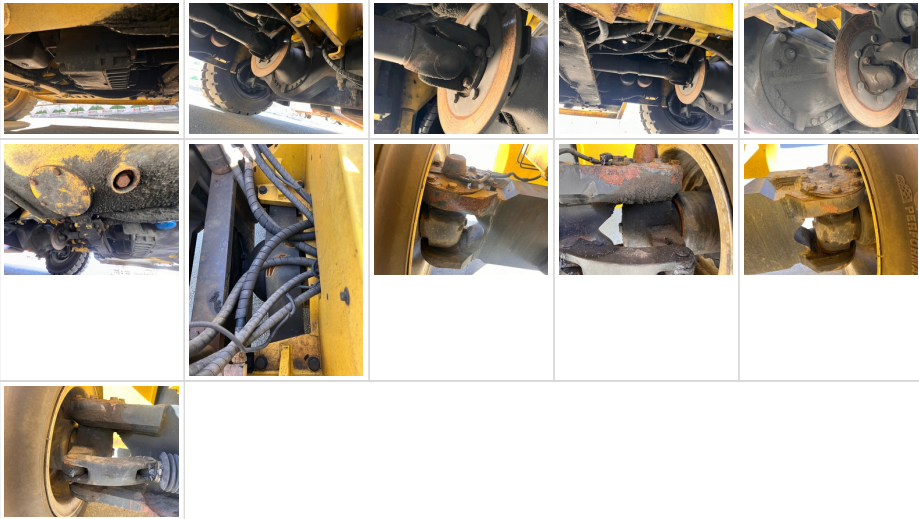
Drivetrain Photos

Hydrostatic Transmission?	No
Transmission Info (Make/Model/Speeds)	Unable to verify
Drive Type	2WD
Transmission Components	3 - Normal Wear & Tear
Transmission Condition	Good forward and reverse function, No unusual noises or vibrations
Parking Brake	3 - Normal Wear & Tear
Overall Drivetrain Rating	3 - Normal Wear & Tear
Overall Drivetrain Comments	Normal wear and tear no major issues to report
Front Axle	3 - Normal Wear & Tear
Rear Axle	0
