## Inspection Report (Forklift)

B&B Stock Number	A5747994
Year	2014
Make	Hyundai
Model	70D-9
Serial Number	HFA03LC0000631
Hour Meter Reading	14913.8
Previous Application (e.g., earth moving, mining, demolition, etc)	Warehouse

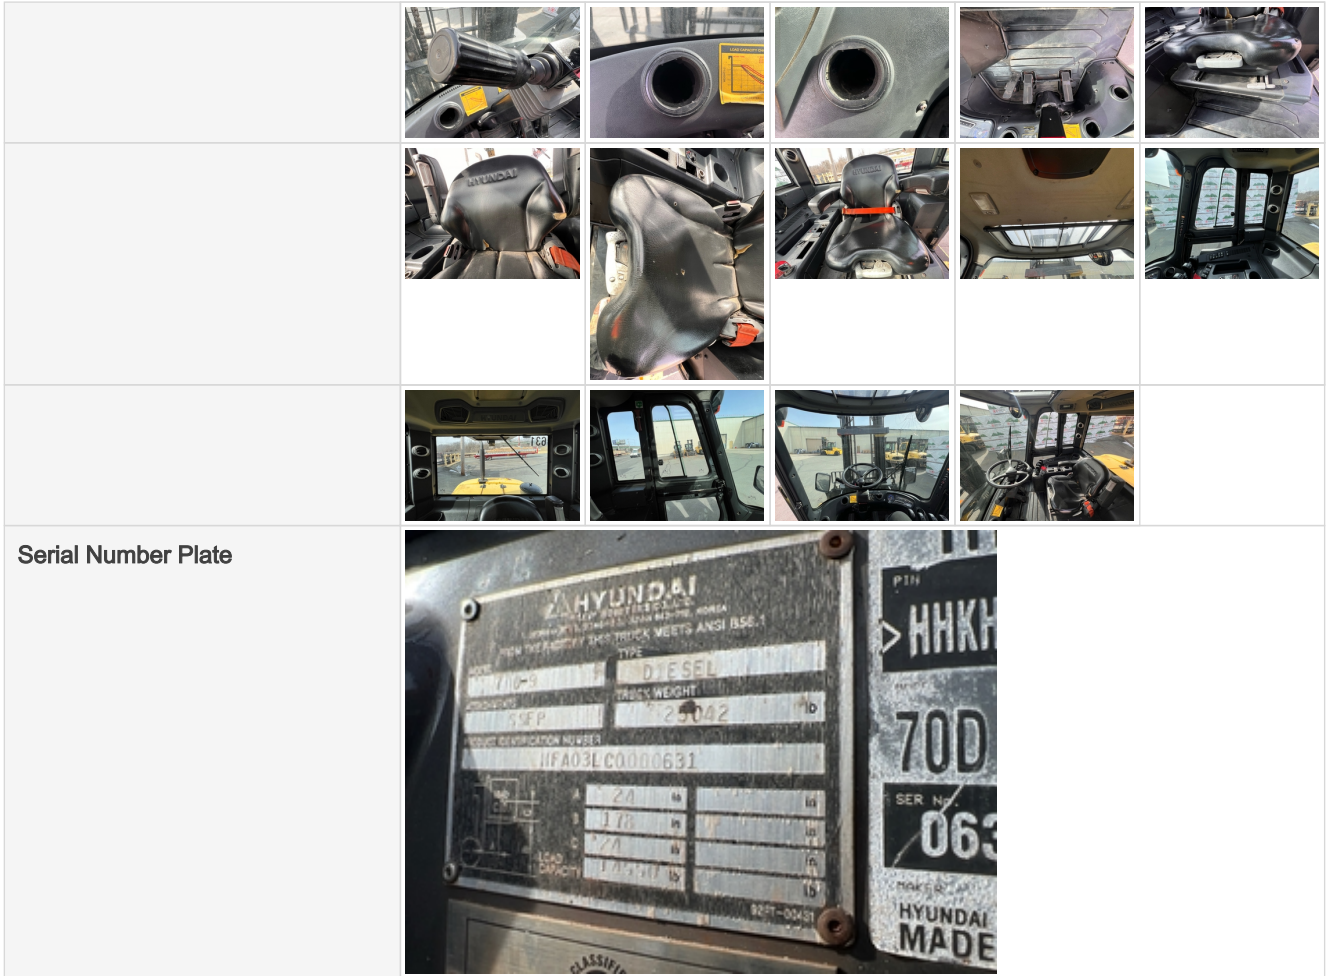
Control Station Type	Enclosed Cab (EROPS)
Option List	Unable to Confirm
Seat	2 - Above Average Wear & Tear
Seat Condition	Seat(s) have minor surface staining or small tears, Seat belt secures properly
Cabin Lights	3 - Normal Wear & Tear
Cabin Lights Condition	Cabin lights are installed with all light covers in place, bulbs are installed and working properly
Safety Lock Out / Stop	3 - Normal Wear & Tear
Safety Lock Out / Stop Condition	Safety lock out device is present, in good condition, and functional
Controls & Switches	3 - Normal Wear & Tear
Controls & Switches Condition	All switches are installed and functional
Hour Meter Activity	3 - Normal Wear & Tear
Hour Meter Condition	Hour meter is functional and in good condition
Other Gauge Activity	3 - Normal Wear & Tear
Other Gauge Condition	All cockpit gauges are functional and in good condition
Heater & A/C	2 - Above Average Wear & Tear

Heater & A/C Condition	Only heat functionality works
Travel Alarm	0
Horn	3 - Normal Wear & Tear

Horn Condition	Horn is installed and functioning as expected
Backup Camera	3 - Normal Wear & Tear
Backup Camera Condition	Back up camera is installed and functioning as expected
Control Station Overall Rating	3 - Normal Wear & Tear
Control Station Overall Condition	Good cabin appearance, solid floors, panels, and ceiling

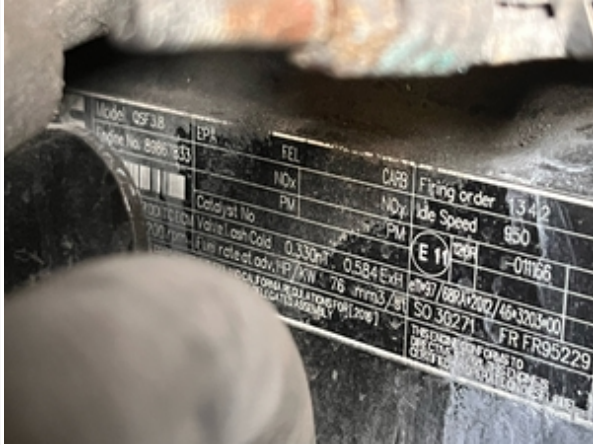
Engine Data Plate

Engine Type (Make, Model, Cylinders, Hp)	Cummins, QSF 3.8				
Emissions Tier	Tier 4F				
Engine Serial Number	89867833				
Engine Fuel Type	Diesel				
Blow-by (Visual Observation Check)	No

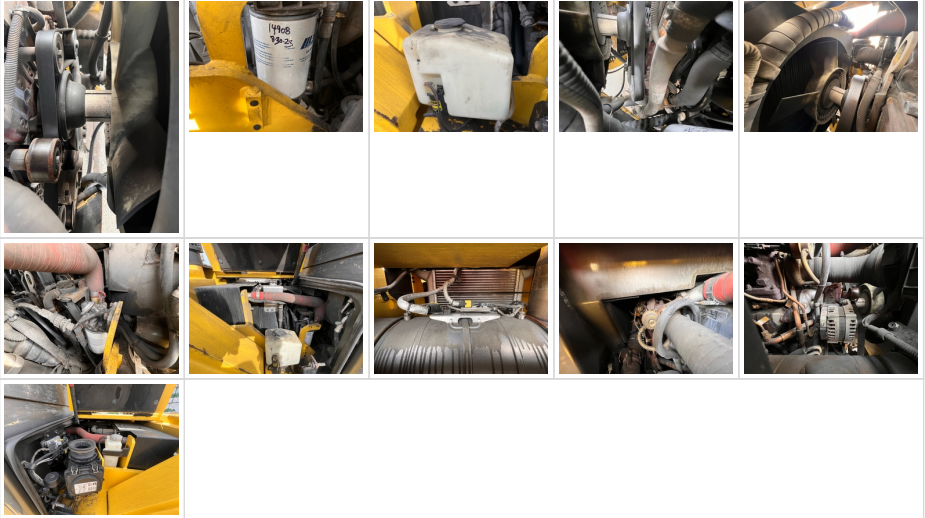
Engine Compartment Photos

Unusual Noises (Upon Start-up, Idle, Shutdown)	No
Engine Smoke (Upon Start-up, Idle, Shutdown)	Yes
Engine Smoke Notes	Engine smoke observed upon start up
Engine Exhaust Color	White
Battery	3 - Normal Wear & Tear
Battery Condition	Inaccessible, unable to determine condition
Radiator	3 - Normal Wear & Tear
Radiator Condition	Radiator fins & components appear to be in good working order, no signs of damage or leaks
Belts	3 - Normal Wear & Tear
Belt Condition	Belts appear in good condition & alignment with proper tension
Hoses	3 - Normal Wear & Tear
Hose Condition	Firm, pliant hoses with no signs of wear or leaks
Water Pump	3 - Normal Wear & Tear
Water Pump Condition	No unusual pump noises heard
Cooling System Leaks	No
Coolant Appearance	3 - Normal Wear & Tear
Coolant Appearance Notes	Normal Translucent appearance, no visual signs of contamination
Oil Leaks	No
Oil Appearance	3 - Normal Wear & Tear
Oil Appearance Notes	Appropriate oil level

Fuel Leaks	No
Equipped with DPF (Diesel Particulate Filter)	Yes
DPF Condition	3 - Normal Wear & Tear
DPF Condition Notes	Filter housing is intact with no signs of damage or malfunction, DPF indicator is not illuminated
Requires DEF (Diesel Exhaust Fluid)	Yes
DEF Tank	3 - Normal Wear & Tear
DEF Tank Condition	Area around DEF tank cap is clean, fluid is clear & appears free of contaminants
Overall Engine Rating	3 - Normal Wear & Tear
Overall Engine Appearance	Dusty & dry
Overall Engine Comments	Normal wear and tear No major issues to report

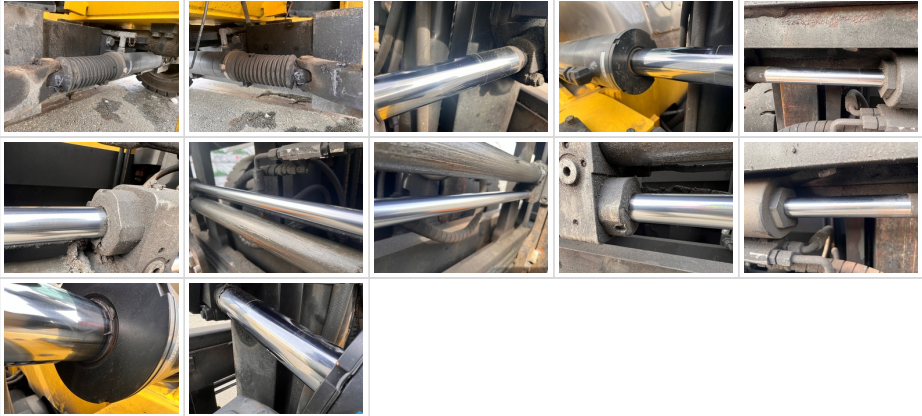
Hydraulic Cylinder Photos

Mounting Pins	3 - Normal Wear & Tear				
Cylinder Oil Leaks	No				
Hydraulic System Overall	3 - Normal Wear & Tear
