## Inspection Report (Forklift)

B&B Stock Number	A0426859
Year	2014
Make	Hyundai
Model	70D-9
Serial Number	HHKHFA03LG0000188
Hour Meter Reading	13256.4
Previous Application (e.g., earth moving, mining, demolition, etc)	Warehouse

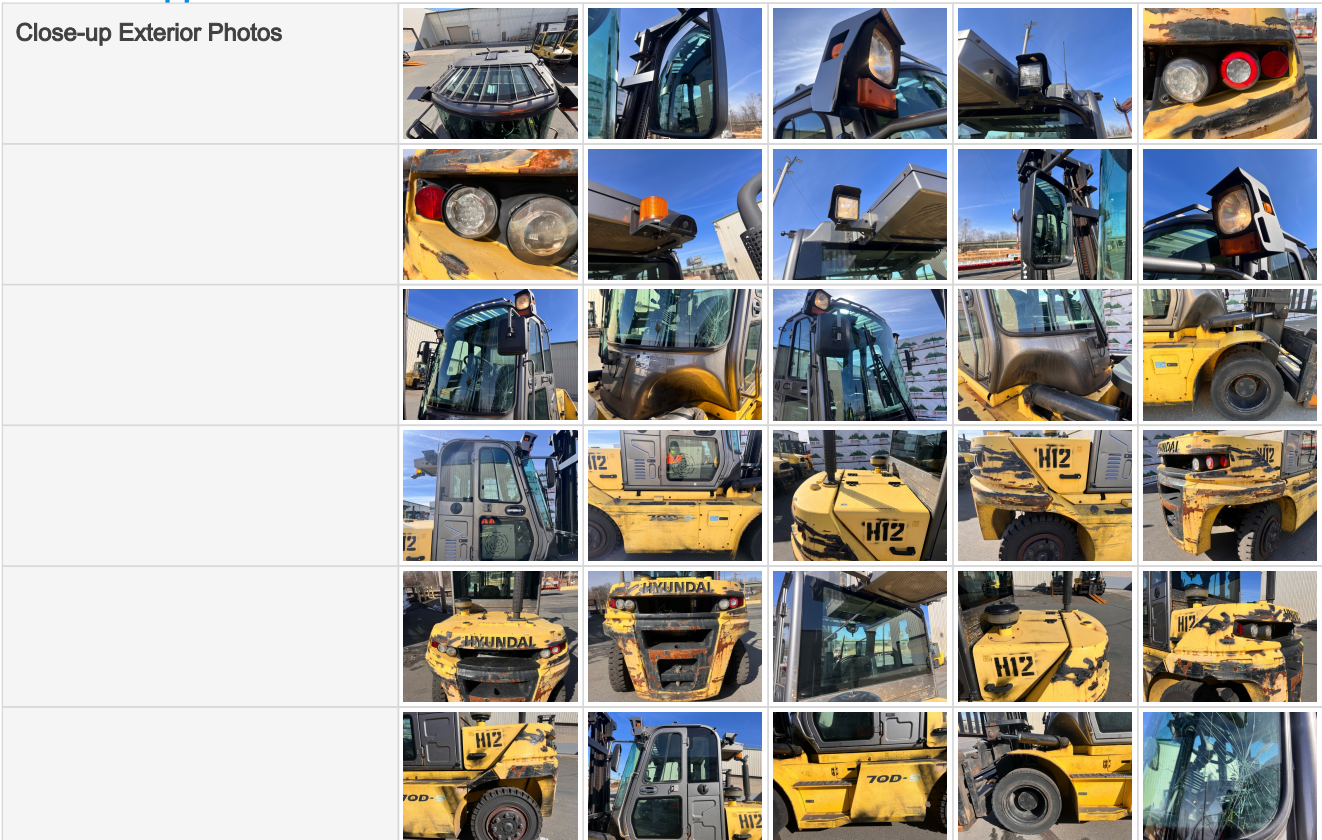
#### General Appearance Photos

Steps / Ladders Condition	Steps/ladders are fully intact and appear structurally sound
Handrails	3 - Normal Wear & Tear
Handrails Condition	Handrails are fully intact and appear structurally sound
Glass	1 - Service Required
Glass Condition	Major chips or cracks observed
Comments	Windshield major crack
Mirrors	3 - Normal Wear & Tear
Exterior Lights	3 - Normal Wear & Tear
Exterior Lights Condition	No visible damage, lighting system is operational
Overall Exterior	2 - Above Average Wear & Tear
Comments	Paint chips throughout exterior of machine, areas of surface rust observed, major crack on windshield glass, left rear tail lights cracked

What Needs Work	The things that need work on this machine are the front windshield that is cracked, the Left rear tail lights that are cracked and The heater vents that are damaged.	
Date/Time	02-15-2024	
Inspector Name	Javier Bocanegra

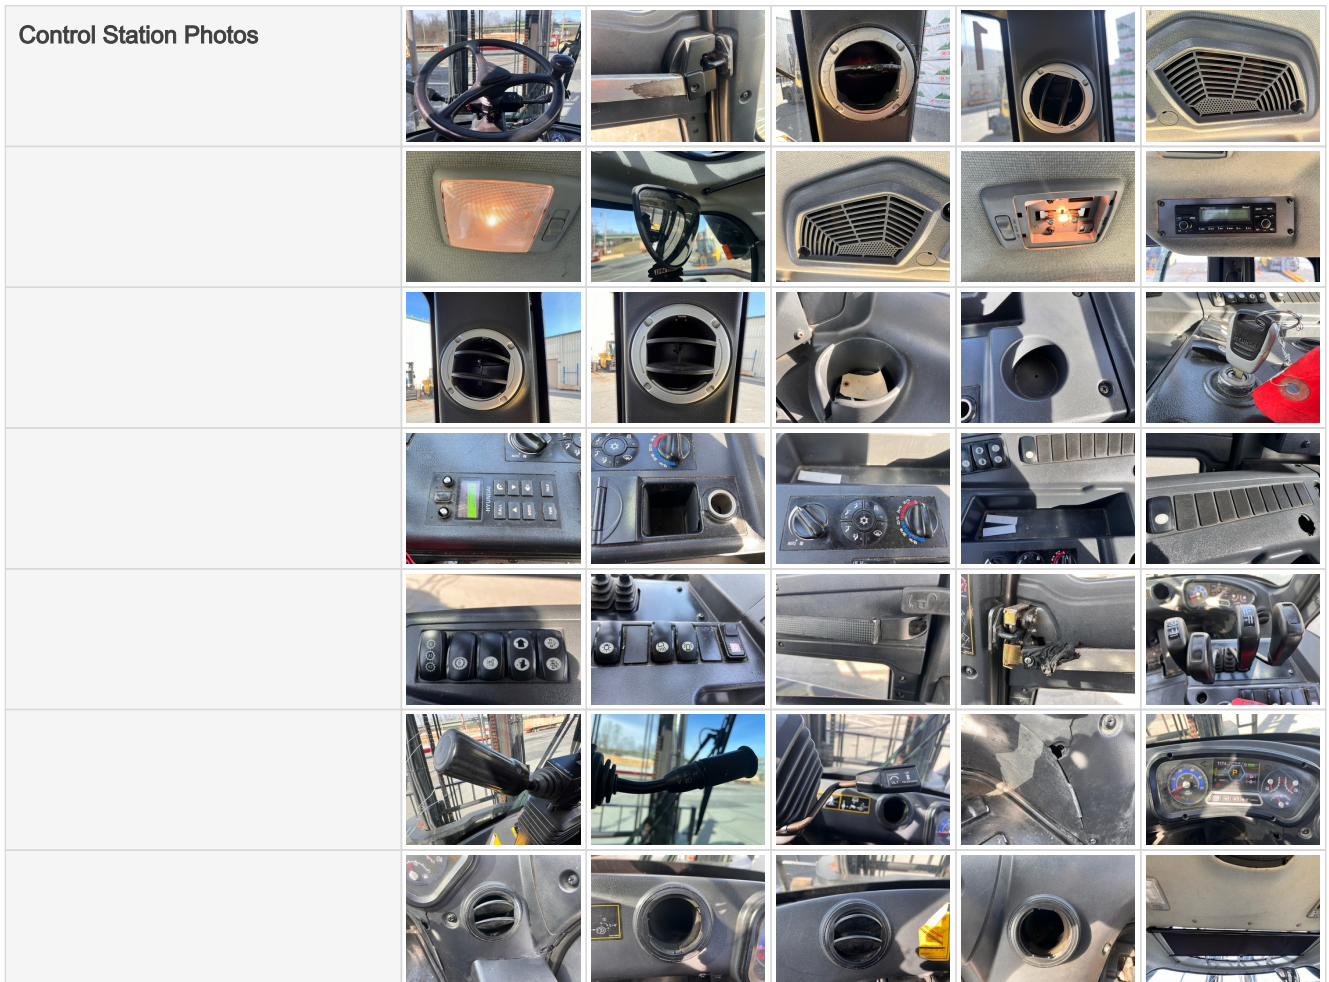
### Control Station Photos

<b>Serial Number Plate</b>	 
<b>Hour Meter/Odometer</b>	 
<b>Control Station Type</b>	Enclosed Cab (EROPS)
<b>Option List</b>	Unable to Confirm
<b>Seat</b>	2 - Above Average Wear & Tear
<b>Seat Condition</b>	Seat(s) have minor surface staining or small tears, Seat belt secures properly

Cabin Lights	2 - Above Average Wear & Tear
Cabin Lights Condition	One or more light cover or bulb is missing, lighting system is operational
Safety Lock Out / Stop	3 - Normal Wear & Tear
Safety Lock Out / Stop Condition	Safety lock out device is present, in good condition, and functional
Controls & Switches	3 - Normal Wear & Tear
Controls & Switches Condition	All switches are installed and functional
Hour Meter Activity	3 - Normal Wear & Tear
Hour Meter Condition	Hour meter is functional and in good condition
Other Gauge Activity	3 - Normal Wear & Tear
Other Gauge Condition	All cockpit gauges are functional and in good condition
Heater & A/C	2 - Above Average Wear & Tear
Heater & A/C Condition	Only heat functionality works
Travel Alarm	0
Horn	3 - Normal Wear & Tear
Horn Condition	Horn is installed and functioning as expected
Backup Camera	3 - Normal Wear & Tear
Backup Camera Condition	Back up camera is installed and functioning as expected

Control Station Overall Rating	3 - Normal Wear & Tear
Control Station Overall Condition	Good cabin appearance, solid floors, panels, and ceiling

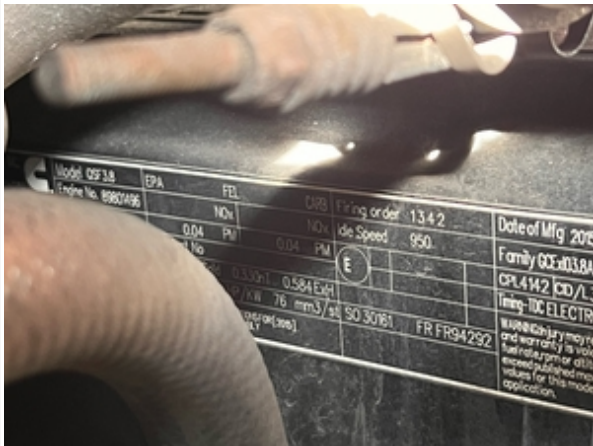
Engine Data Plate

<b>Engine Type (Make, Model, Cylinders, Hp)</b>	Cummins, QSF 3.8
<b>Emissions Tier</b>	Tier 4F
<b>Engine Serial Number</b>	89801496
<b>Engine Fuel Type</b>	Diesel
<b>Blow-by (Visual Observation Check)</b>	No
<b>Engine Smoke (Upon Start-up, Idle, Shutdown)</b>	Yes
<b>Engine Smoke Notes</b>	Engine smoke observed upon start up
<b>Engine Exhaust Color</b>	White
<b>Battery</b>	3 - Normal Wear & Tear
<b>Battery Condition</b>	Inaccessible, unable to determine condition
<b>Radiator</b>	3 - Normal Wear & Tear
<b>Radiator Condition</b>	Radiator fins & components appear to be in good working order, no signs of damage or leaks
<b>Belts</b>	3 - Normal Wear & Tear
<b>Belt Condition</b>	Belts appear in good condition & alignment with proper tension
<b>Hoses</b>	3 - Normal Wear & Tear
<b>Hose Condition</b>	Firm, pliant hoses with no signs of wear or leaks
<b>Water Pump</b>	3 - Normal Wear & Tear

DPF Condition	3 - Normal Wear & Tear
DPF Condition Notes	Filter housing is intact with no signs of damage or malfunction, DPF indicator is not illuminated
Requires DEF (Diesel Exhaust Fluid)	Yes
DEF Tank	3 - Normal Wear & Tear
DEF Tank Condition	Area around DEF tank cap is clean, fluid is clear & appears free of contaminants
Overall Engine Rating	3 - Normal Wear & Tear
Overall Engine Appearance	Dusty & dry
Overall Engine Comments	Normal wear and tear No major issues to report

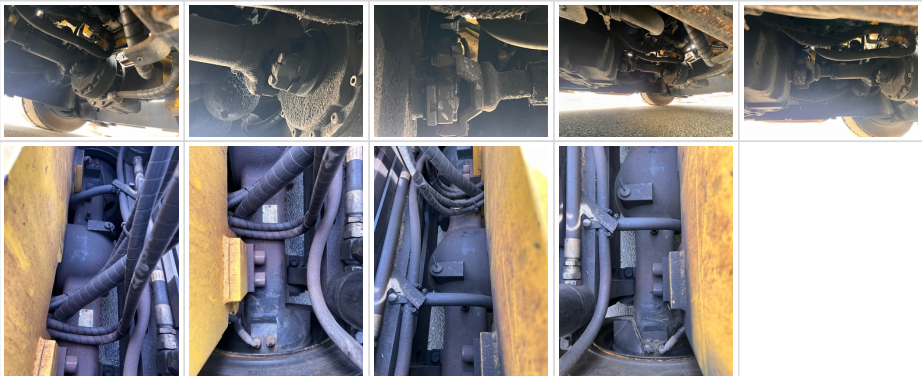
Drivetrain Photos

Hydrostatic Transmission?	No
Transmission Info (Make/Model/Speeds)	Unable to verify
Drive Type	2WD
Transmission Components	3 - Normal Wear & Tear
Transmission Condition	Good forward and reverse function, No unusual noises or vibrations
Parking Brake	3 - Normal Wear & Tear
Overall Drivetrain Rating	3 - Normal Wear & Tear
Overall Drivetrain Comments	Normal wear and tear No major issues to report
Front Axle	3 - Normal Wear & Tear
Rear Axle	0

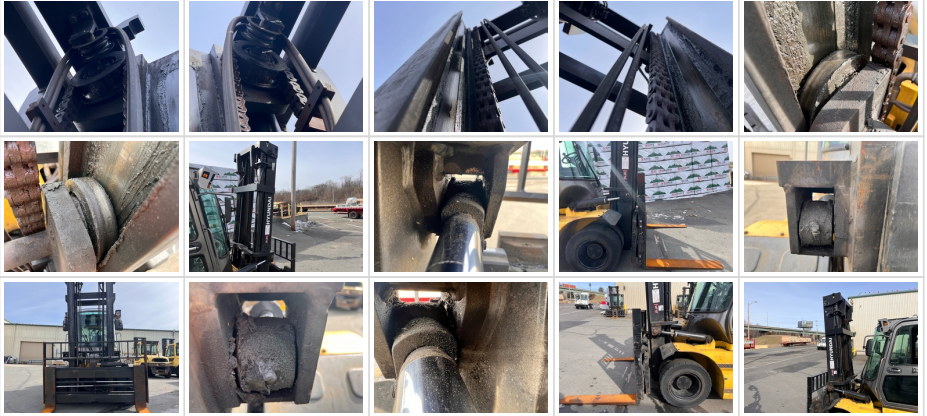
Chassis Photos

Frame	3 - Normal Wear & Tear
Stance	3 - Normal Wear & Tear
Carriage Appearance	2 - Above Average Wear & Tear
Comments	Slightly bent backrest
Mast Condition	3 - Normal Wear & Tear
Chain / Tensioners	3 - Normal Wear & Tear
Rollers & Guides	3 - Normal Wear & Tear

Overall Chassis	3 - Normal Wear & Tear
Overall Chassis Comments	Normal wear and tear No major issues to report

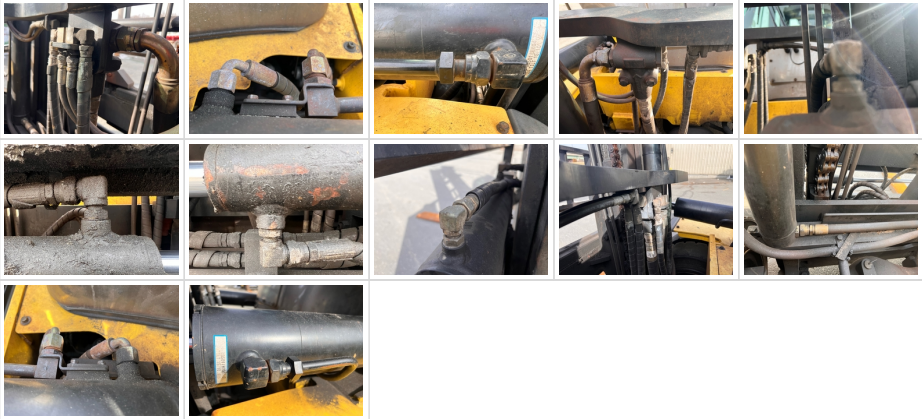
Hydraulic System Photos

Wet or Damp Hydraulic Lines / Fittings	No
Hydraulic Lines/Fittings	3 - Normal Wear & Tear
Hydraulic Lines / Fittings Condition	Hydraulic lines & fittings are clean and in good condition
Hydraulic Pump(s)	3 - Normal Wear & Tear
Unusual Noises	No
Hydraulic Pump Notes	No unusual noises heard during operation

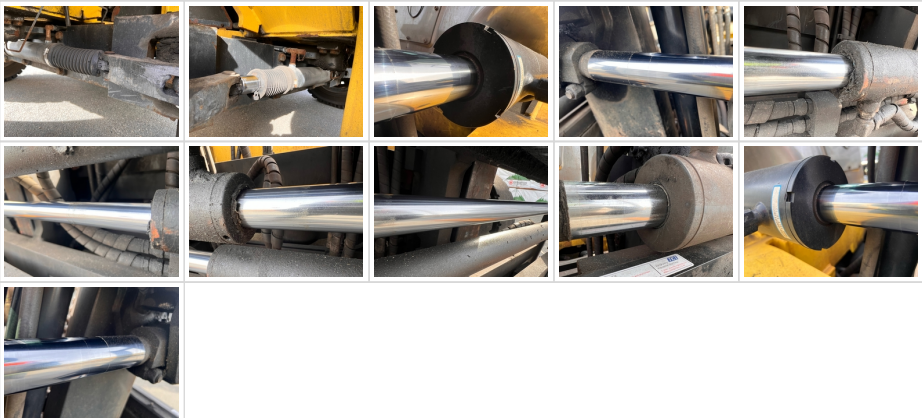
Hydraulic Cylinder Photos

Mounting Pins	3 - Normal Wear & Tear
Cylinder Oil Leaks	No
Hydraulic System Overall	3 - Normal Wear & Tear
