Inspection Report (Scraper)

B&B Stock Number	A1426606
Year	1980
Make	CAT
Model	623B
Serial Number	46P1583
Hour Meter Reading	15,236 Hrs. (Exact hours may vary)
Previous Application (e.g., earth moving, mining, demolition, etc)	General Construction

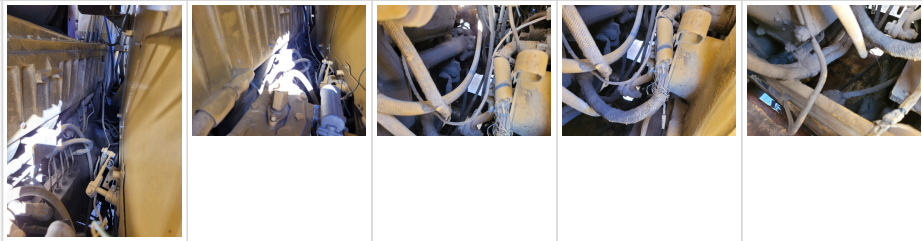
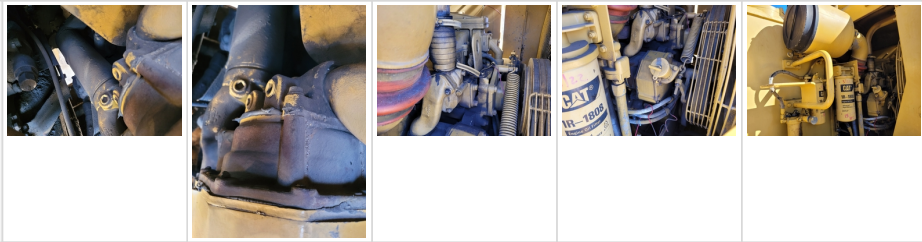
Engine Compartment Photos

Engine Type (Make, Model, Cylinders, Hp)	CAT - 3406PC - 6Cyl.
Emissions Tier	Tier 0
Engine Serial Number	70V10142
Engine Fuel Type	Diesel
Blow-by (Visual Observation Check)	Yes
Comments	Minor blowby seen
Unusual Noises (Upon Start-up, Idle, Shutdown)	No
Engine Smoke (Upon Start-up, Idle, Shutdown)	Yes
Engine Smoke Notes	Engine smoke observed upon start up, Continuous engine smoke observed during operation
Engine Exhaust Color	Black
Battery	3 - Normal Wear & Tear
Battery Condition	Clean & dry appearance, tight connections
Radiator	3 - Normal Wear & Tear

Radiator Condition	Radiator fins & components appear to be in good working order, no signs of damage or leaks
Belts	3 - Normal Wear & Tear
Belt Condition	Frayed belt edges observed, Belts appear in good condition & alignment with proper tension
Hoses	3 - Normal Wear & Tear
Hose Condition	Cracking, stiff, or charred hoses, Dried seepages observed, Other (see comments)
Comments	Most engine hoses are in descent shape.
Water Pump	3 - Normal Wear & Tear
Water Pump Condition	No unusual pump noises heard
Cooling System Leaks	No
Coolant Appearance	3 - Normal Wear & Tear
Coolant Appearance Notes	Normal Translucent appearance, no visual signs of contamination
Oil Leaks	Yes
Oil Leak Notes	Dried oil seepages seen, Other (see comments)
Comments	Residual oil buildup is present at and around the engine. No major active leaks were observed.
Oil Appearance	3 - Normal Wear & Tear
Oil Appearance Notes	Appropriate oil level, Clean oil appearance, no signs of cross contamination

Fuel Leaks	No
Equipped with DPF (Diesel Particulate Filter)	No
Requires DEF (Diesel Exhaust Fluid)	No
Overall Engine Rating	3 - Normal Wear & Tear
Overall Engine Appearance	Very dirty, Areas of dried seepage seen on engine hoses & components
Overall Engine Comments	The engine did not hesitate to fire up and it sounded normal during the inspection. Multiple areas on the engine have residual oil buildup. Further inspection to determine if and where the leaks may be coming from is recommended.

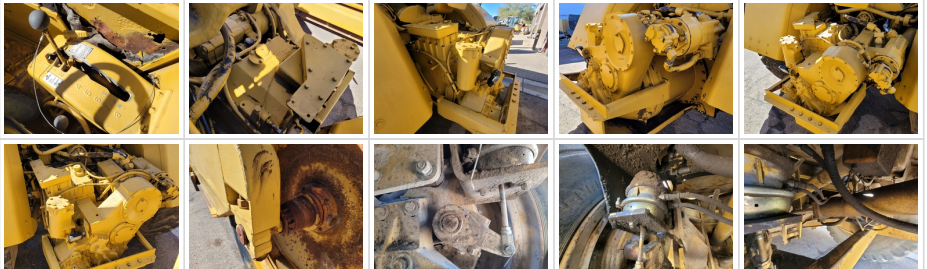
Drivetrain Photos

Hydrostatic Transmission?	No
Transmission Info (Make/Model/Speeds)	8 Speed with a max speed of 30 MPH
Drive Type	2WD
Transmission Components	3 - Normal Wear & Tear
Transmission Condition	Good forward and reverse function, No unusual noises or vibrations, Leaking transmission fluid observed, Other (see comments)
Comments	The transmission was tested in short distances in slow speeds and in low gear.
Parking Brake	3 - Normal Wear & Tear
Parking Brake Function	Good brake function
Overall Drivetrain Rating	3 - Normal Wear & Tear
Overall Drivetrain Comments	The machine traveled well in both directions and was only tested in short distances. The transmission components have residual oil buildup and should be further inspected to determine if an active leak may exist.

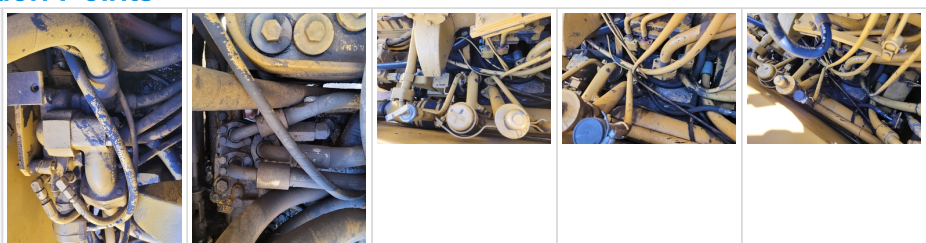
Hydraulic System Photos

Wet or Damp Hydraulic Lines / Fittings	Yes
Hydraulic Lines/Fittings	3 - Normal Wear & Tear
Hydraulic Lines / Fittings Condition	Twisted, kinked, or flattened hydraulic hoses, Cracking, stiff, or charred hydraulic hoses, Worn, cut, or damaged hose covering, Dried seepages observed, Other (see comments)
Comments	Some hydraulic tubes are worn and have weld repairs.
Hydraulic Pump(s)	3 - Normal Wear & Tear
Unusual Noises	No
Hydraulic Pump Notes	No unusual noises heard during operation
