## Inspection Report (Forklift)

B&B Stock Number	A0329940
Year	2014
Make	Hyster
Model	H155FT
Serial Number	K006V02468M
Hour Meter Reading	15190
Previous Application (e.g., earth moving, mining, demolition, etc)	Warehouse

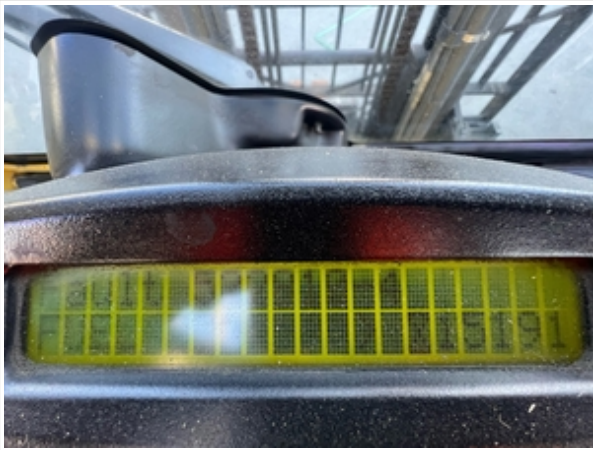
Control Station Type	Enclosed Cab (EROPS)														
Option List	Unable to Confirm														
Seat	2 - Above Average Wear & Tear														
Seat Condition	Seat(s) have minor surface staining or small tears, Seat belt secures properly														
Cabin Lights	1 - Service Required														
Cabin Lights Condition	Cabin light system is not operational														
Safety Lock Out / Stop	3 - Normal Wear & Tear														
Safety Lock Out / Stop Condition	Safety lock out device is present, in good condition, and functional

Controls & Switches	3 - Normal Wear & Tear
Controls & Switches Condition	All switches are installed and functional
Hour Meter Activity	2 - Above Average Wear & Tear
Hour Meter Condition	Hour meter is unreadable or not functioning
Last Known Hour Meter Reading	15191
Comments	Display contrast too low hard to see what is being displayed
Other Gauge Activity	0
Heater & A/C	1 - Service Required
Heater & A/C Condition	Fan only, heating and A/C components inoperative
Travel Alarm	0
Backup Camera	0
Control Station Overall Rating	2 - Above Average Wear & Tear
Control Station Overall Condition	Other (see comments)
Comments	Door latch to exit left door not operational, display screen contrast is too low, heater does not blow hot, left side mirror taped up

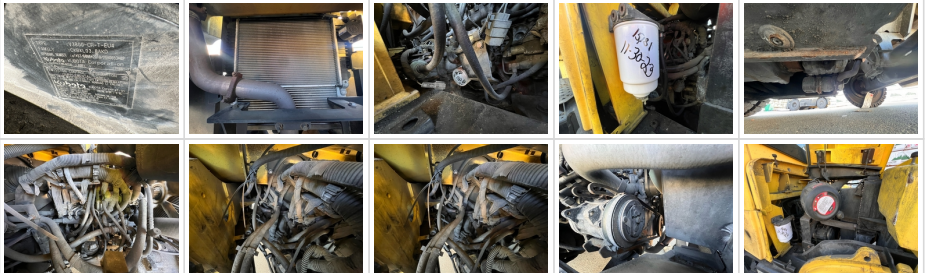
Engine Compartment Photos

Equipped with DPF (Diesel Particulate Filter)	Yes
DPF Condition	3 - Normal Wear & Tear
DPF Condition Notes	Filter housing is intact with no signs of damage or malfunction, DPF indicator is not illuminated
Requires DEF (Diesel Exhaust Fluid)	No
Overall Engine Rating	2 - Above Average Wear & Tear
Overall Engine Appearance	Dusty & dry
Overall Engine Comments	Unknown fault code on display screen.

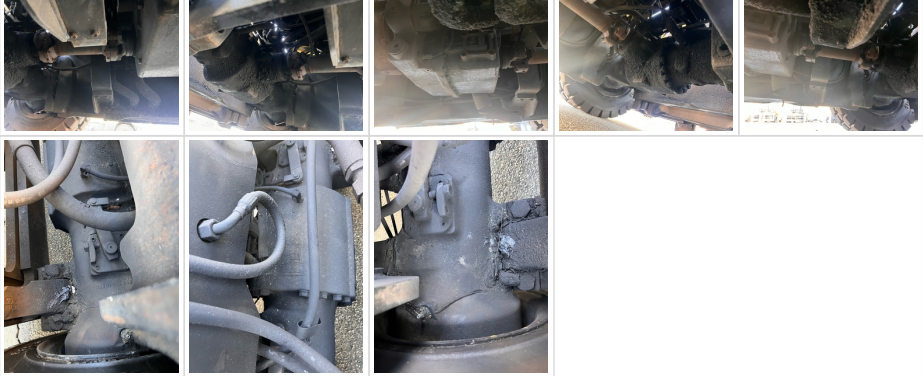
Drivetrain Photos

Hydrostatic Transmission?	No
Transmission Info (Make/Model/Speeds)	Unable to verify
Drive Type	2WD
Transmission Components	3 - Normal Wear & Tear
Transmission Condition	Good forward and reverse function
Parking Brake	3 - Normal Wear & Tear
Overall Drivetrain Rating	3 - Normal Wear & Tear
Overall Drivetrain Comments	Normal wear and tear No major issues to report
Front Axle	3 - Normal Wear & Tear
Rear Axle	0

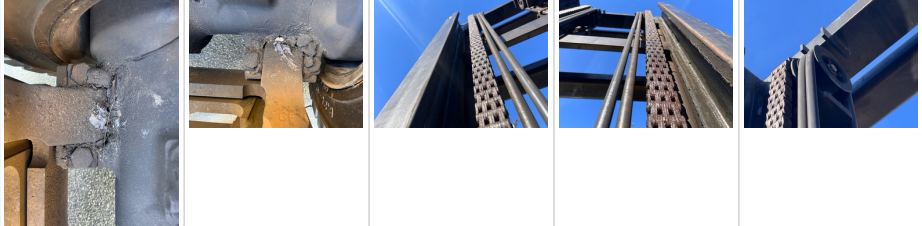
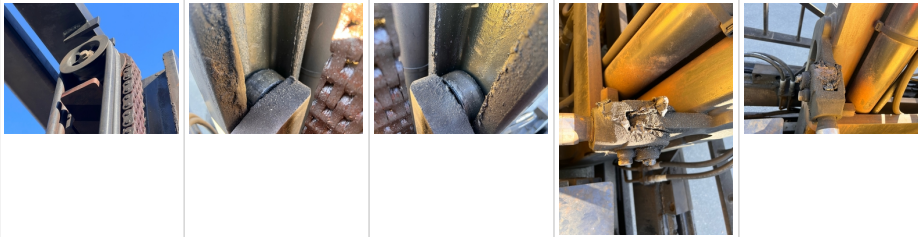
Chassis Photos

Frame	3 - Normal Wear & Tear				
Stance	3 - Normal Wear & Tear				
Carriage Appearance	3 - Normal Wear & Tear				
Mast Condition	3 - Normal Wear & Tear

Chain / Tensioners	3 - Normal Wear & Tear
Rollers & Guides	3 - Normal Wear & Tear
Overall Chassis	3 - Normal Wear & Tear
Overall Chassis Comments	Normal wear and tear No major issues to report
