Inspection Report (Forklift)

B&B Stock Number	A6215243
Year	2014
Make	Hyundai
Model	70D-9
Serial Number	HHKHFA03HG0000192
Hour Meter Reading	13857.3
Previous Application (e.g., earth moving, mining, demolition, etc)	Warehouse

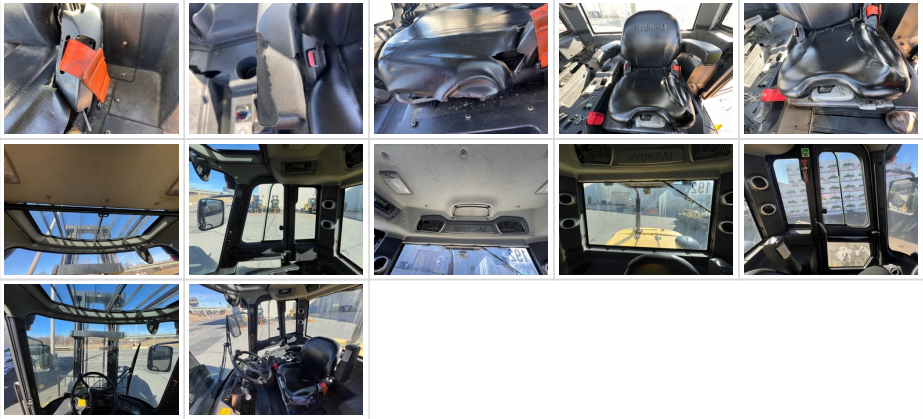
Control Station Type	Enclosed Cab (EROPS)
Option List	Unable to Confirm
Seat	2 - Above Average Wear & Tear
Seat Condition	Seat(s) has major surface staining or tears, Seat belt shows limited functionality or does not secure properly
Comments	Major seat damage, seatbelt not operational
Cabin Lights	3 - Normal Wear & Tear
Cabin Lights Condition	Cabin lights are installed with all light covers in place, bulbs are installed and working properly

Comments	Broken interior paneling, damage seat, Seatbelt Not operational,

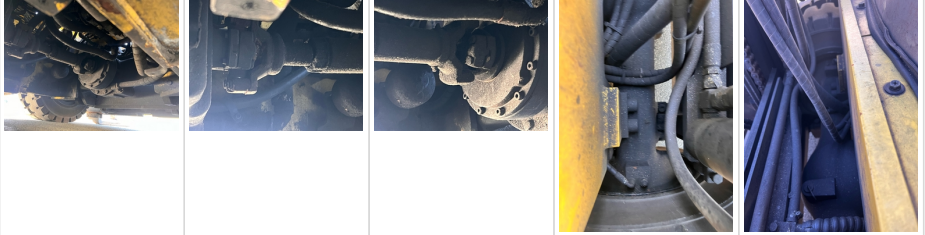
Drivetrain Photos

Hydrostatic Transmission?	No
Transmission Info (Make/Model/Speeds)	Unable to verify
Drive Type	2WD
Transmission Components	3 - Normal Wear & Tear
Transmission Condition	No unusual noises or vibrations, Good forward and reverse function
Parking Brake	3 - Normal Wear & Tear
Overall Drivetrain Rating	3 - Normal Wear & Tear
Overall Drivetrain Comments	Normal wear and tear no major issues to report
Front Axle	3 - Normal Wear & Tear
Rear Axle	0

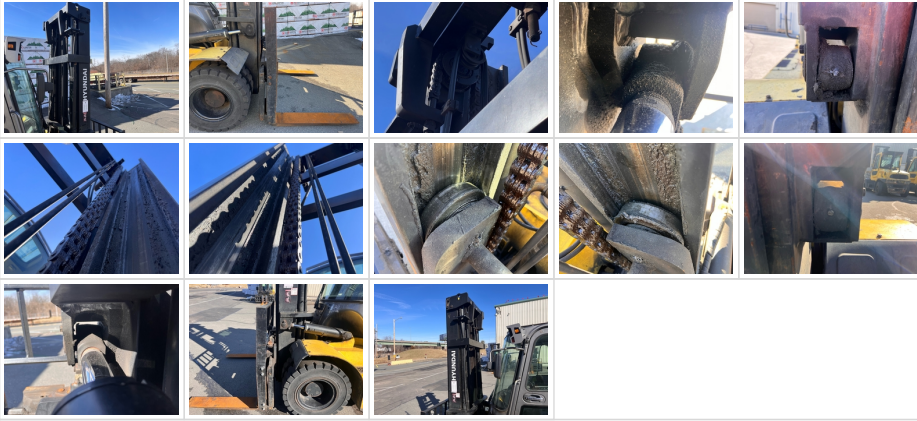
Chassis Photos

Frame	3 - Normal Wear & Tear				
Stance	3 - Normal Wear & Tear				
Carriage Appearance	3 - Normal Wear & Tear				
Mast Condition	3 - Normal Wear & Tear				
Chain / Tensioners	3 - Normal Wear & Tear				
Rollers & Guides	3 - Normal Wear & Tear

Overall Chassis	3 - Normal Wear & Tear
Overall Chassis Comments	Normal wear and tear No major issues to report

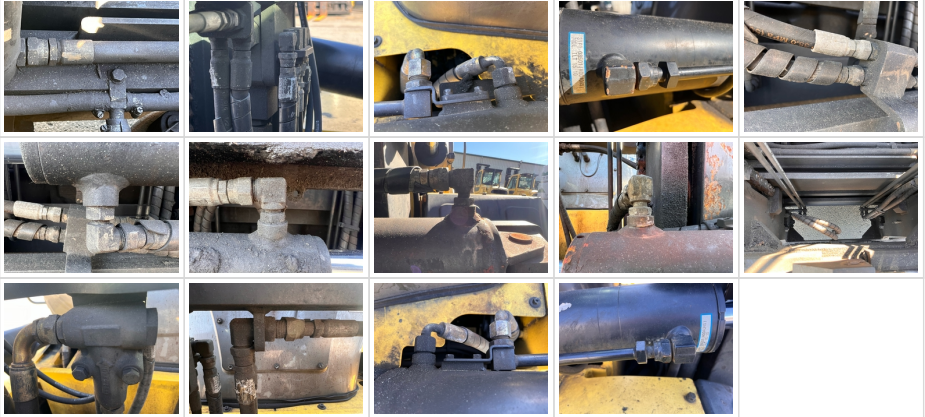
Hydraulic System Photos

Wet or Damp Hydraulic Lines / Fittings	No
Hydraulic Lines/Fittings	3 - Normal Wear & Tear
Hydraulic Lines / Fittings Condition	Hydraulic lines & fittings are clean and in good condition
Hydraulic Pump(s)	3 - Normal Wear & Tear
Unusual Noises	No
Hydraulic Pump Notes	No unusual noises heard during operation

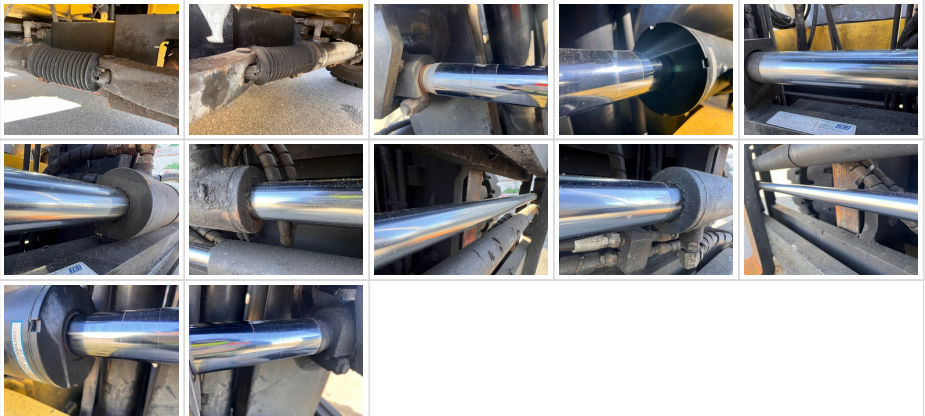
Hydraulic Cylinder Photos

Mounting Pins	3 - Normal Wear & Tear
Cylinder Oil Leaks	No
Hydraulic System Overall	3 - Normal Wear & Tear
