Inspection Report (Forklift)

B&B Stock Number	A4733489
Year	2014
Make	Hyundai
Model	40D-9F
Serial Number	HHKH FV34AK0000064
Hour Meter Reading	8981.8
Previous Application (e.g., earth moving, mining, demolition, etc)	Warehouse

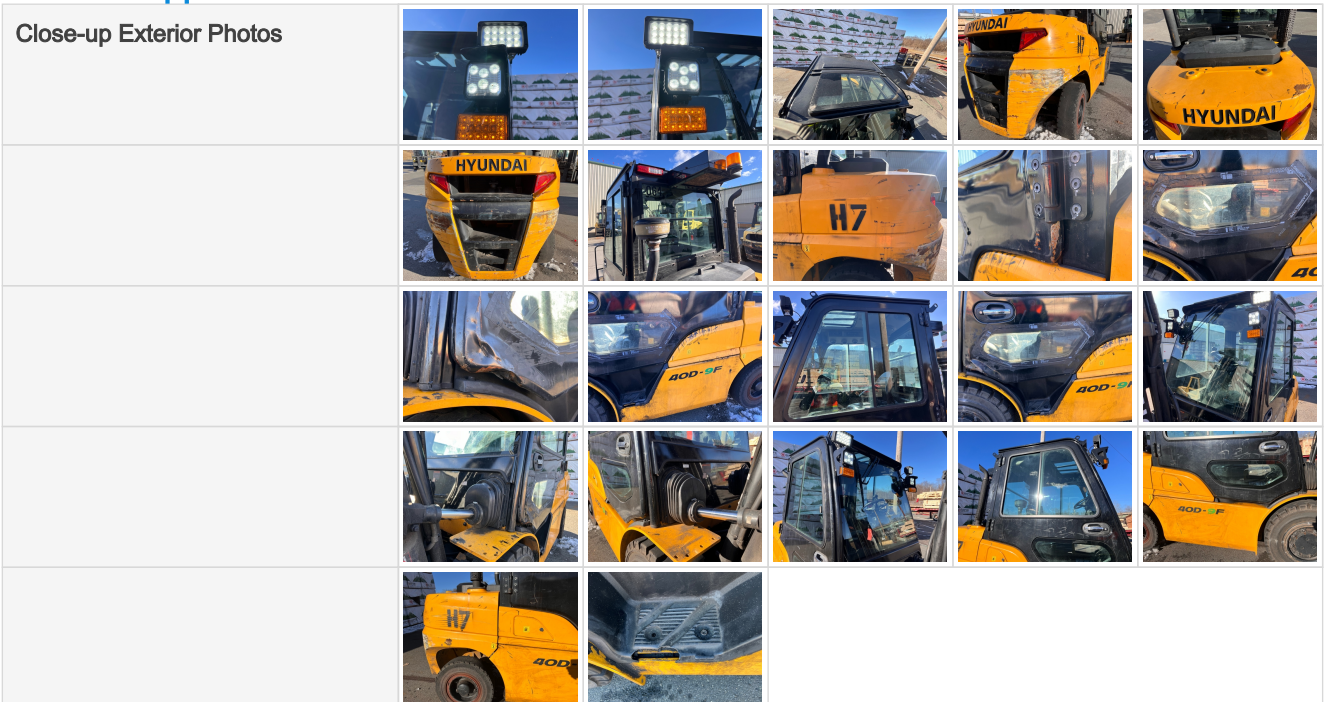
General Appearance Photos

Steps / Ladders	2 - Above Average Wear & Tear	
Steps / Ladders Condition	Bent or broken steps or rungs	
Handrails	3 - Normal Wear & Tear	
Handrails Condition	Handrails are fully intact and appear structurally sound	
Glass	3 - Normal Wear & Tear	
Glass Condition	Glass intact, no visible damage	
Mirrors	3 - Normal Wear & Tear	
Mirror Condition	Mirrors present and intact, no visible damage	
Exterior Lights	3 - Normal Wear & Tear	
Exterior Lights Condition	No visible damage, lighting system is operational	
Overall Exterior	2 - Above Average Wear & Tear	
Comments	Left side door damaged, lower glass held on by tape, paint gouges at rear of machine

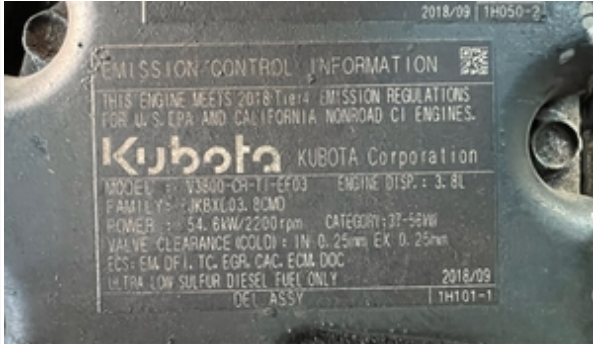
Engine Data Plate

<p>2018/09 1H050-2</p> <p>EMISSION CONTROL INFORMATION</p> <p>THIS ENGINE MEETS 2018 Tier 4 EMISSION REGULATIONS FOR U.S. EPA AND CALIFORNIA NONROAD CI ENGINES.</p> <p>Kubota KUBOTA Corporation</p> <p>MODEL: V3800-CP-11-EF03 ENGINE DTSP: 3.8L</p> <p>FAMILY: K8X03, BOMD</p> <p>POWER: 54.6kW/2200rpm CATEGORY: 37-55kW</p> <p>VALVE CLEARANCE (COLD): IN: 0.25mm EX: 0.25mm</p> <p>ECS: EM, OF, I, TC, EGR, CAC, ECM, DOC</p> <p>ULTRA LOW SULFUR DIESEL FUEL ONLY</p> <p>2018/09</p> <p>DET. ASSY 1H101-1</p>
Engine Compartment Photos

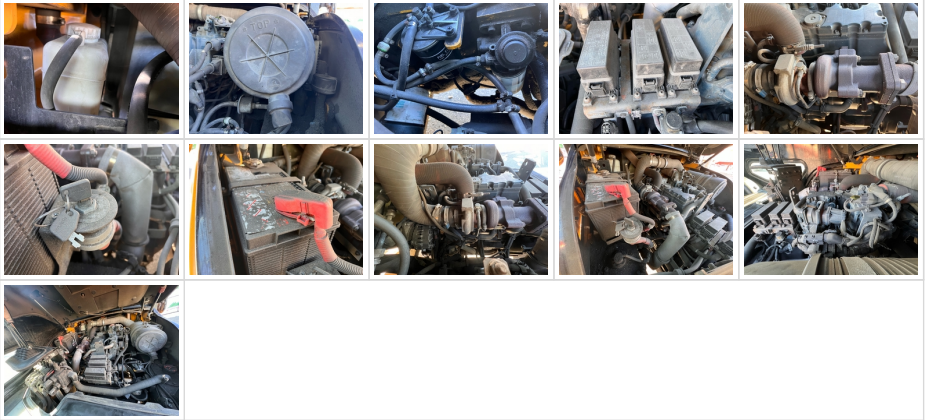
Engine Type (Make, Model, Cylinders, Hp)	Kubota, V3800
Emissions Tier	Tier 4F
Engine Serial Number	Unable to verify
Engine Fuel Type	Diesel
Blow-by (Visual Observation Check)	No
Unusual Noises (Upon Start-up, Idle, Shutdown)	No
Engine Smoke (Upon Start-up, Idle, Shutdown)	Yes
Engine Smoke Notes	Engine smoke observed upon start up
Engine Exhaust Color	White

Requires DEF (Diesel Exhaust Fluid)	No
Overall Engine Rating	3 - Normal Wear & Tear
Overall Engine Appearance	Dusty & dry
Overall Engine Comments	Normal wear and tear no major issues to report

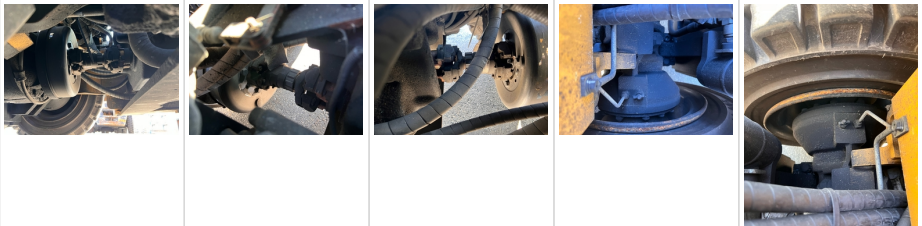
Drivetrain Photos

Hydrostatic Transmission?	No
Transmission Info (Make/Model/Speeds)	Unable to verify
Drive Type	2WD
Transmission Components	3 - Normal Wear & Tear
Transmission Condition	Good forward and reverse function
Parking Brake	3 - Normal Wear & Tear
Overall Drivetrain Rating	3 - Normal Wear & Tear
Overall Drivetrain Comments	Normal wear and tear no major issues to report
Front Axle	3 - Normal Wear & Tear
Rear Axle	0
