Inspection Report (Wheel Loader)

B&B Stock Number	A2830665
Year	2013
Make	John Deere
Model	644K
Serial Number	1DW644KZCDE654176
Hour Meter Reading	7,017 Hrs.
Previous Application (e.g., earth moving, mining, demolition, etc)	General Construction

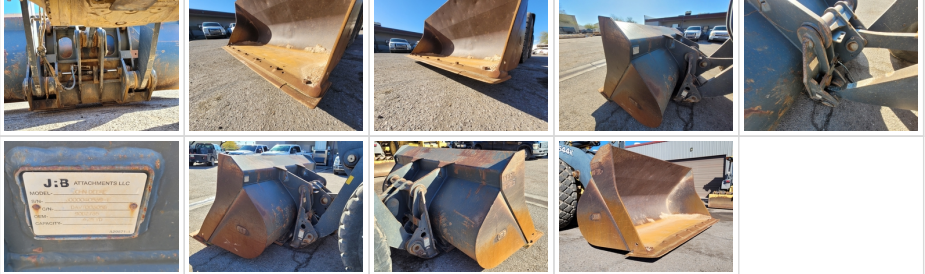
Attachment Type	GP Bucket & Quick Coupler				
Attachment Make	JRB				
Attachment Size / Specs	N/A				
Attachment Condition	3 - Normal Wear & Tear				
Comments	Bucket and Quick Coupler are in good working condition.				
Attachment Photos
