Inspection Report (Vibratory Compactor)

B&B Stock Number	A3094393
Year	2013
Make	Volvo
Model	SD75B
Serial Number	VCESD75BC0S241140
Hour Meter Reading	1709.7hrs
Previous Application (e.g., earth moving, mining, demolition, etc)	This machine was used in civil construction

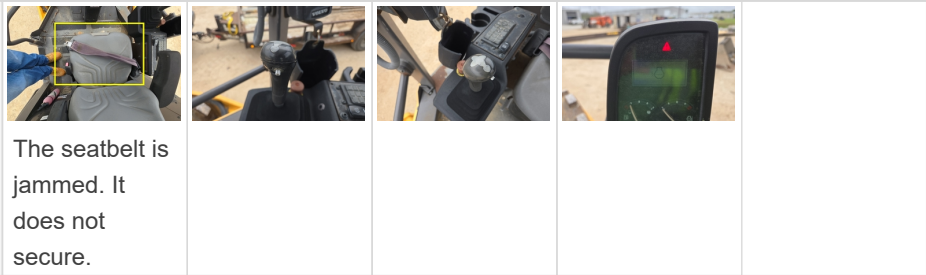
<p>The seatbelt is jammed. It does not secure.</p>
Serial Number Plate

Seat Condition	Seat(s) in good condition, no stains or tears in upholstery, Seat adjustment controls have limited range of motion, Seat belt shows limited functionality or does not secure properly
Cabin Lights	0
Safety Lock Out / Stop	3 - Normal Wear & Tear
Safety Lock Out / Stop Condition	Safety lock out device is present, in good condition, and functional
Controls & Switches	3 - Normal Wear & Tear
Controls & Switches Condition	All switches are installed and functional
Hour Meter Activity	3 - Normal Wear & Tear
Hour Meter Condition	Hour meter is functional and in good condition
Other Gauge Activity	3 - Normal Wear & Tear
Other Gauge Condition	All cockpit gauges are functional and in good condition
Heater & A/C	0
Travel Alarm	0
Horn	0
Backup Camera	0
Control Station Overall Rating	3 - Normal Wear & Tear
Control Station Overall Condition	Minor cosmetic wear to cabin surfaces, floors, panels, and ceiling
Comments	The seatbelt does not secure properly.
