Inspection Report (Wheel Loader)

B&B Stock Number	A0358356
Year	2020
Make	Volvo
Model	L70H
Serial Number	VCE0L70HH0S624241
Hour Meter Reading	4202hrs
Previous Application (e.g., earth moving, mining, demolition, etc)	This machine was used in civil construction

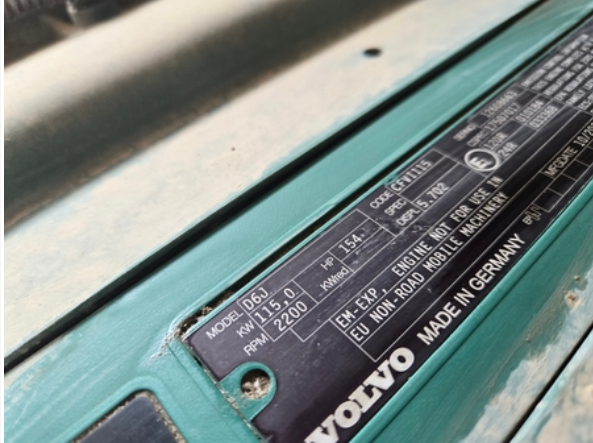
Engine Data Plate

Engine Type (Make, Model, Cylinders, Hp)	Volvo, D6J, Hp 154
Emissions Tier	Tier 4F
Engine Serial Number	12608663
Engine Fuel Type	Diesel
Blow-by (Visual Observation Check)	Yes
Unusual Noises (Upon Start-up, Idle, Shutdown)	No
Engine Smoke (Upon Start-up, Idle, Shutdown)	No
Engine Exhaust Color	Clear
Battery	3 - Normal Wear & Tear
Battery Condition	Dusty & dirty appearance
Radiator	3 - Normal Wear & Tear
Radiator Condition	Radiator fins & components appear to be in good working order, no signs of damage or leaks
Belts	3 - Normal Wear & Tear
Belt Condition	Belts appear in good condition & alignment with proper tension
Hoses	3 - Normal Wear & Tear
Hose Condition	Firm, pliant hoses with no signs of wear or leaks
Water Pump	3 - Normal Wear & Tear
Water Pump Condition	No unusual pump noises heard
Cooling System Leaks	No
Coolant Appearance	3 - Normal Wear & Tear

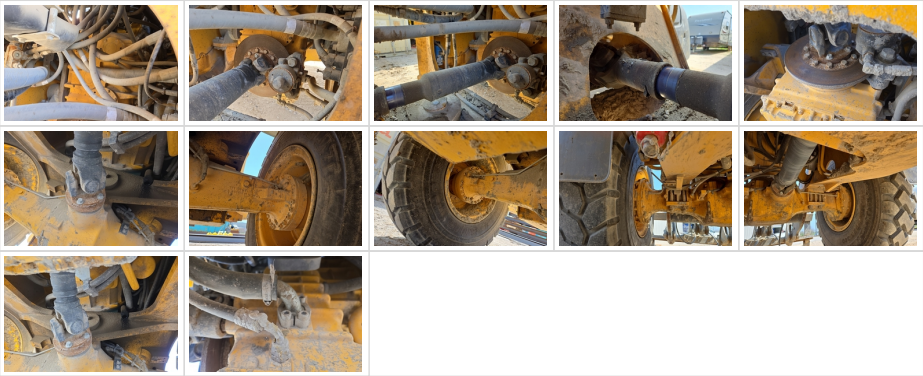
Drivetrain Photos

Hydrostatic Transmission?	No				
Transmission Info (Make/Model/Speeds)	Volvo, HTE 125,				
Drive Type	Other (see comments)				
Other Drive Type	This machine is a 2WD with a differential lock				
Transmission Components	3 - Normal Wear & Tear				
Transmission Condition	Good forward and reverse function, No unusual noises or vibrations				
Parking Brake	3 - Normal Wear & Tear				
Parking Brake Function	Good brake function				
Overall Drivetrain Rating	3 - Normal Wear & Tear

Overall Drivetrain Comments	The drivetrain is in good working condition.
-----------------------------	--

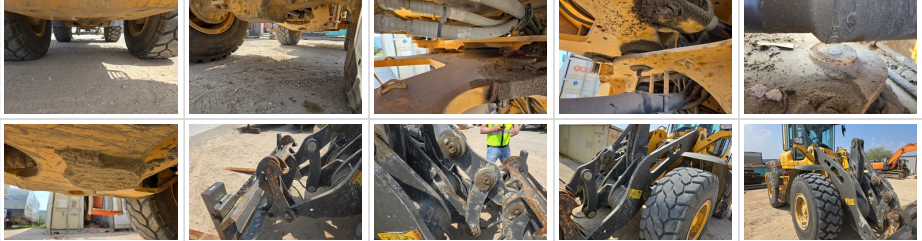
Chassis Photos

Frame	3 - Normal Wear & Tear
Stance	3 - Normal Wear & Tear
Front Axle Appearance	3 - Normal Wear & Tear
Rear Axle Appearance	3 - Normal Wear & Tear
Articulating Center Pin Appearance	3 - Normal Wear & Tear
Lift Arm	3 - Normal Wear & Tear
Chassis to Arm Pins	3 - Normal Wear & Tear
Tilt Linkage	3 - Normal Wear & Tear
Tilt Linkage Pins and Bushings	3 - Normal Wear & Tear
Quick Coupler	3 - Normal Wear & Tear
Quick Coupler to Arms Pins	3 - Normal Wear & Tear
Overall Chassis	3 - Normal Wear & Tear
Overall Chassis Comments	The chassis is in good condition.
