Inspection Report (Telehandler)

B&B Stock Number	A8431658
Year	2016
Make	Skytrak
Model	10042
Serial Number	unable to verify
Hour Meter Reading	unable to verify
Previous Application (e.g., earth moving, mining, demolition, etc)	This machine was used in civil construction

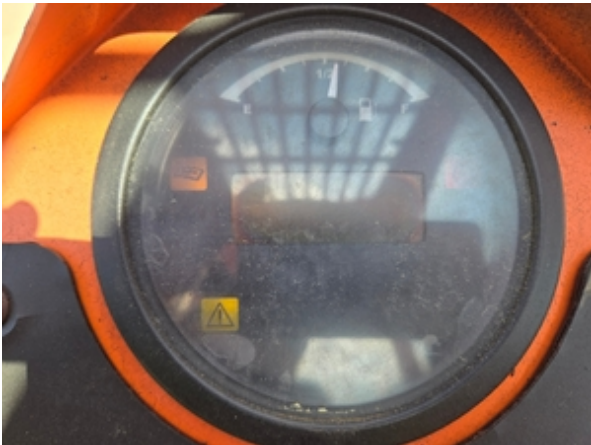
Hour Meter/Odometer

The gauge is unreadable

What Needs Work	Rust was seen throughout the machine and in the engine. The hour meter gauge can not be read due to sun damage.	
Any Additional Info from the Seller?	This machine was used in civil construction	
Date/Time	03-06-2024	
Inspector Name	Steven Mesa

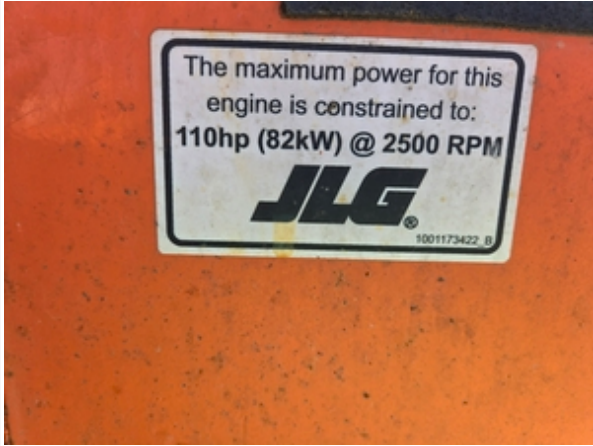
Engine Data Plate

<p>Rust seen throughout the engine</p>

Overall Engine Appearance	Areas of surface corrosion seen on some engine components
Overall Engine Comments	Rust was seen throughout the engine

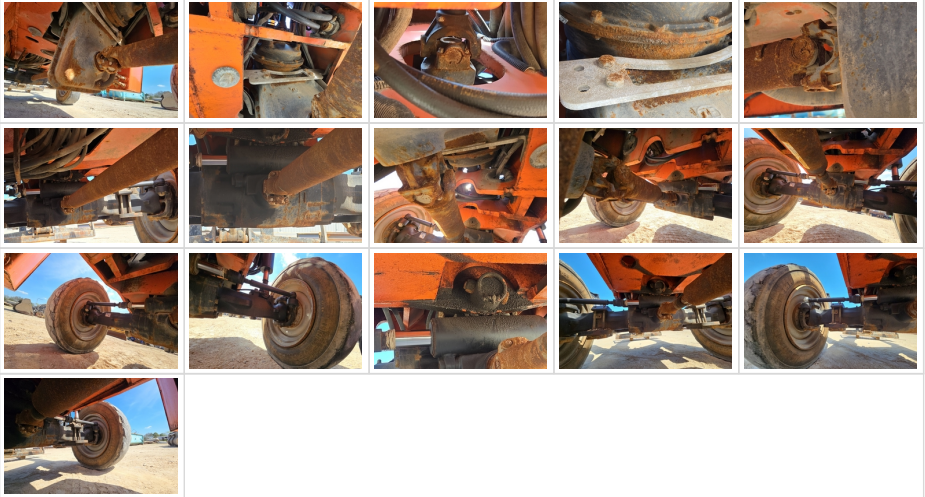
Drivetrain Photos

Hydrostatic Transmission?	No
Drive Type	Other (see comments)
Transmission Components	3 - Normal Wear & Tear
Parking Brake	3 - Normal Wear & Tear
Overall Drivetrain Rating	3 - Normal Wear & Tear
Overall Drivetrain Comments	Good condition
Front Axle	3 - Normal Wear & Tear
Rear Axle	3 - Normal Wear & Tear
