## Inspection Report (Skid Steer/Track Loader)

B&B Stock Number	A3027145
Year	2013
Make	Case
Model	SR220SSL
Serial Number	NDM454781
Serial Plate Photo

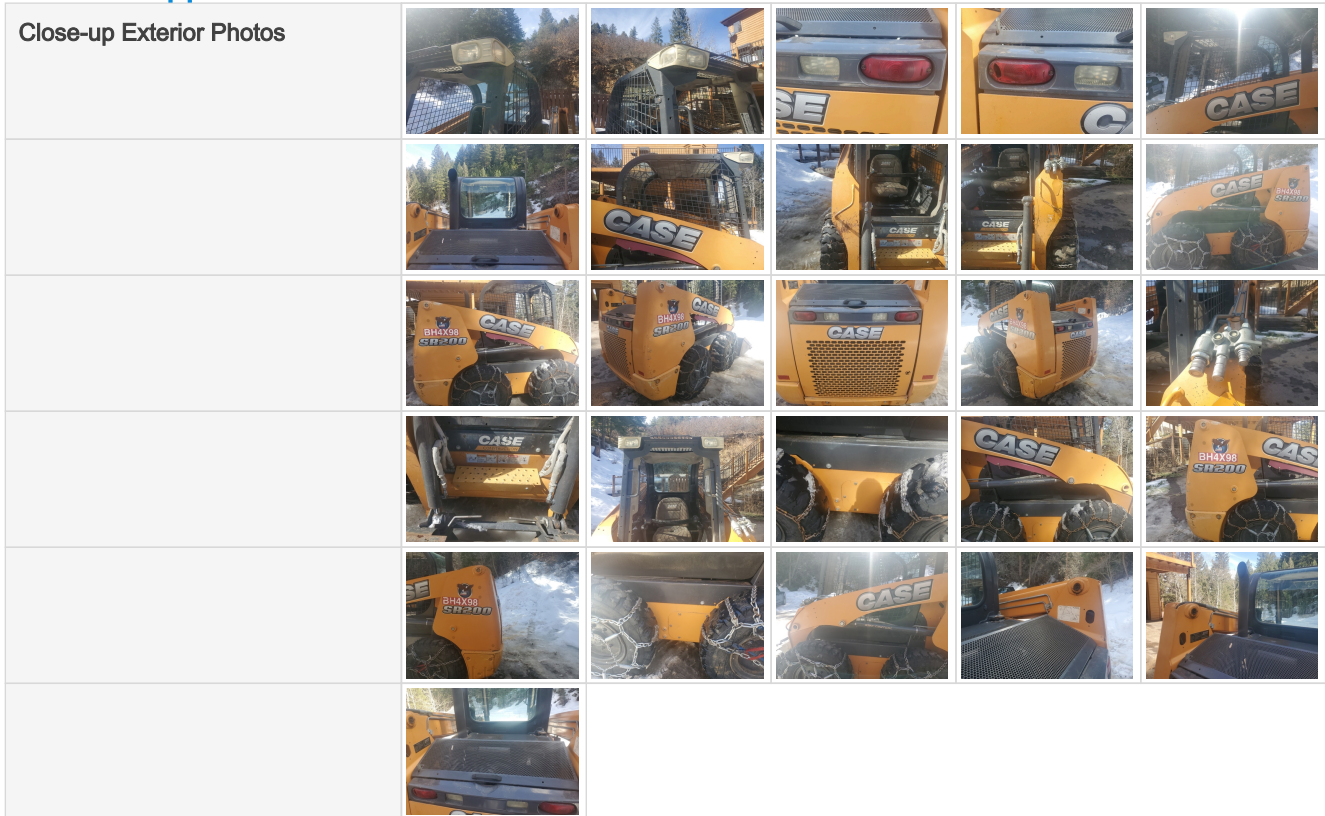
#### General Appearance Photos

Glass	4 - Very Light or Minimal Wear
Mirrors	0
Exterior Lights	3 - Normal Wear & Tear
Exterior Lights Condition	Major chip or cracks seen on light casings
Comments	Left taillamp cracked
Overall Exterior	4 - Very Light or Minimal Wear
Comments	No collision damage. All decals intact.

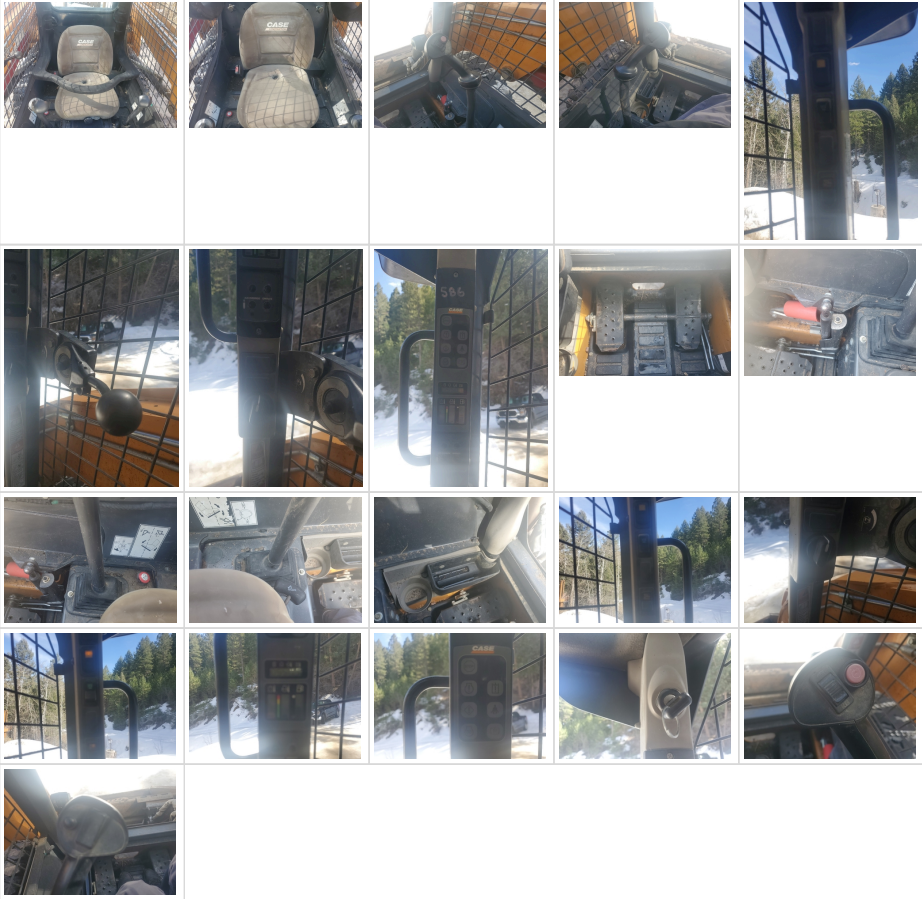
Control Station Photos

Control Station Type	Open Cab (OROPS), Canopy
Control Type	Pilot Controls
Control Configuration	ISO (JD)
Seat	2 - Above Average Wear & Tear
Seat Condition	Seat(s) is damaged due to sun exposure; fading, cracking observed
Cabin Lights	3 - Normal Wear & Tear

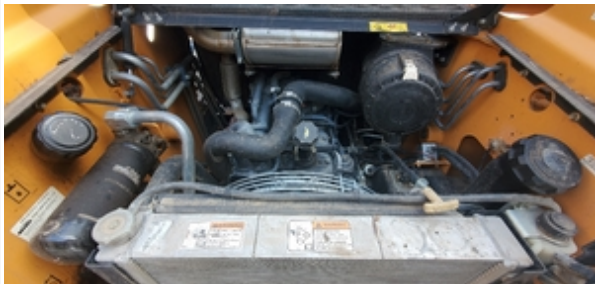
Engine Data Plate

Engine Type (Make, Model, Cylinders, Hp)	Case 432T/M3 4 cylinder 76hp
Emissions Tier	Tier 3
Engine Fuel Type	Diesel
Blow-by (Visual Observation Check)	Yes
Unusual Noises (Upon Start-up, Idle, Shutdown)	No
Engine Smoke (Upon Start-up, Idle, Shutdown)	Yes
Engine Smoke Notes	Engine smoke observed upon start up
Engine Exhaust Color	Clear at operating temperature
Battery	3 - Normal Wear & Tear
Radiator	3 - Normal Wear & Tear
Belts	3 - Normal Wear & Tear
Hoses	3 - Normal Wear & Tear
Water Pump	3 - Normal Wear & Tear
Cooling System Leaks	No
Coolant Appearance	3 - Normal Wear & Tear
Coolant Appearance Notes	Normal Translucent appearance, no visual signs of contamination
Oil Leaks	No
Oil Appearance	3 - Normal Wear & Tear
Oil Appearance Notes	Clean oil appearance, no signs of cross contamination
Fuel Leaks	No
Overall Engine Rating	3 - Normal Wear & Tear
Overall Engine Appearance	Dusty & dry
Overall Engine Comments	Starts and runs strong.
