Inspection Report (Excavator)

B&B Stock Number	A8659687
Year	2014
Make	Hitachi
Model	ZX350LC-5N
Serial Number	1FFDDC70CEE930553
Serial Plate Photo

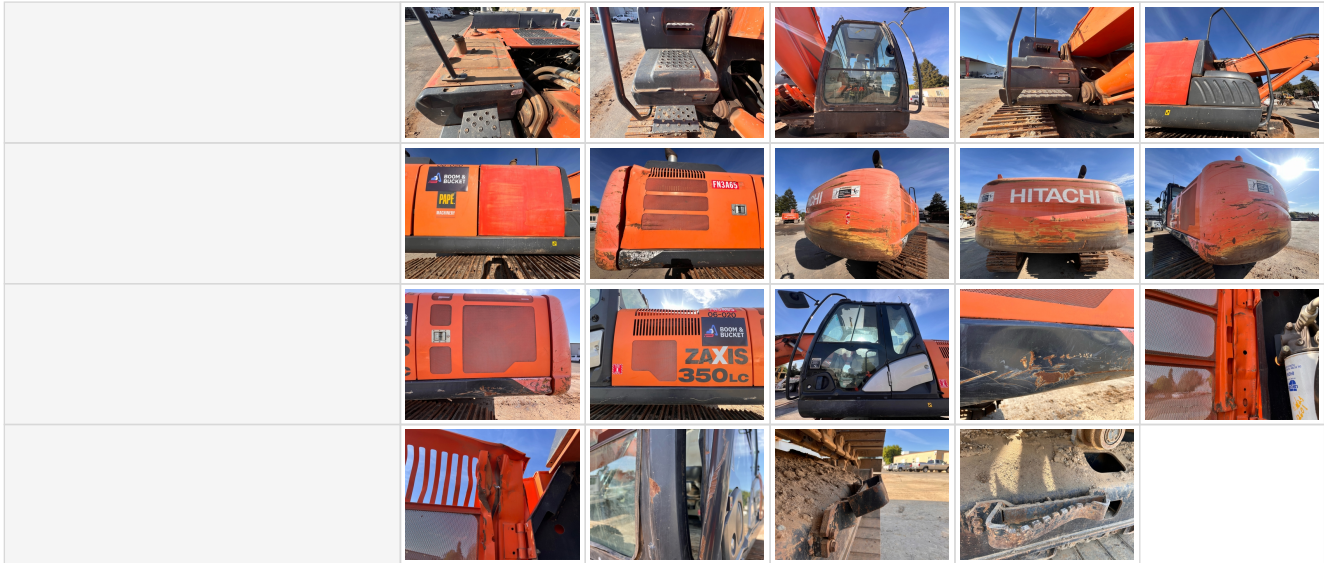
Close-up Exterior Photos

Handrails	2 - Above Average Wear & Tear	
Handrails Condition	Bent or broken railings	
Glass	3 - Normal Wear & Tear	
Glass Condition	Glass intact, no visible damage	
Mirrors	1 - Service Required	
Mirror Condition	One or more mirrors are broken or missing	
Exterior Lights	1 - Service Required	
Exterior Lights Condition	One or more exterior lights are non-operational, Overall lighting system is non-operational	
Overall Exterior	2 - Above Average Wear & Tear

Comments	Above average wear and tear, bent maintenance doors, Broken or missing mirrors, not operational or missing lights.
----------	--

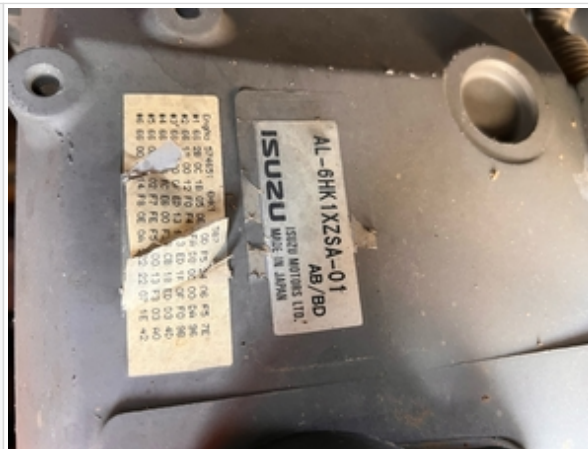
Engine Data Plate

Engine Type (Make, Model, Cylinders, Hp)	Isuzu, AL - 6HK 1X
Emissions Tier	Tier 4i
Engine Serial Number	6HK1XDLAA-01
Engine Fuel Type	Diesel
Blow-by (Visual Observation Check)	No
Unusual Noises (Upon Start-up, Idle, Shutdown)	No
Engine Smoke (Upon Start-up, Idle, Shutdown)	No
Engine Exhaust Color	Clear
Battery	3 - Normal Wear & Tear
Battery Condition	Dusty & dirty appearance
Radiator	3 - Normal Wear & Tear
Radiator Condition	Radiator fins & components appear to be in good working order, no signs of damage or leaks
Belts	3 - Normal Wear & Tear
Belt Condition	Belts appear in good condition & alignment with proper tension
Hoses	3 - Normal Wear & Tear
Hose Condition	Firm, pliant hoses with no signs of wear or leaks
Water Pump	3 - Normal Wear & Tear
Water Pump Condition	No unusual pump noises heard
Cooling System Leaks	No

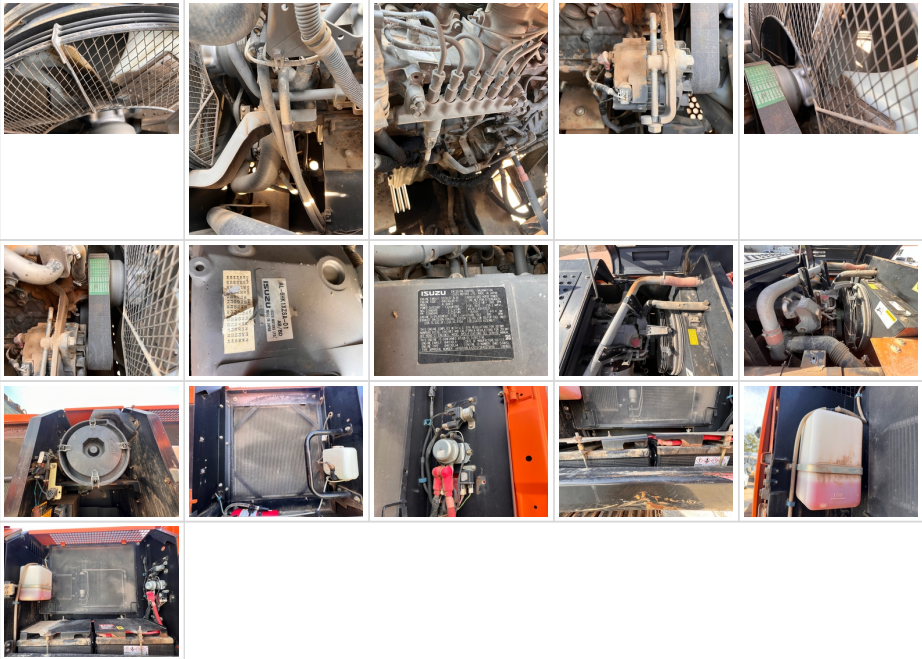
Engine Compartment Photos

Coolant Appearance	3 - Normal Wear & Tear
Coolant Appearance Notes	Normal Translucent appearance, no visual signs of contamination
Oil Leaks	No
Oil Appearance	3 - Normal Wear & Tear
Oil Appearance Notes	Appropriate oil level
Fuel Leaks	No
Equipped with DPF (Diesel Particulate Filter)	Yes
DPF Condition	3 - Normal Wear & Tear
DPF Condition Notes	Filter housing is intact with no signs of damage or malfunction, DPF indicator is not illuminated
Requires DEF (Diesel Exhaust Fluid)	No
Overall Engine Rating	3 - Normal Wear & Tear
Overall Engine Appearance	Dusty & dry
Overall Engine Comments	Normal wear and tear no major issues to report

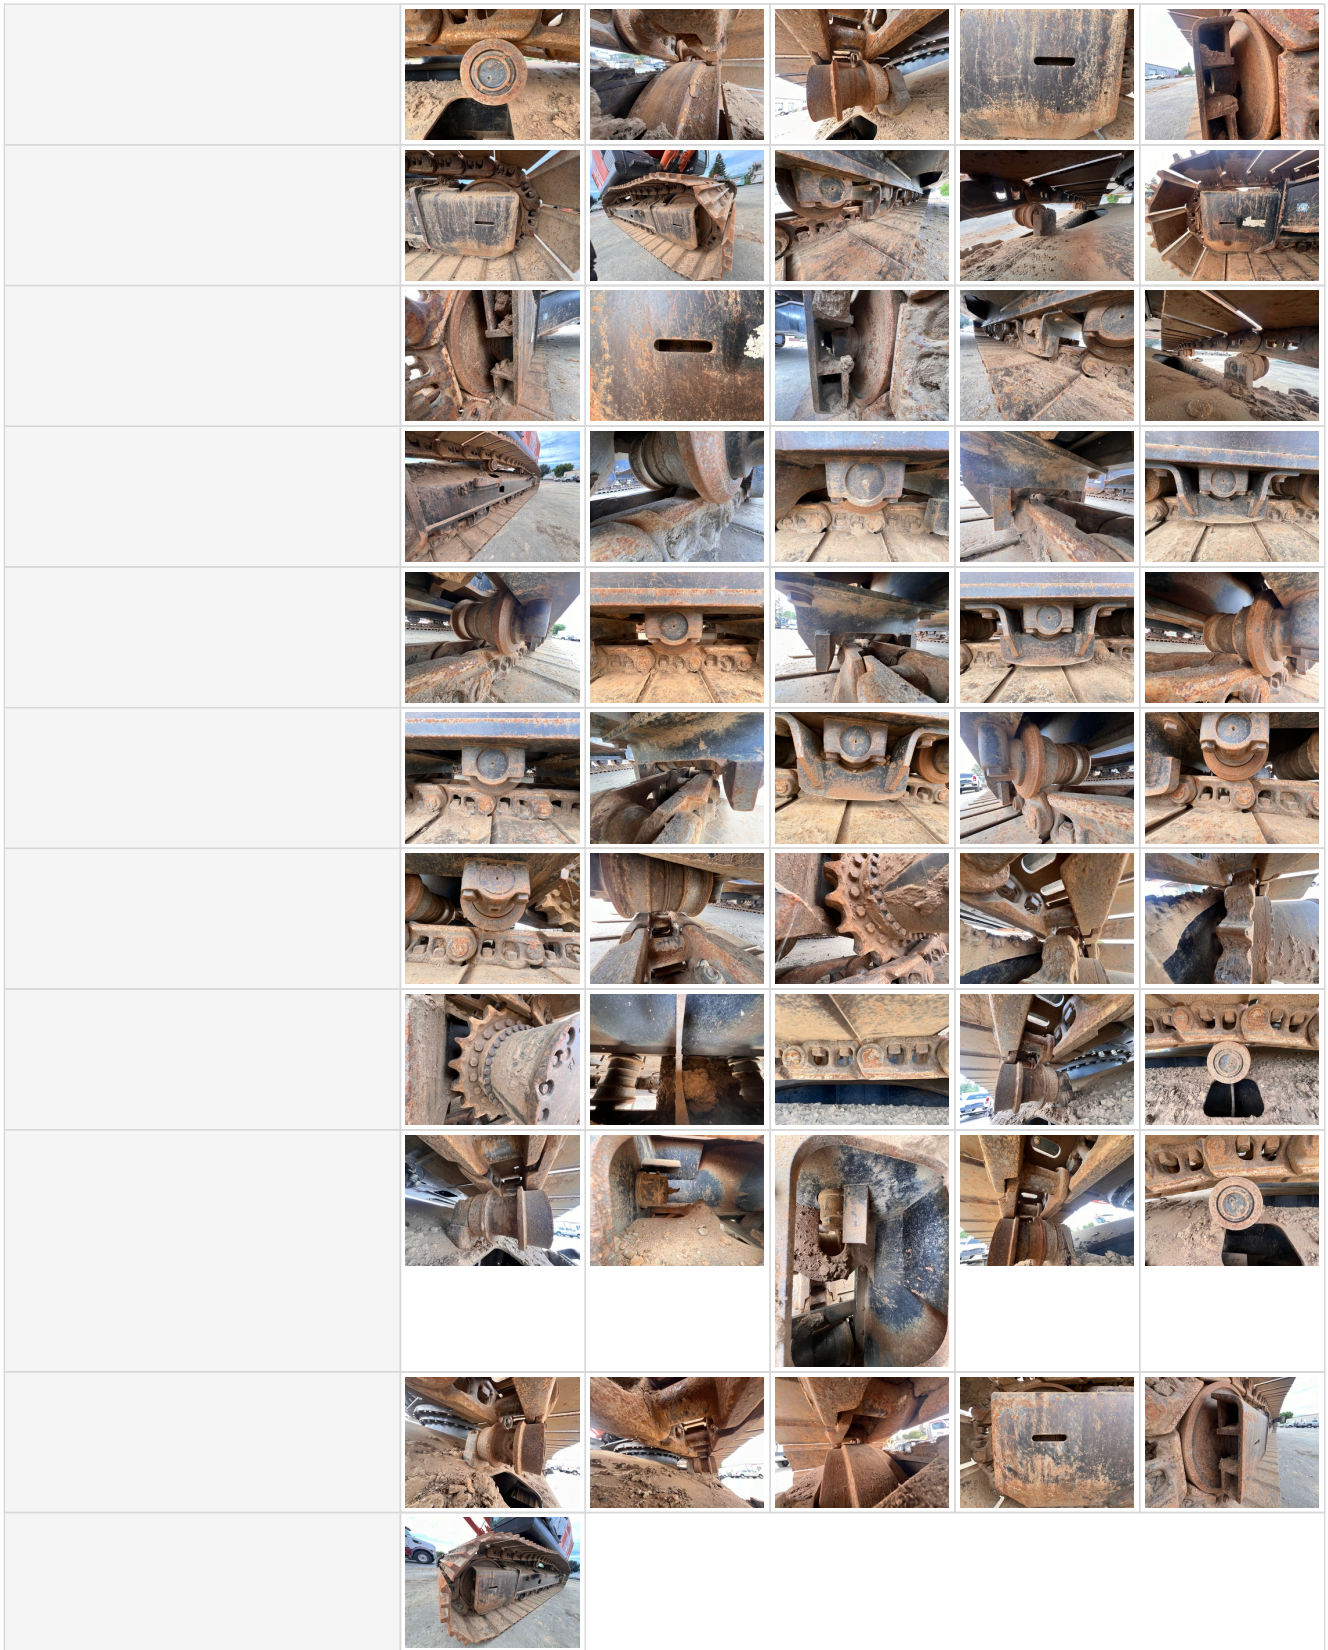
Undercarriage Photos

Sprocket Teeth	3 - Normal Wear & Tear
Track Bushings	3 - Normal Wear & Tear
Track Frames	3 - Normal Wear & Tear
Pivot Shafts	0
Equalizer Bar & Joints	0
Front Idler	3 - Normal Wear & Tear
Track Tensioner	3 - Normal Wear & Tear
Track links	3 - Normal Wear & Tear
Bottom Rollers	3 - Normal Wear & Tear
Carrier Rollers	3 - Normal Wear & Tear
Overall Undercarriage	3 - Normal Wear & Tear
Overall Percent Estimate	50%
Overall Undercarriage Comments	Normal wear and tear no major issues to report
