Inspection Report (On-Highway Truck Cab + Chassis)

B&B Stock Number	A5909592
Year	2012
Make	Freightliner
Model	M2
Serial Number	1FUJJC5DV7CHBJ7011
Serial Plate

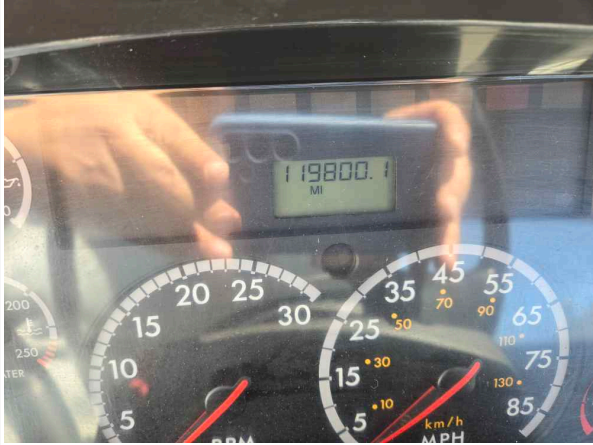
Odometer Reading	119800
Odometer

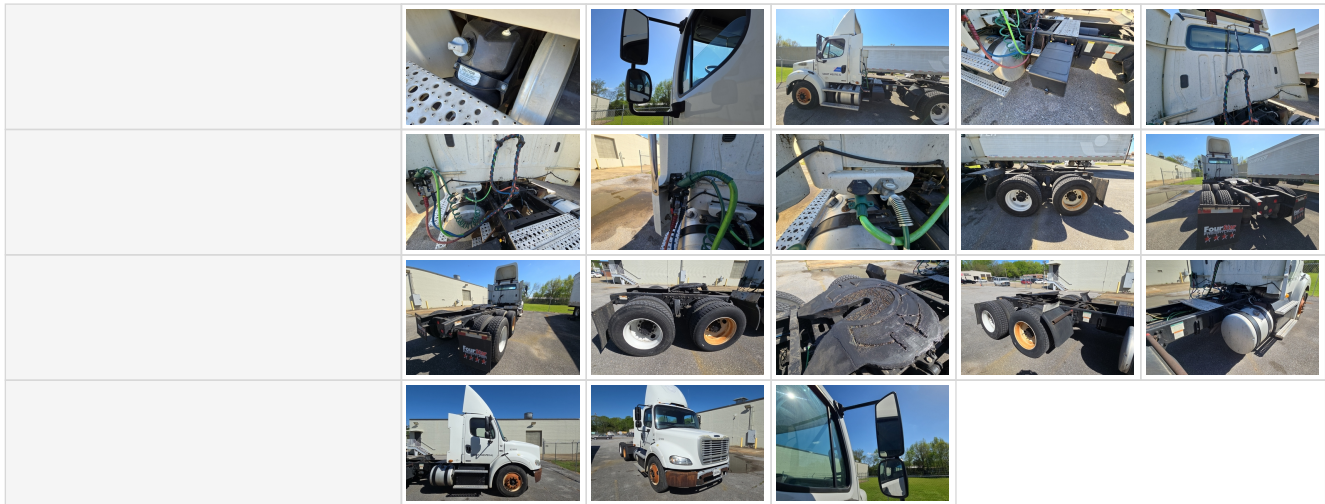
Close-up Exterior Photos

Handrails	3 - Normal Wear & Tear	
Handrails Condition	Handrails are fully intact and appear structurally sound	
Glass	3 - Normal Wear & Tear	
Glass Condition	Glass intact, no visible damage	
Mirrors	3 - Normal Wear & Tear	
Mirror Condition	Mirrors present and intact, no visible damage	
Exterior Lights	3 - Normal Wear & Tear	
Exterior Lights Condition	No visible damage, lighting system is operational	
Overall Exterior	3 - Normal Wear & Tear	
Comments	Overall, the body is in good condition. Some areas of light rust were seen on the front bumper and on some of the trucks rims.

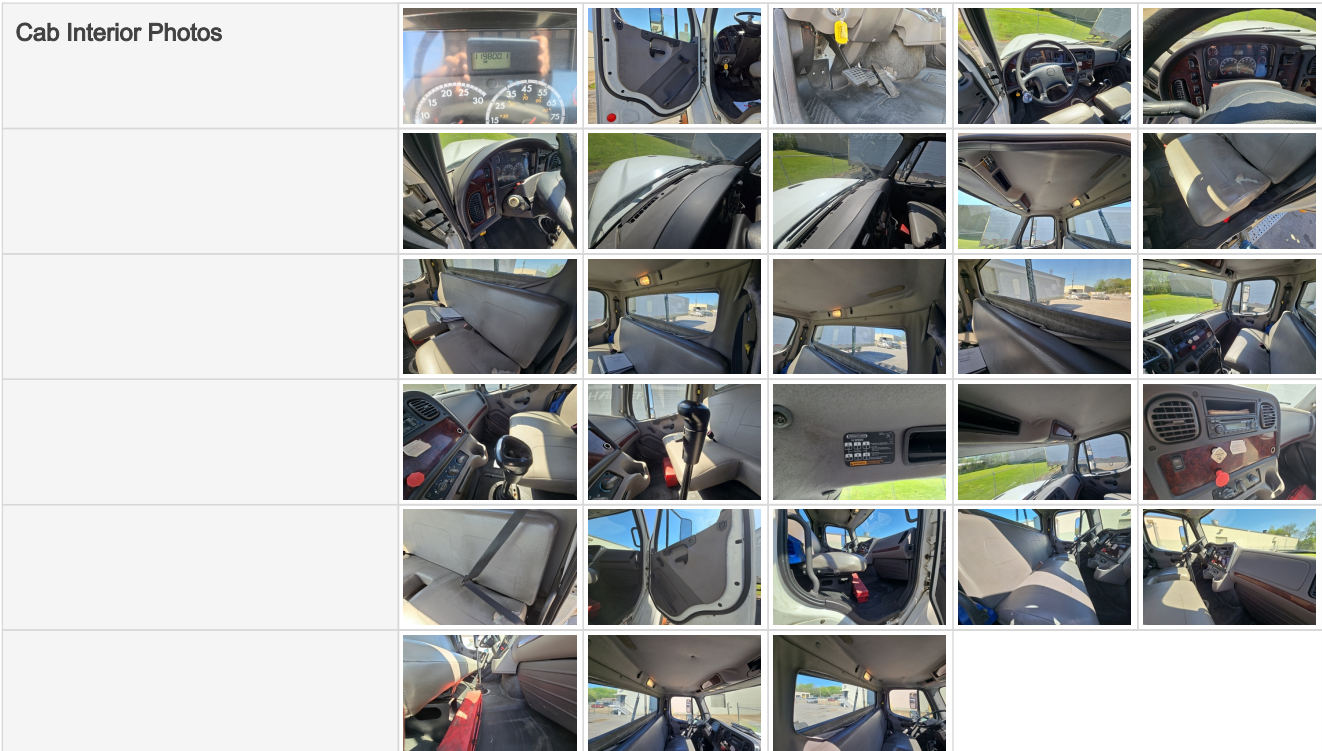
Cab Interior Photos

Odometer Activity	3 - Normal Wear & Tear
Odometer	Odometer is working and in good condition
Controls/Switches/Gauges	3 - Normal Wear & Tear
Controls/Switches/Gauges	All switches/gauges are in good condition and functioning
Brake System Type	Air Brakes
Air Brakes Build Correct Pressure	Yes
Clutch	3 - Normal Wear & Tear
Clutch Function	Clutch is functioning as expected
Horn	3 - Normal Wear & Tear
Horn Function	Horn is functioning as expected
Reverse Alarm / Backup Camera	0
Heater & A/C	2 - Above Average Wear & Tear
Heat & A/C	A/C Blows cool - noticeably cooler than air temp
Interior Lights	3 - Normal Wear & Tear
Interior Lights	All interior lights are installed and functioning
Seats/Seat Belts	3 - Normal Wear & Tear

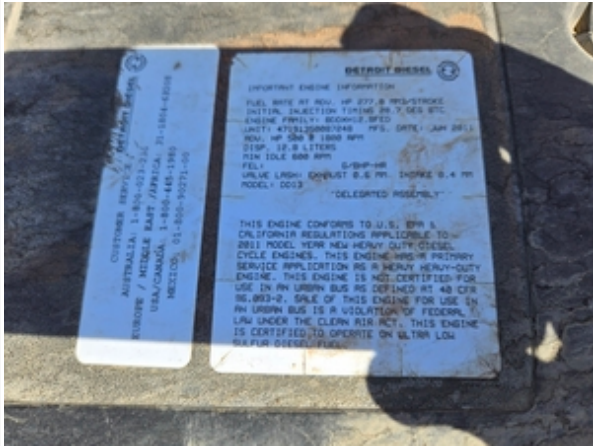
Engine Data Plate

Engine Type (Make, Model, Cylinders, Hp)	Detroit, Hp 277				
Emissions Tier	Tier 4F				
Engine Serial Number	unable to verify				
Engine Fuel Type	Diesel				
Blow-by (Visual Observation Check)	Yes				
Comments	The blowby check was good				
Unusual Noises (Upon Start-up, Idle, Shutdown)	Yes				
Unusual Noise Notes	High-pitched metallic pinging heard				
Comments	The sound went away after the truck warmed up

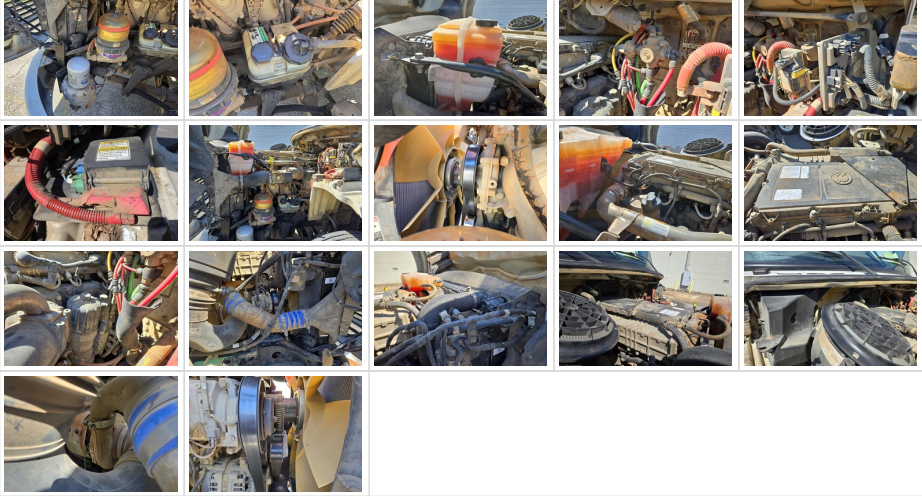
Engine Compartment Photos

DPF Condition	3 - Normal Wear & Tear
DPF Condition Notes	Filter housing is intact with no signs of damage or malfunction, DPF indicator is not illuminated
Requires DEF (Diesel Exhaust Fluid)	Yes
DEF Tank	3 - Normal Wear & Tear
DEF Tank Condition	Area around DEF tank cap is clean, fluid is clear & appears free of contaminants
Overall Engine Rating	3 - Normal Wear & Tear
Overall Engine Appearance	Dusty & dry
Overall Engine Comments	The engine is in good condition
