## Inspection Report (On-Highway Truck Cab + Chassis)

B&B Stock Number	A9653085
Year	2007
Make	Freightliner
Model	Columbia
Serial Number	1FUJA6CK97LX83192
Serial Plate

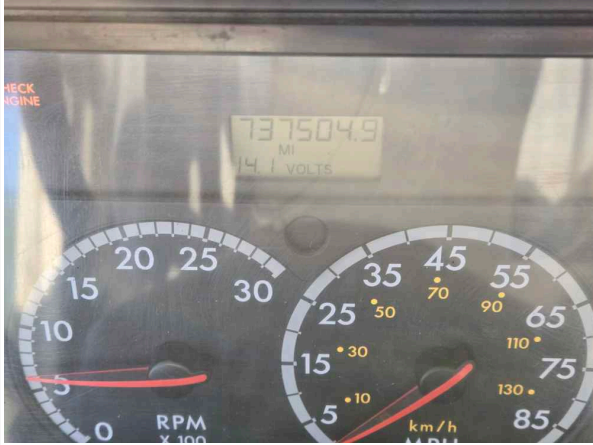
Odometer Reading	737504
Odometer
