## Inspection Report (Trailer)

B&B Stock Number	A3830712
Year	2022
Make	AM
Model	AM360 2000GN
Serial Number	2M9FGH2A8PL200330
Serial Plate Photo

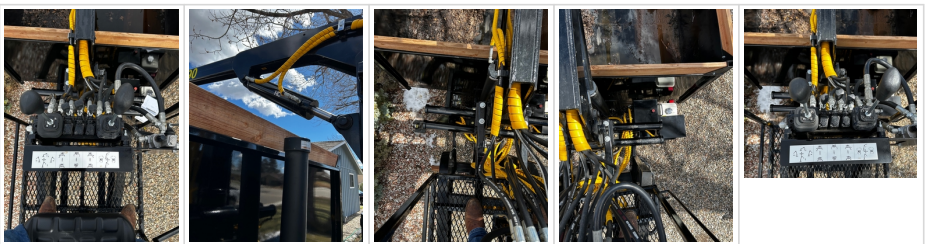
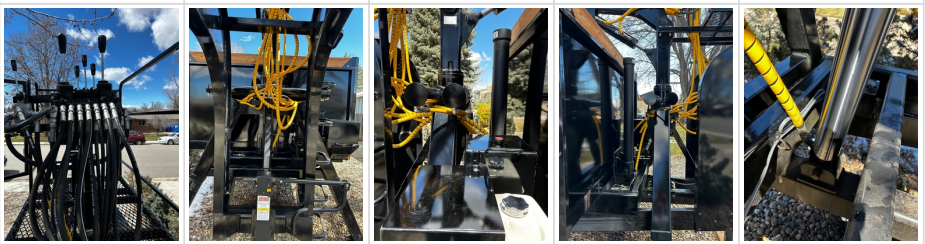
Hydraulic System Photos

Wet or Damp Hydraulic Lines / Fittings	No			
Hydraulic Lines/Fittings	4 - Very Light or Minimal Wear			
Hydraulic Lines / Fittings Condition	Hydraulic lines & fittings are clean and in good condition			
Hydraulic Pump(s)	4 - Very Light or Minimal Wear			
Unusual Noises	No			
Hydraulic Pump Notes	No unusual noises heard during operation

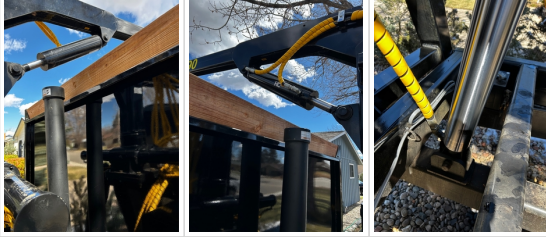
Hydraulic Cylinder Photos

Mounting Pins	4 - Very Light or Minimal Wear
Cylinder Oil Leaks	No
Comments	Entire unit is dry with no seepage seen. Only visible oil is seen below engine from changing oil of engine
Hydraulic System Overall	4 - Very Light or Minimal Wear
Comments	Seller added hydraulic hose protection after the trailer was purchased. No hose damage or seepage can be seen
